MASTER THESIS

**ADAPTIVE REUSE OF SILO BUILDINGS WITH
CONTEMPORARY APPROACHES**

DEPARTMENT OF INTERIOR ARCHITECTURE

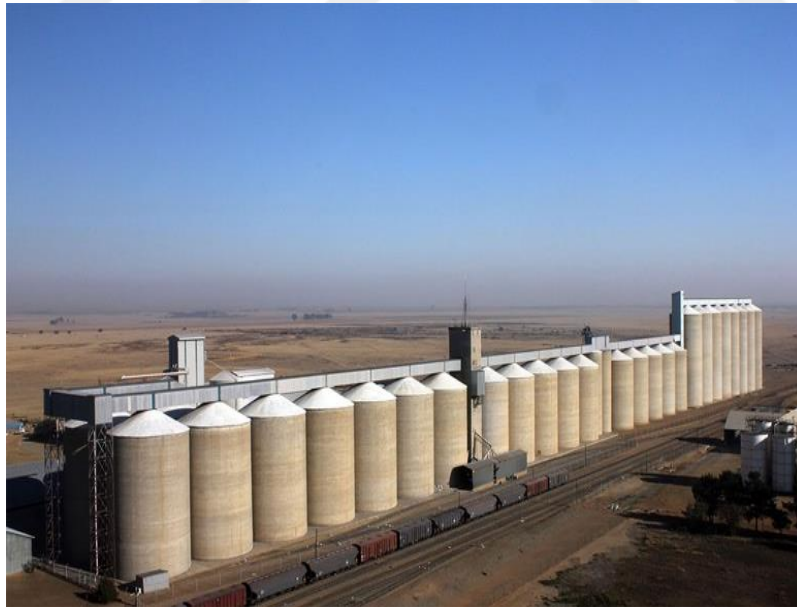
Figure 3.6: World's largest reinforced concrete silo with a capacity of 275.000 tons located in South Africa
Retrieved from <https://www.xtraspace.co.za/blog/articles/five-of-the-worlds-biggest-storage-spaces-no5> in 16.09.2019

Throughout history, small scale silo samples, in cubic, cylindrical etc. form, were encountered with materials, such as wood (Figure 3.3), stone block (Figure 3.4), special curved tile (Figure 3.5) due to differences in region, period, culture, environment, local techniques and so on, and large scale reinforced concrete silos (Figure 3.6) started to be built from the beginning of the 20th century (Beedle, 2001, 3). At the present time, instead of huge concrete structures, steel silos are built via the developing materials and technology due to the cheaper cost and shorter duration of construction. (Fernandez, 2018) (Figure 3.7)

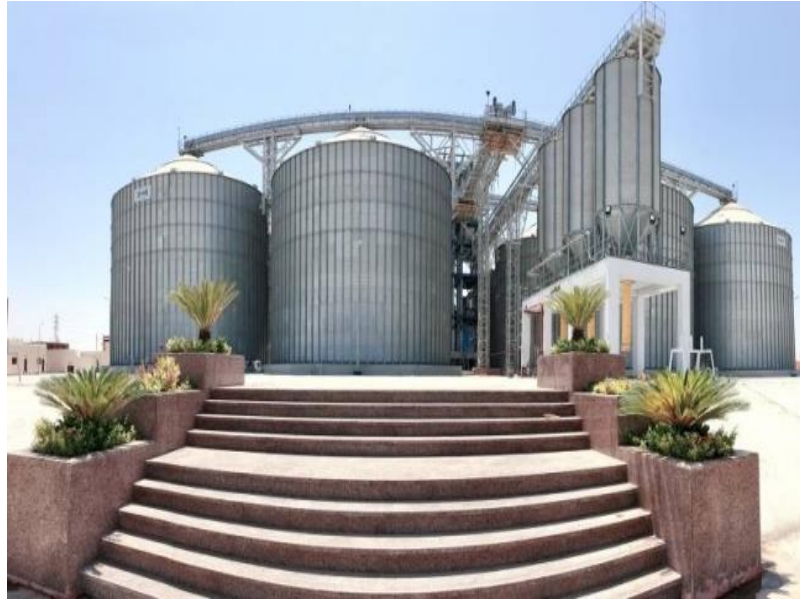
Figure 3.7: World's largest steel silo facility with a capacity of 1,3 million tons located in Egypt.

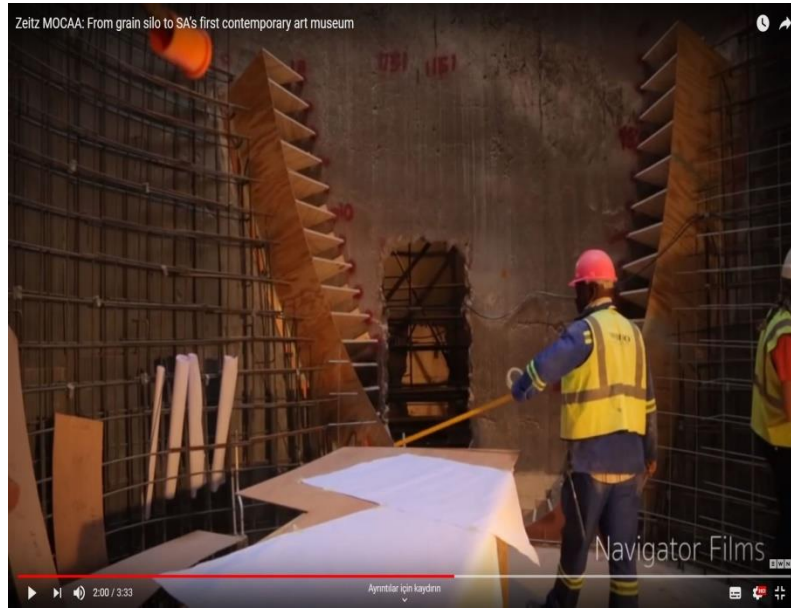
Figure 3.34: Reinforcement works during the intervention to Zeitz MOCCA's silos.

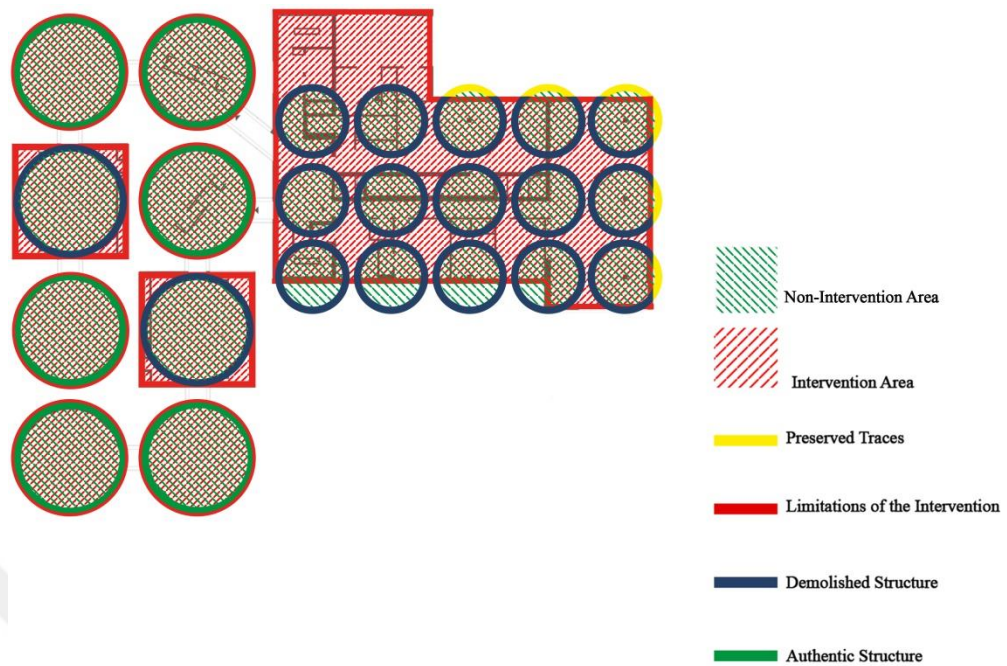
Figure 3.40: Visual showing the lines of intervention on the plan of Kanaal.
 Plan retrieved from <https://www.archdaily.com/885884/kanaal-in-wijnegem-stephane-beel-architects/5a3b2f6db22e384b3a00013e-kanaal-in-wijnegem-stephane-beel-architects-third-level-plan> in 15.06.2019. The diagram showing the intervention was created by the author.

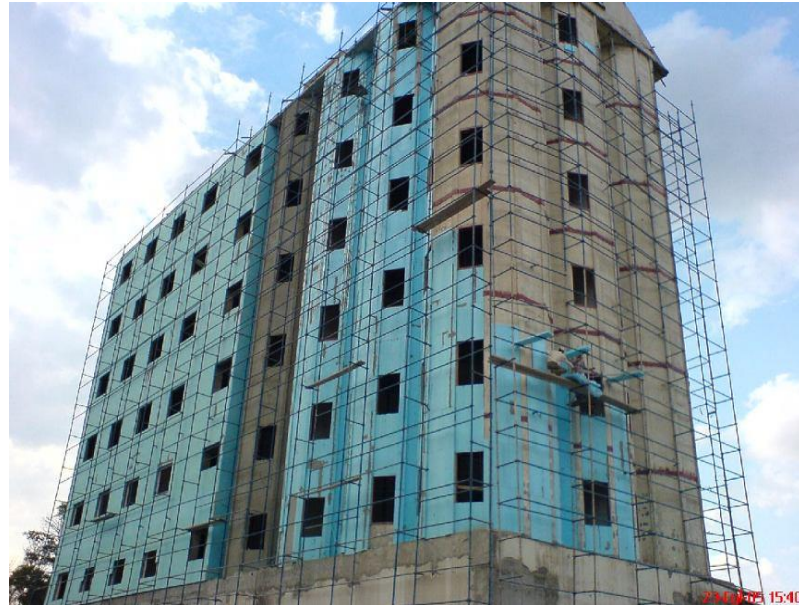
Figure 3.57: Heat insulation installation to the exterior façade during the intervention phase.

The spatial arrangements, required by the new function, were made in the intervention process due to the silos' structural gap. The window gaps were opened to correspond to the accommodation conditions of the reinforced concrete structure of the building. In the building, which has transformed to be re-used as a hotel, a restaurant, a lobby, meeting rooms and 108 bedrooms were formed. (Figure 3.58) The materials used in the hotel building, created by the intervention applied to the original building, were used in accordance with its own period and are oriented towards the needs of the developing city. However, no characteristic of the authentic silos has been conserved except the cylindrical exterior formation. That being said, this new building, created by intervention, is a non-creative design that does neither contribute to the enrichment of the environment, nor incompatible with the current context. The silo, which is close to the railway, remained in the developing city over time and lost its relationship with its surroundings. However, due to the spatial needs required by the new function inside the silos, the interior equipment has been completely removed.

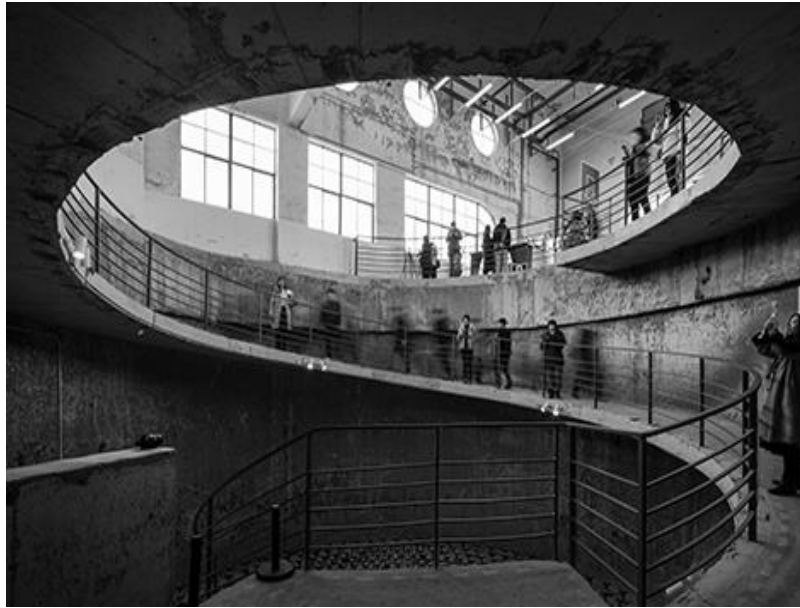
Figure 3.64: Spiral ramp built into one of the silos.
