MASTER THESIS

**THE ENHANCEMENT OF CASTLE RUINS WITH
CONTEMPORARY ADDITIONS AS AN ADAPTIVE
REUSE INTERVENTIONS**

MSC IN INTERIOR ARCHITECTURE

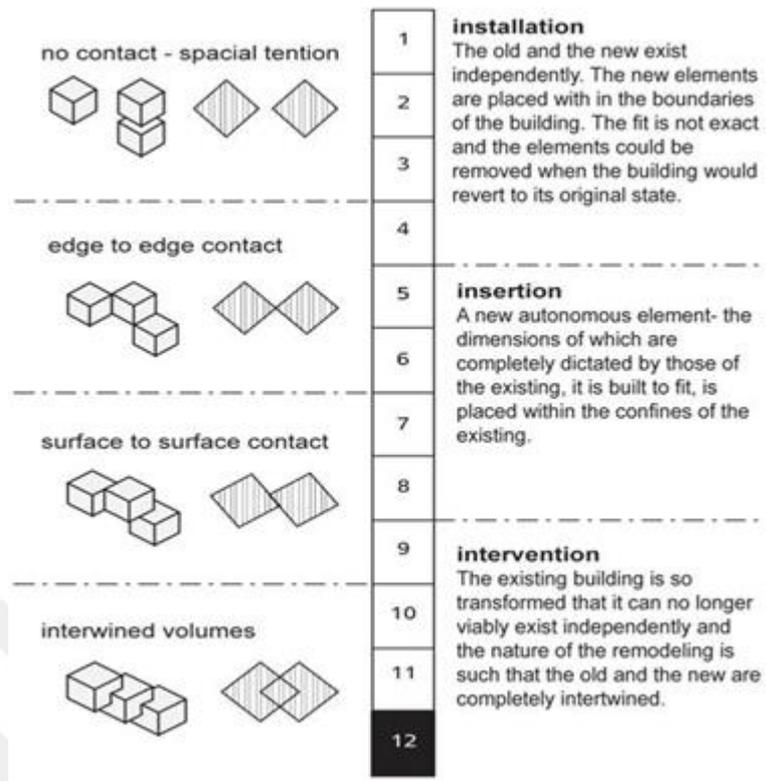
Figure 2.1. The extent of remodeling an existing building, including the three strategies/categories, four diagrams illustrating physical application, and a numerical scale linking the two measures. (Fisher-Gewirtzman, 2016)

When the examples of the refunctioning of the buildings are examined, different approaches and strategies that vary between simple repairs and complete reconstruction of the ruin are seen. While applying these methods, it has been emphasized that keeping the building or structures as they are, no matter how worn out, is important for understanding the history of that place (Brooker & Stone, 2016). Based on the extent of integration between the existing building and the new additions, Brooker and Stone examine reuse strategies under the headings of installation, insertion and intervention (Figure 2.1).

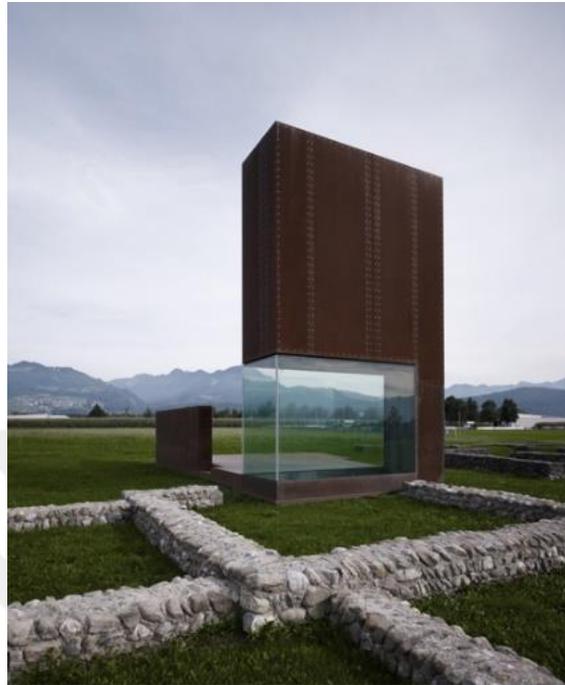
Figure 2.2. Example of Installation: Rusty steel tower over Roman ruins. Retrieved from <https://www.dezeen.com/2013/11/25/rusty-steel-tower-over-roman-ruins-marte-marte-architects/> in December, 2021

An installation may be defined as a new addition that is placed on the building itself or to an environmental element of the building without establishing any structural relationship with the building. This structure need not be abandoned or in ruins. Installations can also be performed independently of adaptive reuse interventions. This addition may be located within, adjacent to, or in a specific portion of the building and it is usually an object that may have aesthetic or artistic value in its own right but is expected to provide a contextual or functional relationship to the existing structure. The installation usually aims to raise awareness of the existing structure while using the space as an exhibition area for itself. Installations are usually temporary, but permanent installations are also quite common (Figure 2.2).

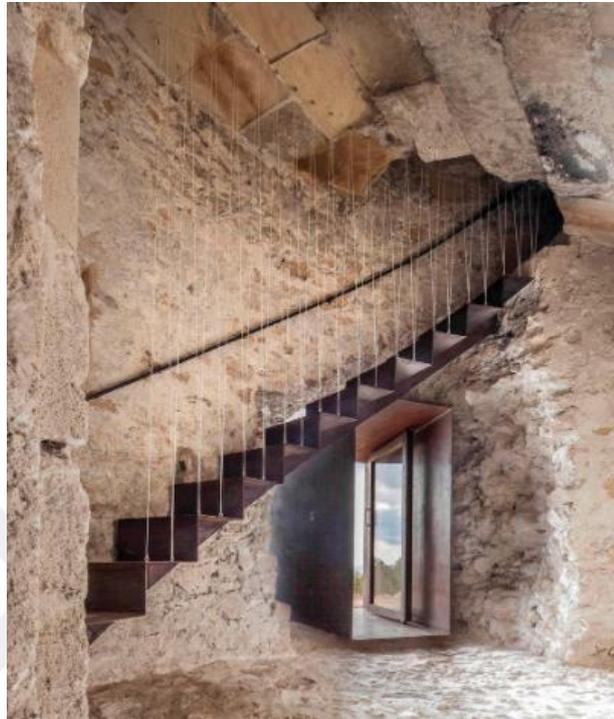
Figure 2.3. Example of Insertion: Pi des Catalá Tower. The original stone staircase and doorway has been replaced with a steel structure. Retrieved from <https://www.designboom.com/architecture/maria-castello-martinez-pi-des-catala-tower-restoration-formentera-spain>

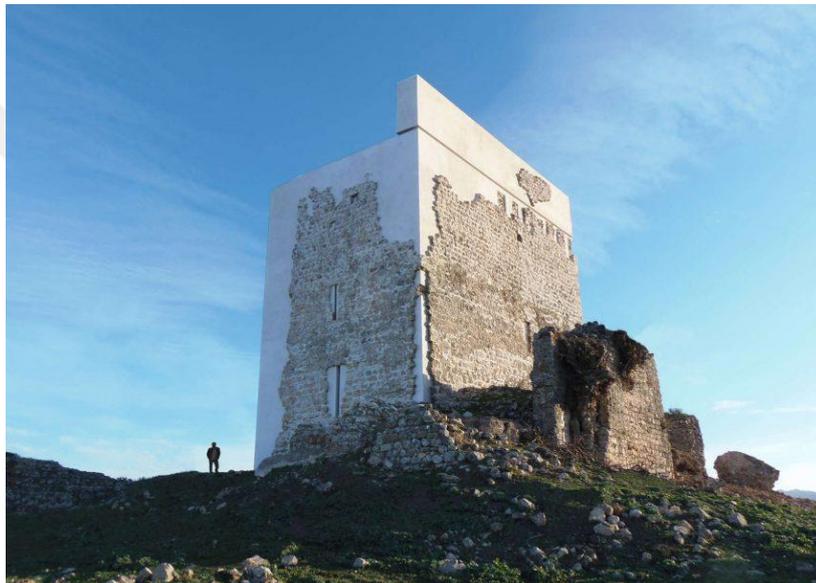
Figure 2.4. Example of Intervention Method. Matrera Castle by Carquero Arquitectura. Retrieved from <https://www.dezeen.com/2016/10/03/carquero-arquitectura-matrera-castle-contemporary-restoration-cadiz-spain-architizer-awards/> in December, 2021.

In the Intervention method, the main instrument of the designer is the existing structure. In this approach, the design takes almost every data from the original structure itself. The item that is wanted to be shown, glorified, and exhibited is the original structure. As in the Insertion and Installation approaches, there is no restriction on the contact of the old with the new. In this method, the old and the new are expected to be intertwined. A direct intervention on the existing structure may represent a completion, a repair, or even just a clean-up operation. It is not just a method based on addition or building; the mentioned intervention can even be a demolition operation in line with the designer's readings. The dose of contrast is slightly lower in the material selection of the new additions. While making selections closer to the materials that make up the original structure, care should still be taken to ensure that the old and the new are distinguishable at first glance (Figure 2.4).

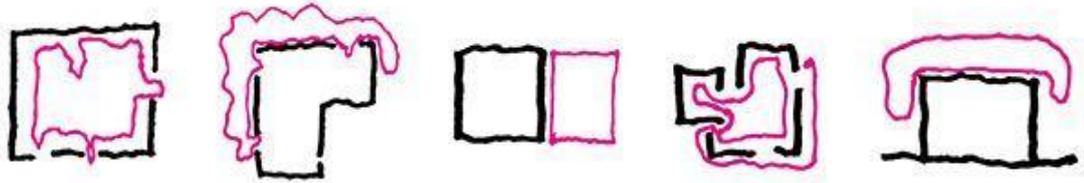
Figure 2.5. In her book *Old Buildings, New Forms*, Bollack divides adaptive reuse projects into five categories, and illustrates each with a diagram (from left to right): insertions, parasites, juxtapositions, weavings, and wraps (Hurley, 2013)

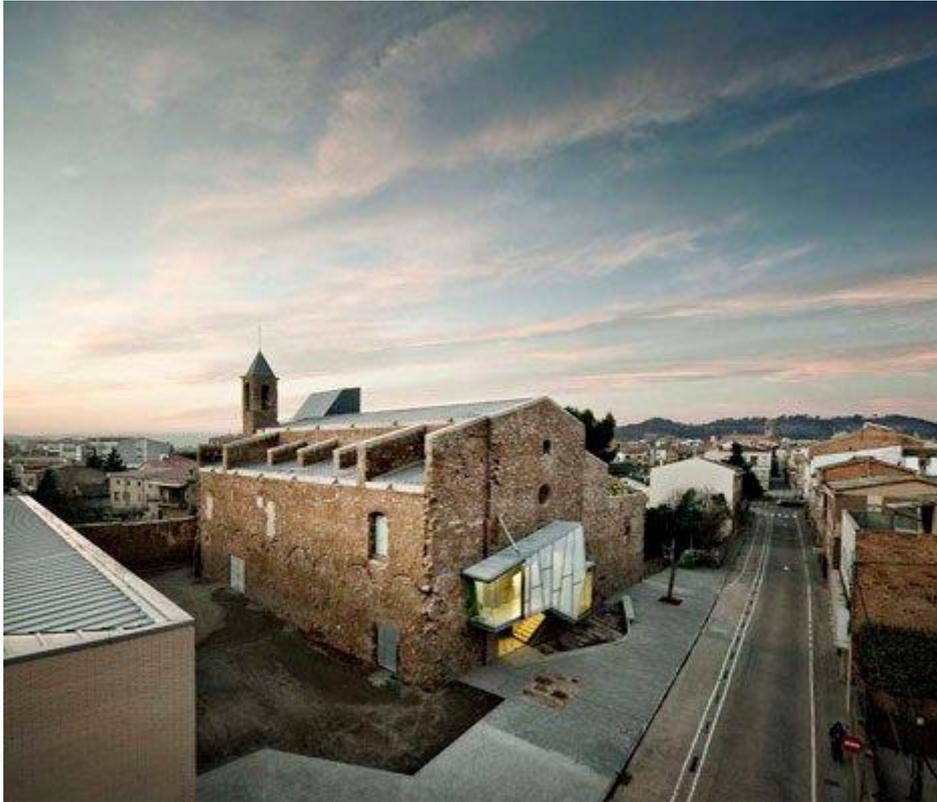
Figure 2.6. Example of Parasites. Church of Saint Francis' by David Closes.
Retrieved from <https://www.dezeen.com/2012/07/26/convent-de-sant-francesc-by-david-closes/> in December, 2021

Parasites; Bollack likens the new attachment to a parasite in this strategy. Since the new structure adds physical and semantic value to the old structure, the parasite also benefits the organism. The host is both the host of the parasite and a symbiotic relationship from which the parasite benefits. In this architectural intervention, the new addition can be attached to any part of the existing building. This addition, which is not concerned about the boundaries of the building, can appear as a mass placed on the roof of the building or as a protrusion from its facade to the street. As with most other strategies, the material is easily distinguishable from the material of the original building, and usually this new addition can be removed if desired without damaging the original building (Figure 2.6).

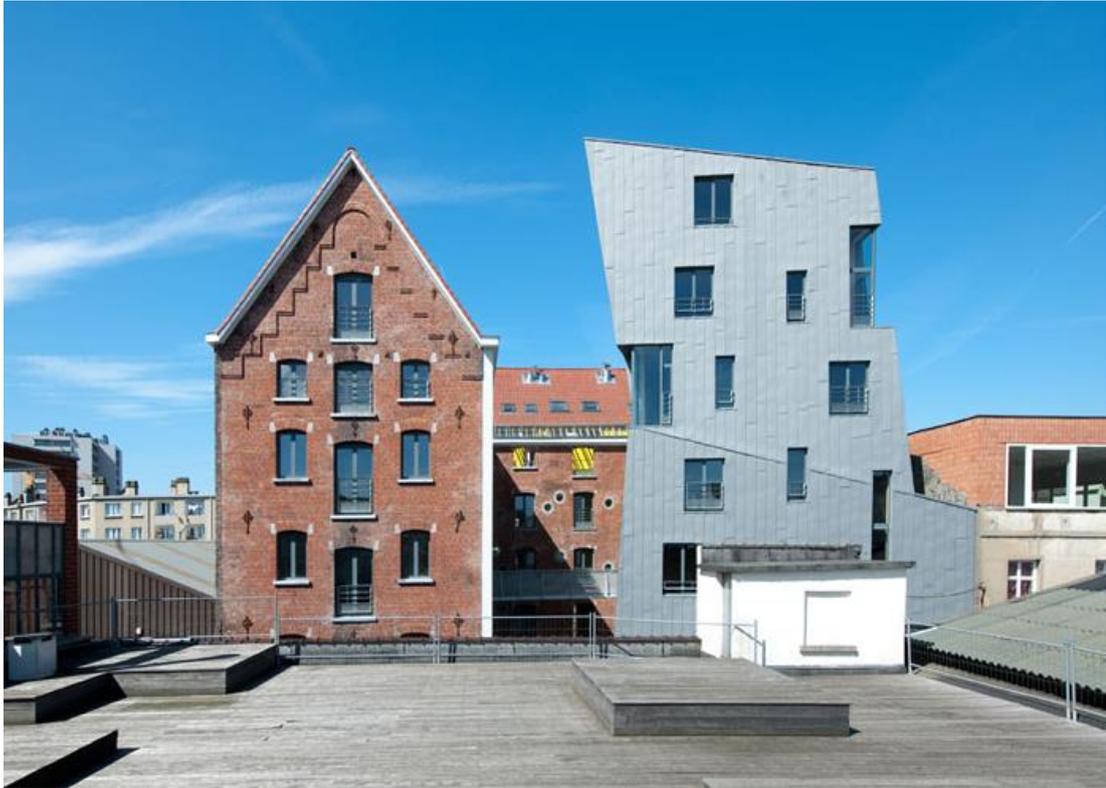
Figure 2.7. Example of Juxtapositions. Housing units/studios by l'escout Architectures & Atelier Gigogne. Retrieved from <https://archello.com/project/housing-unitsstudios-for-artists-cheval-noir> in December, 2021

Juxtapositions; In this approach, the additional building is located next to the old buildings, but is not dependent on the old building. It does not make physical contact with the original structure, but takes references from it such as boundaries, axes, scale, volume. It shows an almost completely discrete structural feature. In applications where this approach is adopted, the aim is to make a functional contribution to the old structure and its environment. While the original structure is fully legible, it is distinguished from the new structure by a clear boundary (Figure 2.7).

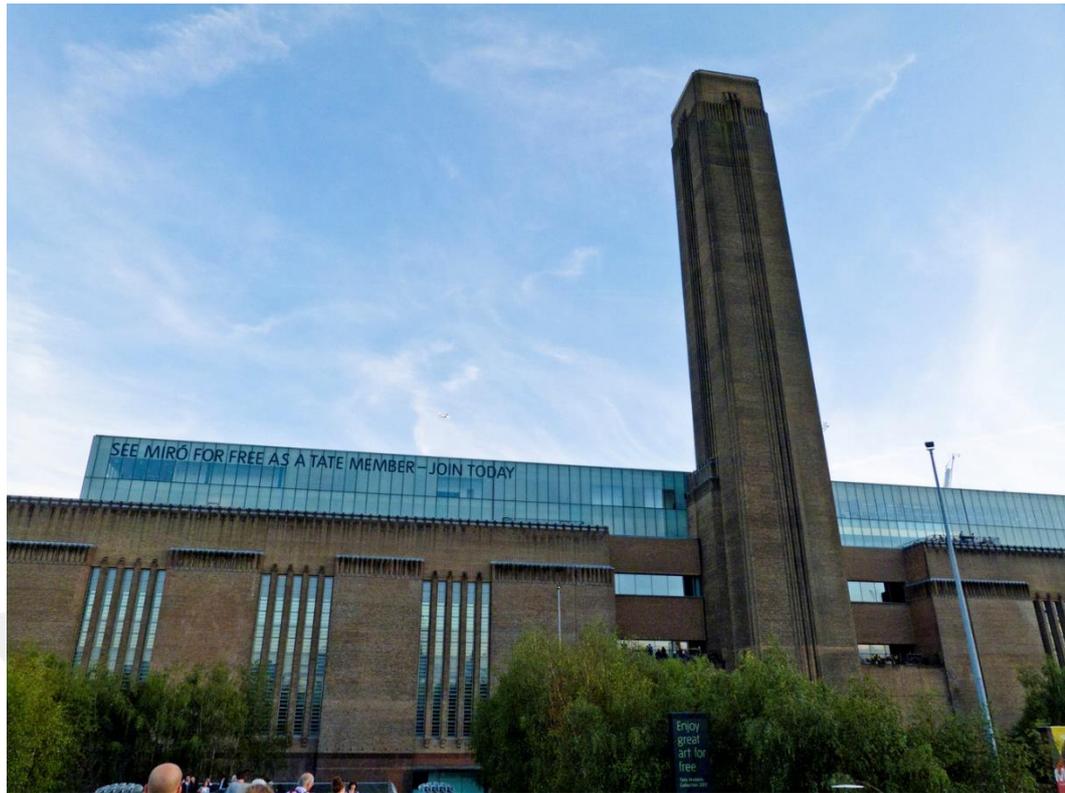
Figure 2.9. Example of Wraps. The Tate Modern by Herzog & de Meuron.
Retrieved from <https://www.archdaily.com/429700/ad-classics-the-tate-modern-herzog-and-de-meuron> in December, 2021

Wraps; In this operation, the new addition may stand on the old building or surround the building like a shell. In the parasite method, the additional building is used as a separate room and is interwoven with the building. Although there is no such commitment with the wrap method, it is usually created with a focus on protecting the building as a top cover or a wall. In some examples, it may be similar to the installation method (Figure 2.9).

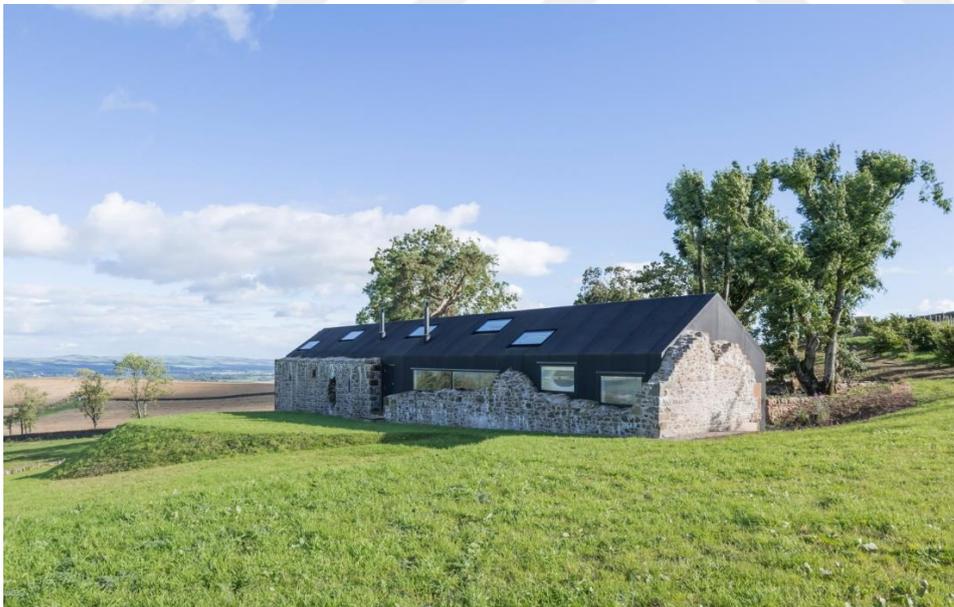
Figure 2.11. Example of Building inside the ruin. Ruin Studio by Lily Jencks Studio + Nathanael Dorent Architecture. Retrieved from <https://www.archdaily.com/881994/ruin-studio-lily-jencks-studio-plus-nathanael-dorent-architecture> in December, 2021

In the "building within the ruin" method, the ruin is more visible than in other methods. The new addition is within the interior boundaries drawn by the ruin, does not establish a structural relationship with the ruin, and uses the area defined by the ruin as an environment for itself. This is consistent with the insertion method mentioned by Brooker, Stone, and Bollack. In the final product, both the ruin and the new addition completely preserve their characteristic features and contribute to each other. The ruin state and ruin value of the existing structure are preserved and visible (Figure 2.11).

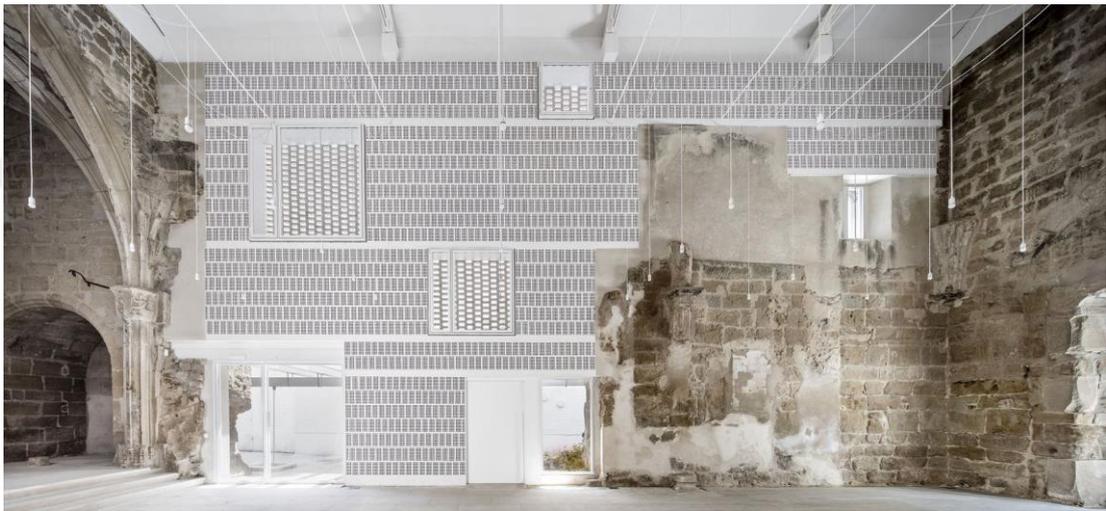
Figure 2.12. Example of Building on the ruin. Santa María de Vilanova de la Barca by AleaOlea architecture & landscape. Retrieved from <https://www.archdaily.com/803620/santa-maria-de-vilanova-de-la-barca-aleaolea-architecture-and-landscape> in December, 2021

on the ruin". The new addition follows the borders drawn by the ruin here, but this time it does not stay indoors and can extend itself to the exterior of the ruin. However, it does not go beyond the massive limits of the ruin. It establishes a direct relationship with the ruins structurally, even uses the remains as a carrier for itself and covers the entire interior. Looking at the final product, the ruin is visible from both sides, but it is no longer possible to read it separately from the new addition. At the same time, the new addition to the ruin is a complementary element. The ruin of the existing structure is easily visible but is now part of the new extension (Figure 2.12).

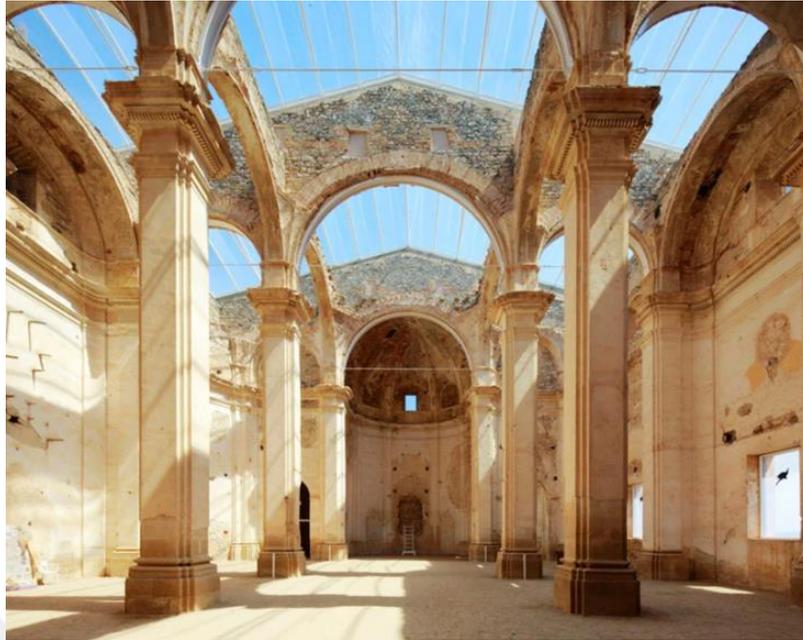
Figure 2.13. Example of Building over the ruin. Derelict Church by Ferran Vizoso. Retrieved from <https://www.designboom.com/architecture/ferran-vizoso-architecture-frames-a-derelict-church/> in December, 2021

The "building over the ruin" method usually appears in the form of a cover or shell. Davies defines this method as "The simplest and least destructive solution." The new addition covers the existing structure. It goes beyond the limits of the ruin. It is larger in mass and volume than the existing structure and is positioned to enclose it. The ruin now continues to live in the interior of the existing building. It restricts or completely cuts off the ruin's connection to the outside world. This protects the ruin from weather-related erosion. The existing building retains the features and value of the ruin but is no longer visible from the outside (Figure 2.13).

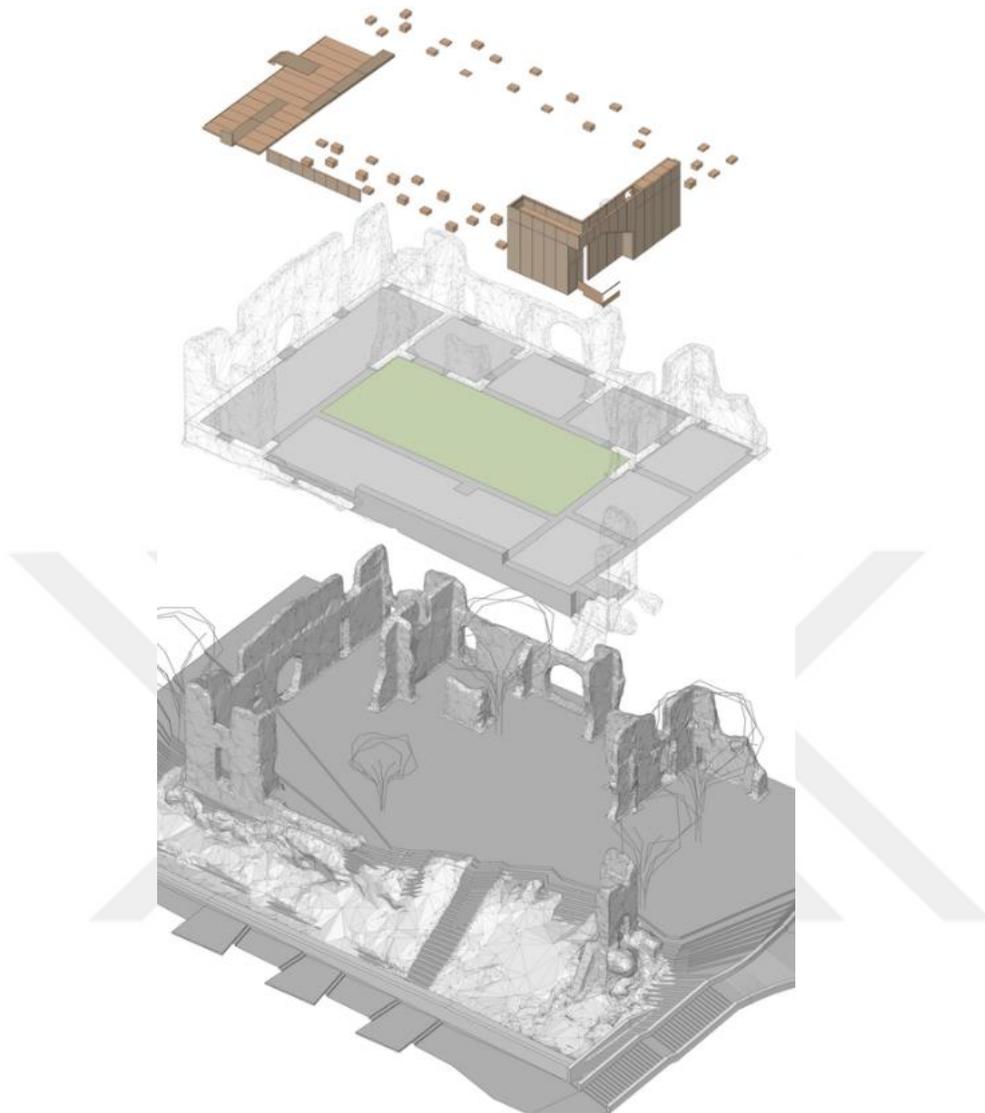
Figure 3.3. A diagram showing the existing ruin structure and adaptive reuse interventions in two layers. Retrieved from <https://www.archdaily.com/272346/szatmary-palace-marp> in October, 2021

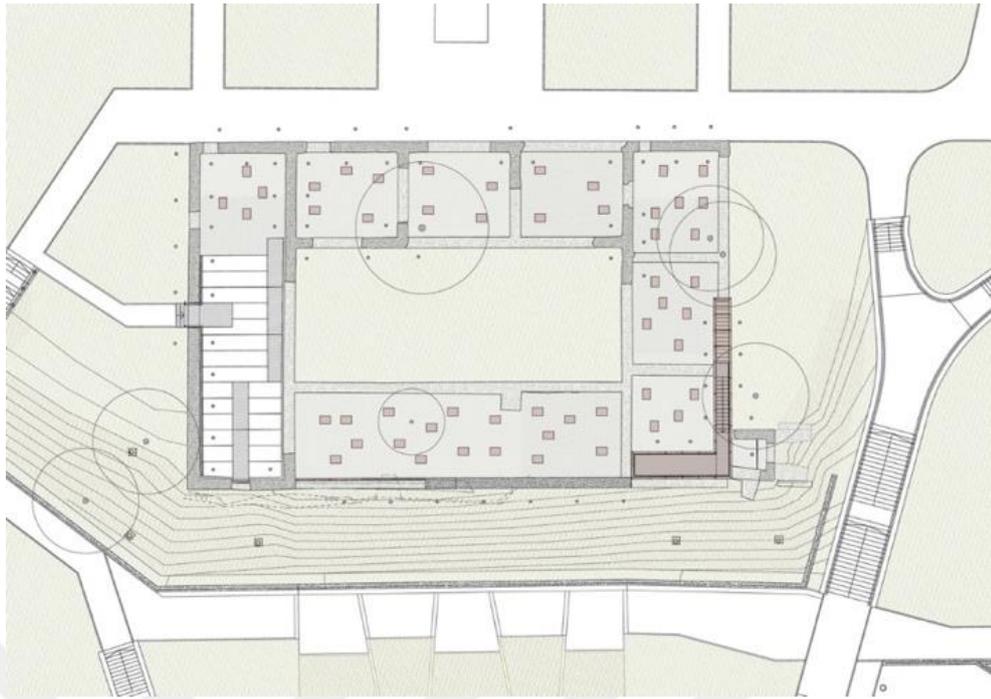
Figure 3.4. Technical drawing showing the existing ruins, contemporary additions and circulation areas. Retrieved from <https://www.archdaily.com/272346/szatmary-palace-marp> in October, 2021

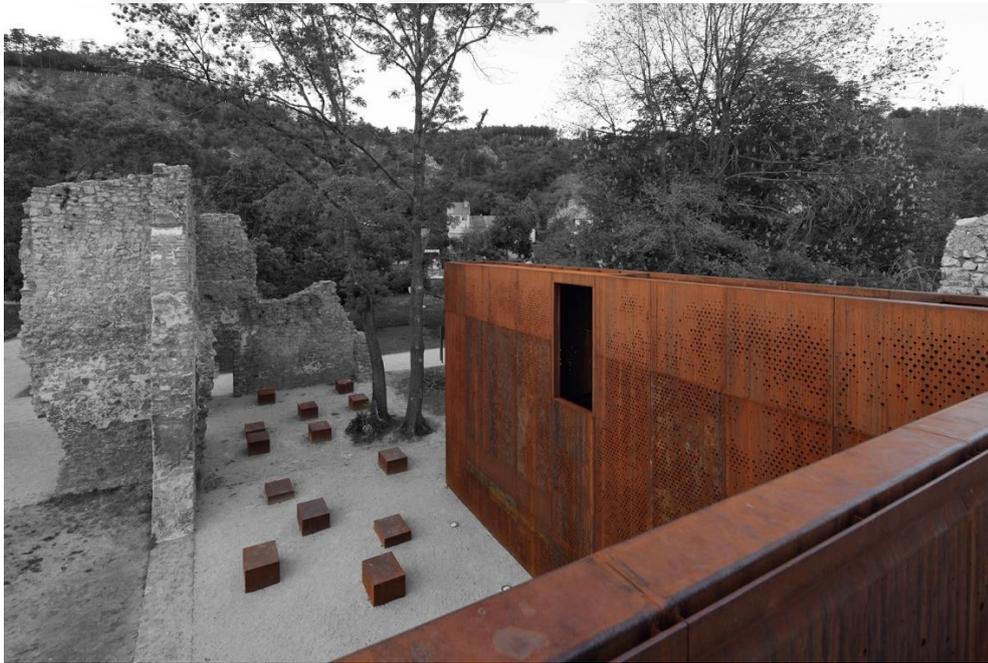
Figure 3.5. A perspective showing the navigational function of the contemporary extension with reference to the disappearing wall of the building. Retrieved from <https://www.archdaily.com/272346/szatmary-palace-marp> in October, 2021 and edited by the author.

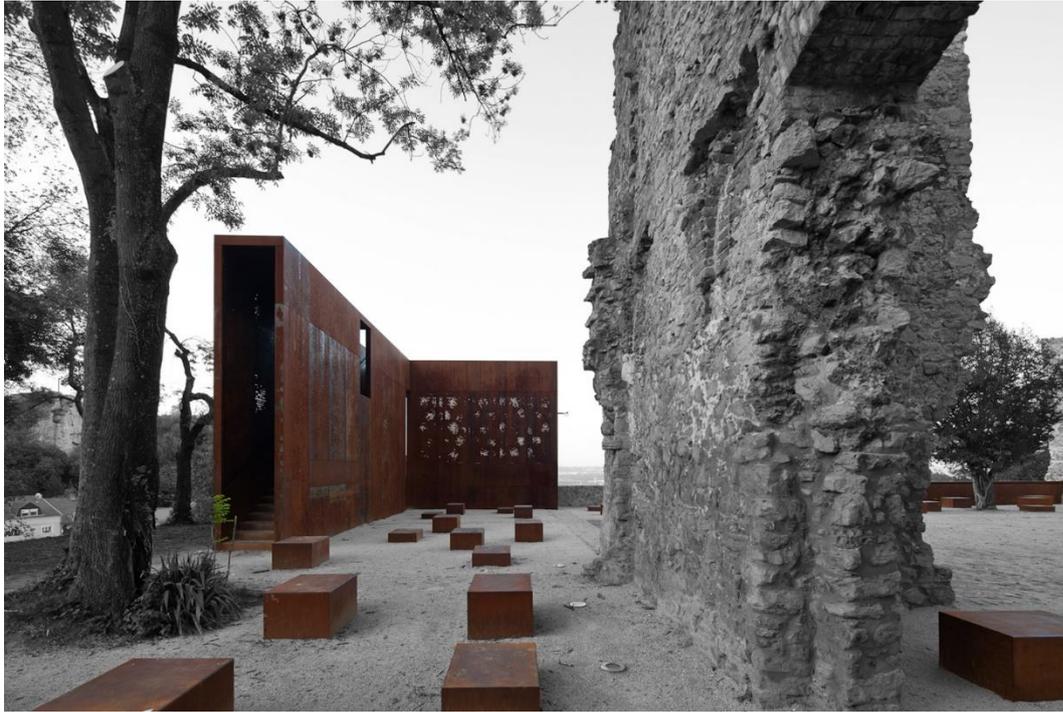
Figure 3.6. Stairway entrance and ruins of contemporary addition placed with reference to the disappearing wall of the building. Retrieved from <https://www.archdaily.com/272346/szatmary-palace-marp> in October, 2021 and edited by the author.

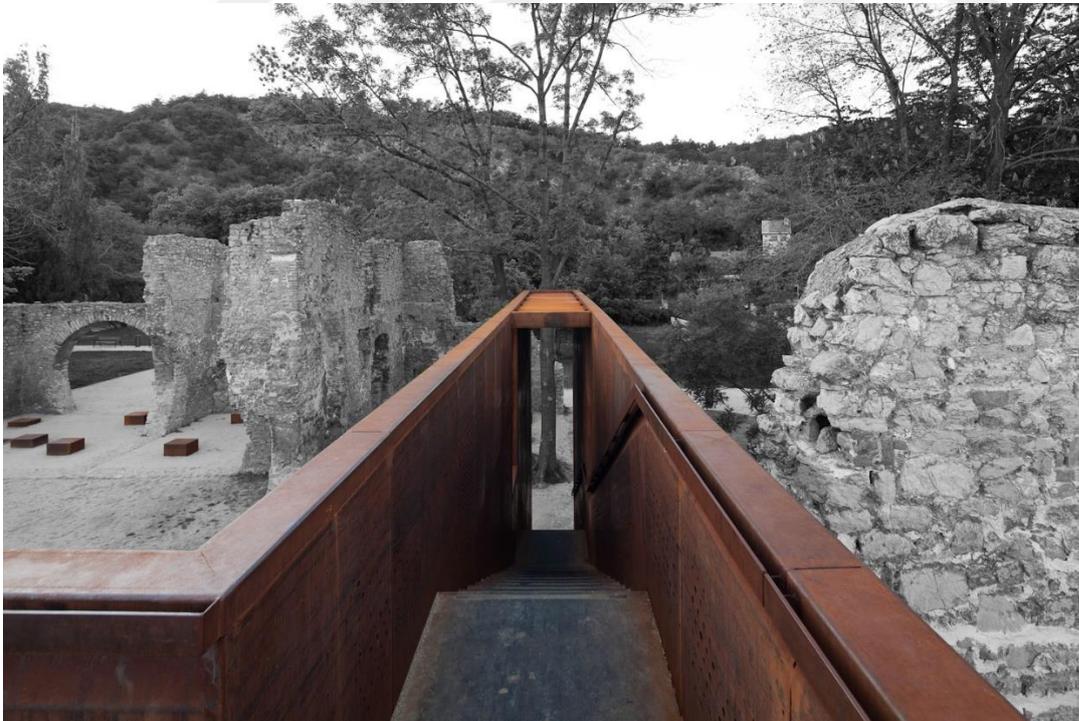
Figure 3.7. The circulation area of the contemporary addition applied with reference to the disappearing wall of the building. Retrieved from <https://www.archdaily.com/272346/szatmary-palace-marp> in October, 2021 and edited by the author.

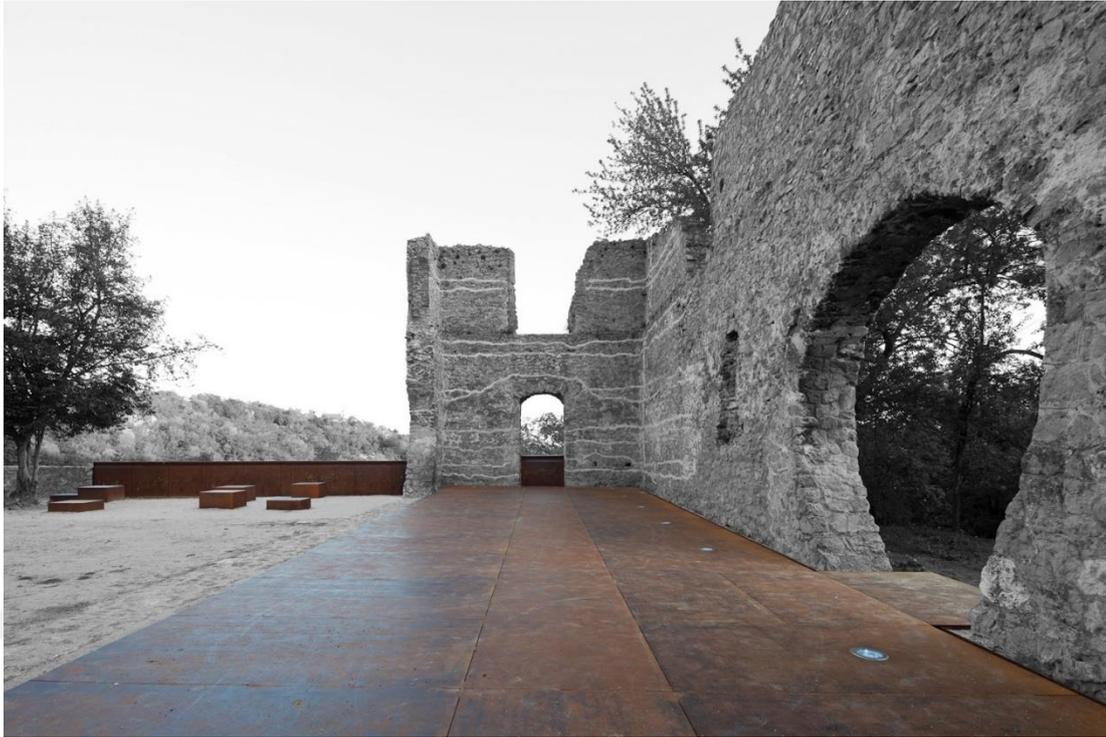
Figure 3.8. Floor covering that refers to the part found in the original structure as the interior. Retrieved from <https://www.archdaily.com/272346/szatmary-palace-marp> in October, 2021 and edited by the author.

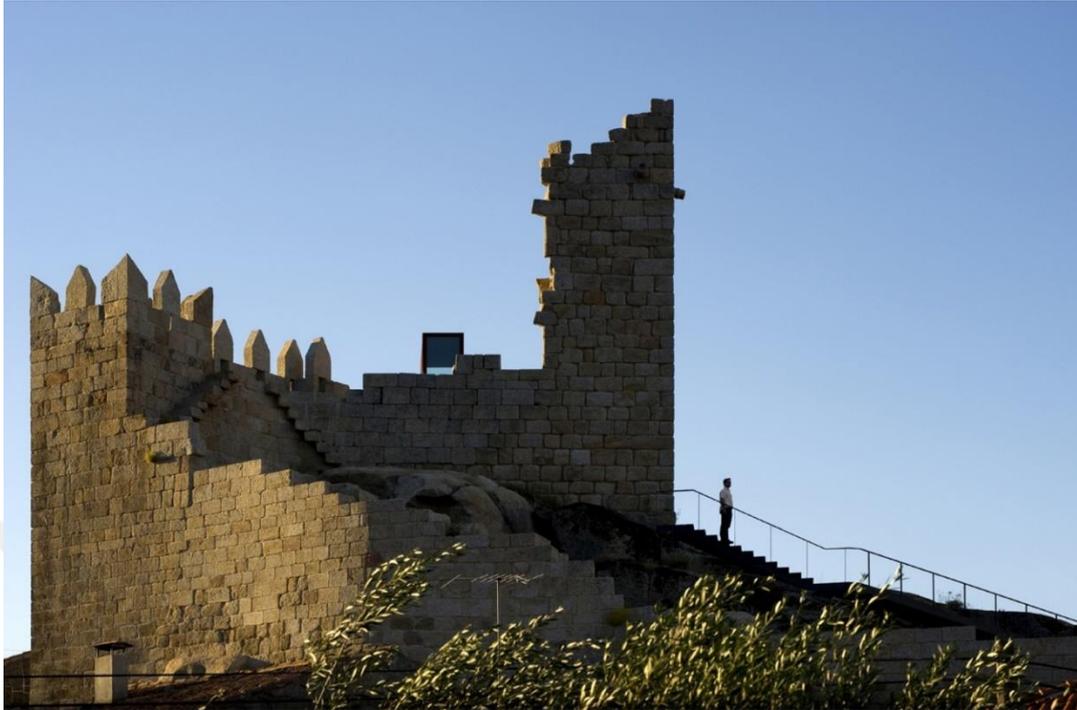
Figure 3.11. The largely destroyed tower of the castle and the contemporary staircase and the ‘steel box’ additions. Retrieved from <https://www.archdaily.com/230727/castelo-novo-castle-comoco> in November, 2021

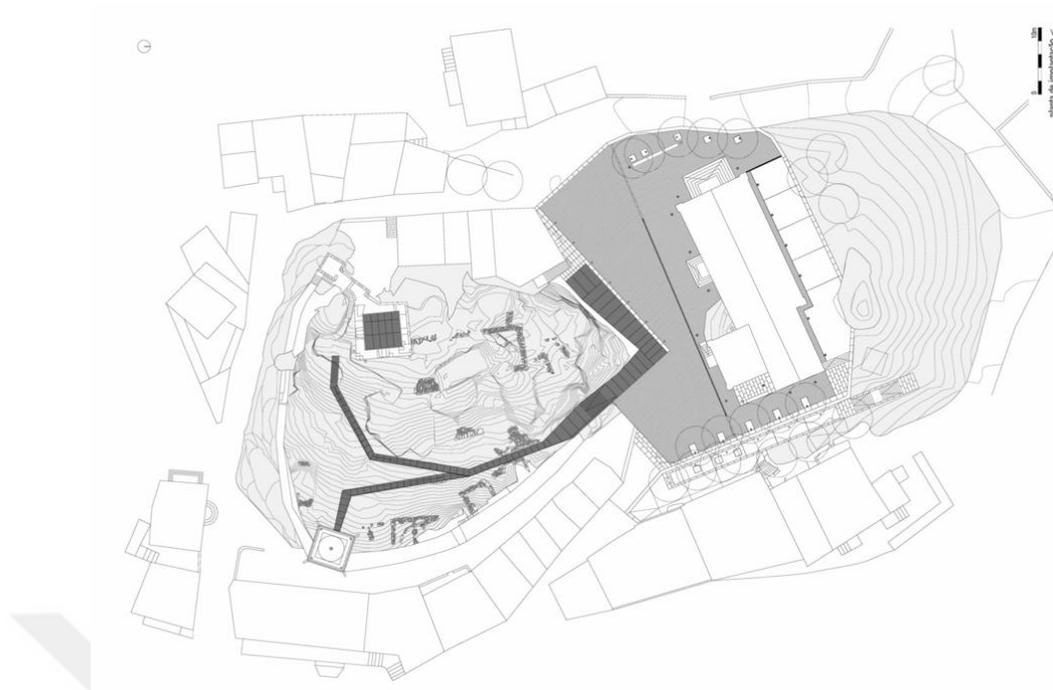
Figure 3.13. Technical drawing showing the current building's surroundings, ruins and contemporary additions. Retrieved from <https://www.archdaily.com/230727/castelo-novo-castle-comoco> in November, 2021

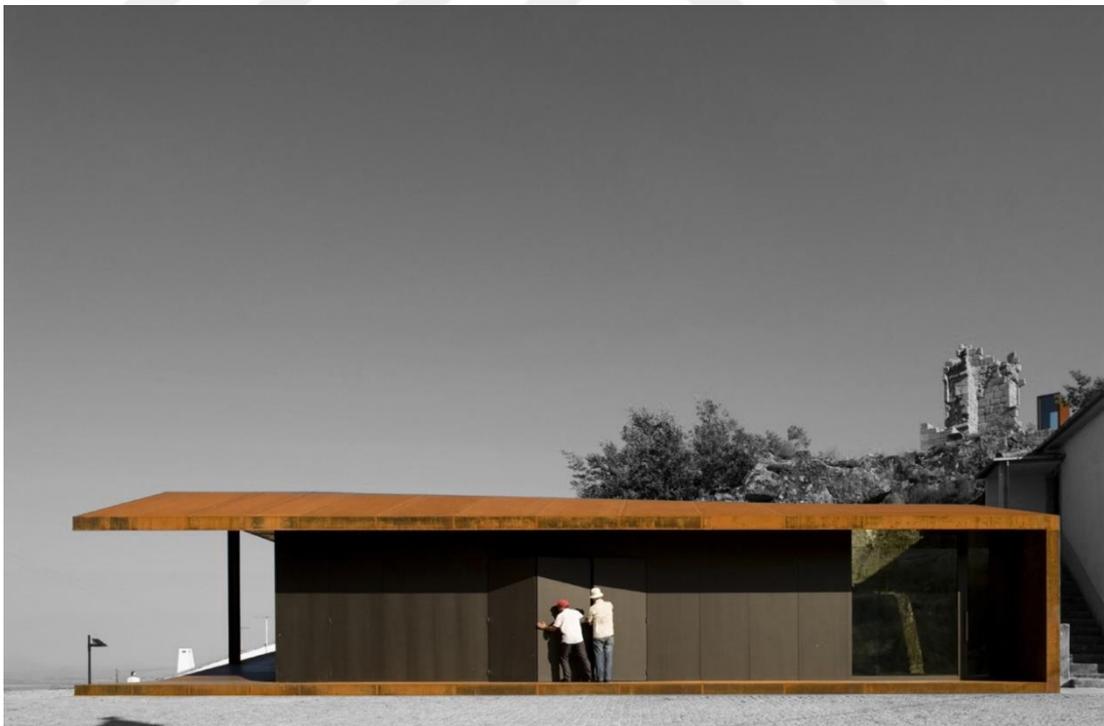
Figure 3.14. "Body" addition that includes a multimedia center. Retrieved from in November, 2021 and edited by the author.

The contemporary addition, called the "body"(Figure 3.13) , was conceived as an abstract object with no definite purpose, but with continuity. This extension, which can show different features depending on the part it is in, serves as a volume that defines the boundaries of the church square, while it turns into a pavement layer with ramps and stairs that form a pedestrian path on the ground inside the castle walls (Figure 3.15). The entire structure is made using lightweight metal materials that allow new additions to be clearly distinguished from existing structures.

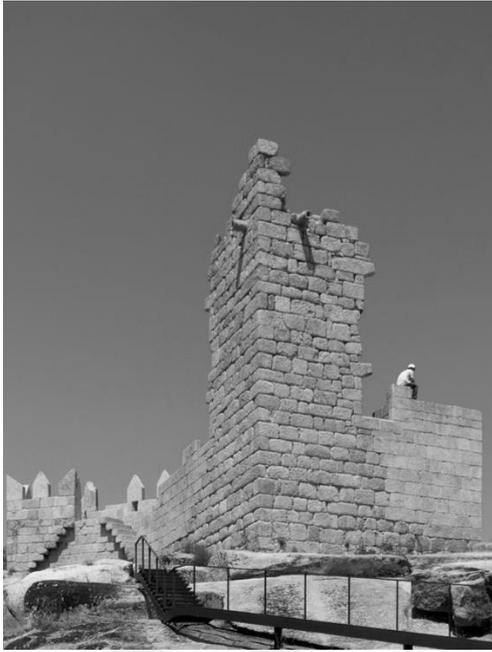
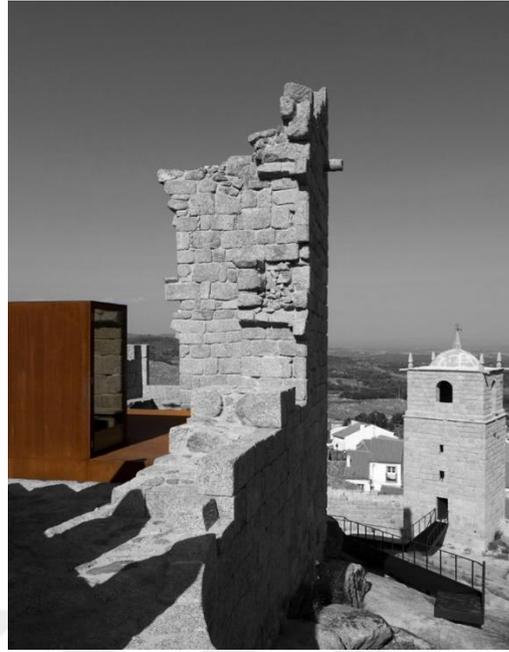
Figure 3.15. Partially preserved ruins of the tower. (left) “steel box” contemporary addition (right) Retrieved from <https://www.archdaily.com/230727/castelo-novo-castle-comoco> in November, 2021 and edited by the author.

With the newly added pedestrian path, it is aimed to ensure that the visitors can visit the archaeological finds, mostly from the ruins of the castle itself, without damaging it. This path leads to the Main Tower, inside which is placed a "steel box" used as a multimedia room (Figure 3.10). This box also allows the creation of a platform where visitors can enjoy the panoramic view. Thus, Castelo Novo Castle has become a touristic spot that can be visited, circulated and used as an observation point. (Archdaily, 2012b)

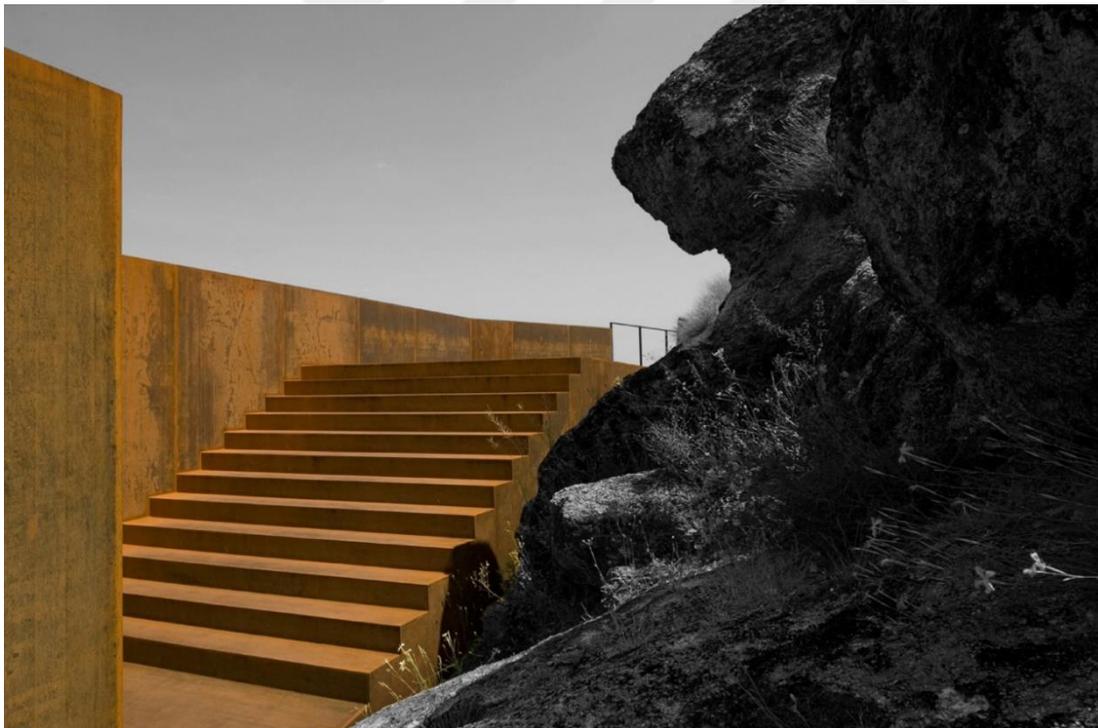
Figure 3.16. Corten staircase extension that provides circulation over the topography of the castle. Retrieved from <https://www.archdaily.com/230727/castelo-novo-castle-comoco> in November, 2021 and edited by the author.

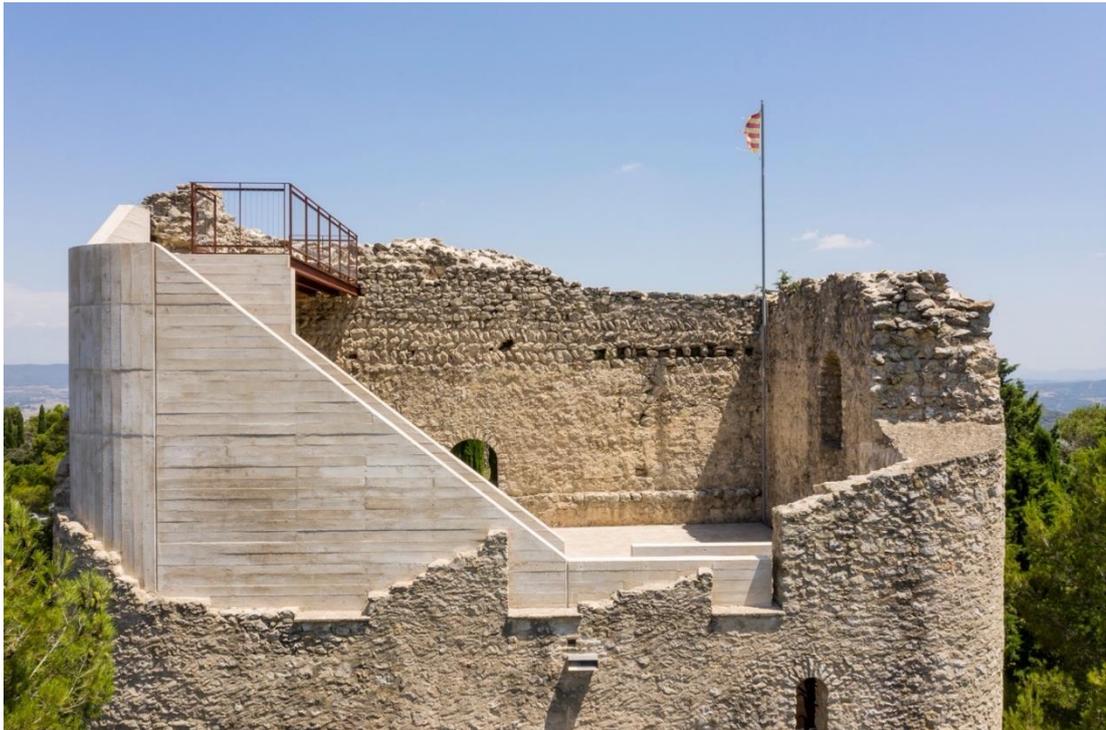
Figure 3.17. Contemporary staircase addition depicting the form of the ruined edge of the castle. Retrieved from <https://www.archdaily.com/951752/restoration-of-castell-de-la-tossa-meritxell-inaraja> in November, 2021

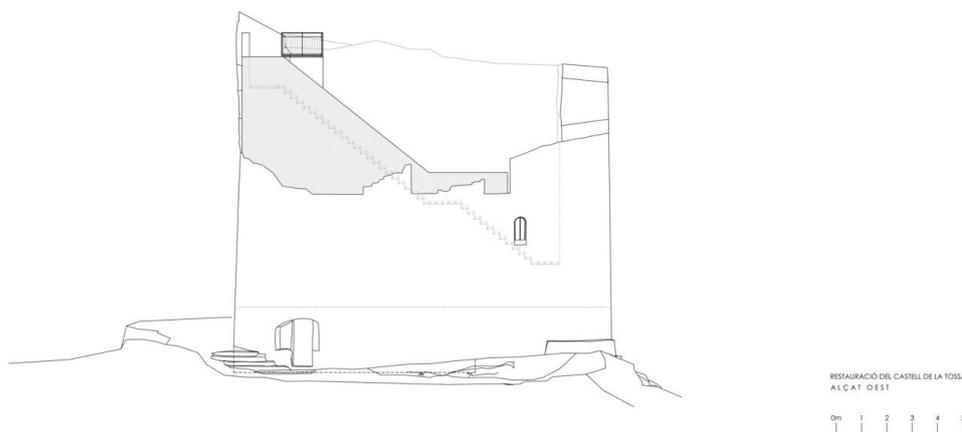
Figure 3.19. Technical drawing showing the modern stair addition, which is the shape of the destroyed castle edge. Retrieved from <https://www.archdaily.com/951752/restoration-of-castell-de-la-tossa-meritxell-inaraja> in November, 2021

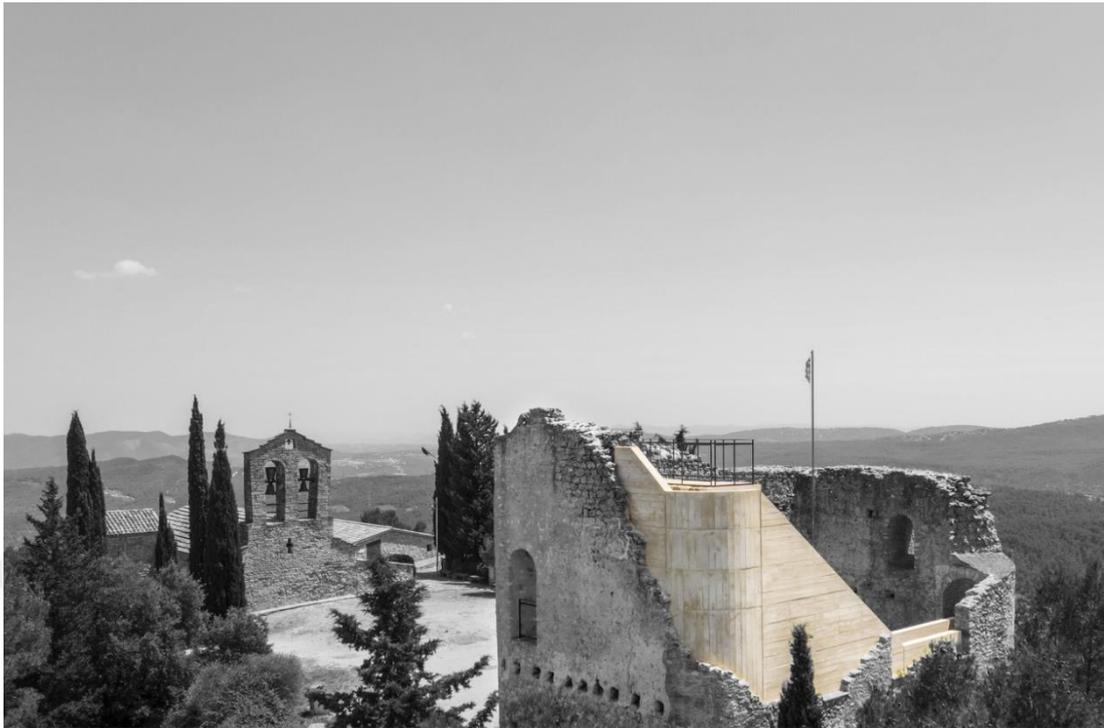
Figure 3.20. The surroundings of the castle and the complementary contemporary addition. Retrieved from <https://www.archdaily.com/951752/restoration-of-castell-de-la-tossa-meritxell-inaraja> in November, 2021 and edited by the author.

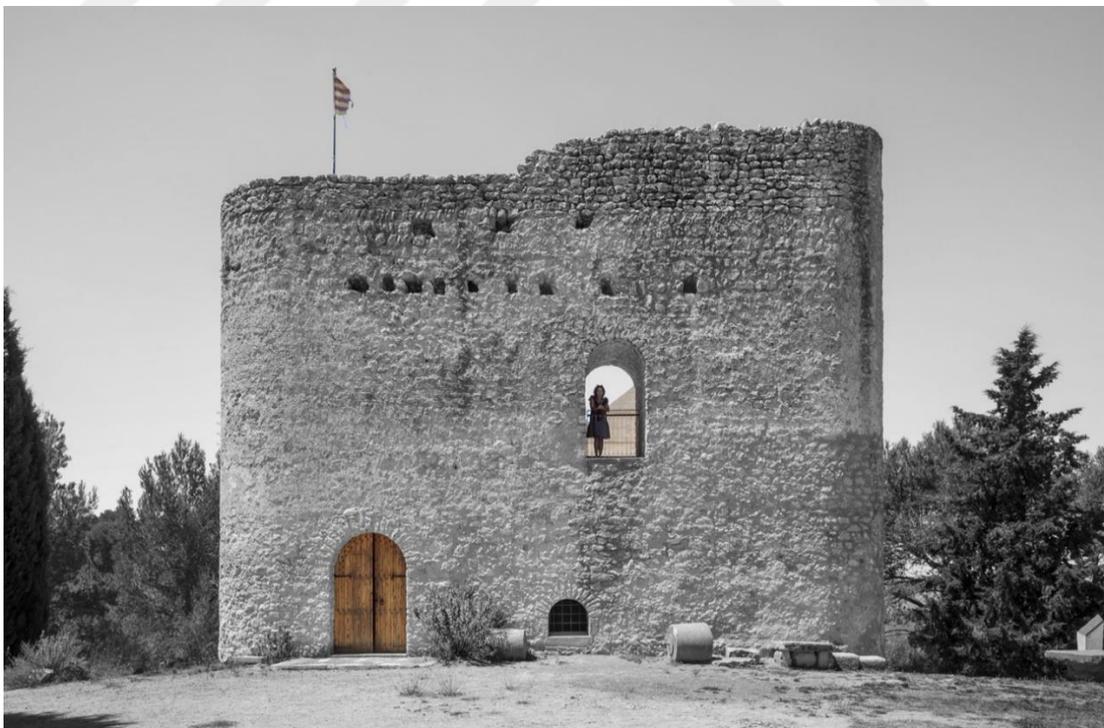
Figure 3.21. The relatively preserved facade of the castle and the contemporary viewpoint point addition. Retrieved from <https://www.archdaily.com/951752/restoration-of-castell-de-la-tossa-meritxell-inaraja> in November, 2021 and edited by the author.

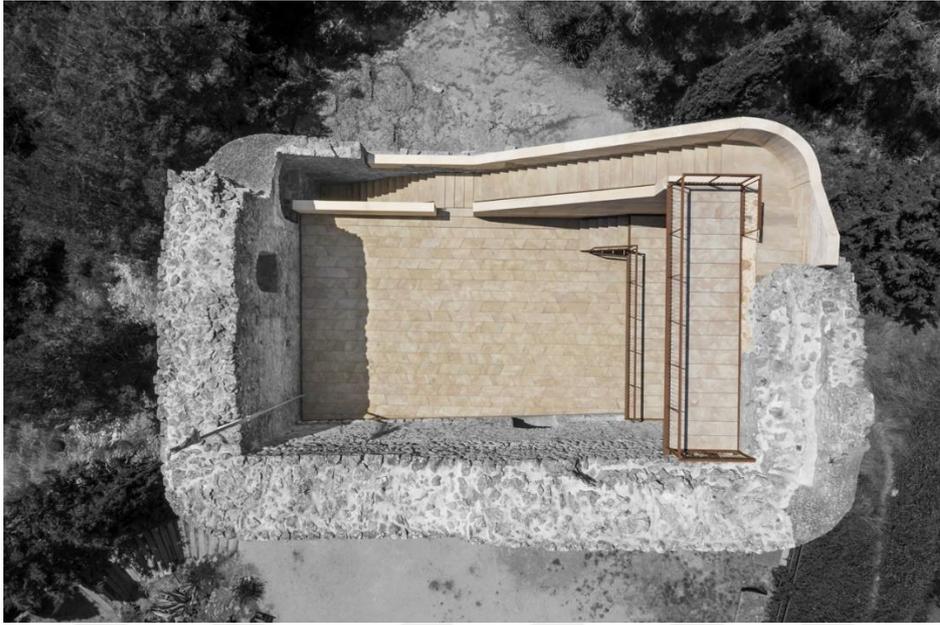
Figure 3.22. Top view of the interior of the castle with the contemporary additions. Retrieved from <https://www.archdaily.com/951752/restoration-of-castell-de-la-tossa-meritxell-inaraja> in November, 2021 and edited by the author.

staircase structure was applied with wooden formwork technique. Today's ground floor level of the building is covered with a stone material that is close in texture and color to the stones used in the original building and to the concrete staircase structure, preventing erosion that may occur in the castle due to weather conditions and a circulation area has been defined.

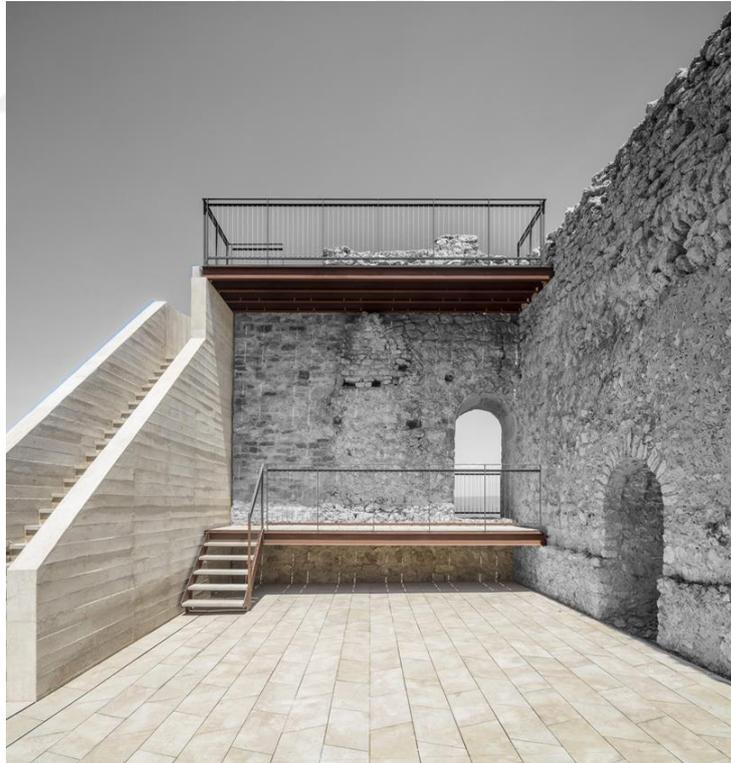
Figure 3.23. Staircase, flooring and viewing platforms additions. Retrieved from <https://www.archdaily.com/951752/restoration-of-castell-de-la-tossa-meritxell-inaraja> in November, 2021 and edited by the author.
