MASTER THESIS

**THE ENHANCEMENT OF CASTLE RUINS WITH
CONTEMPORARY ADDITIONS AS AN ADAPTIVE
REUSE INTERVENTIONS**

MSC IN INTERIOR ARCHITECTURE

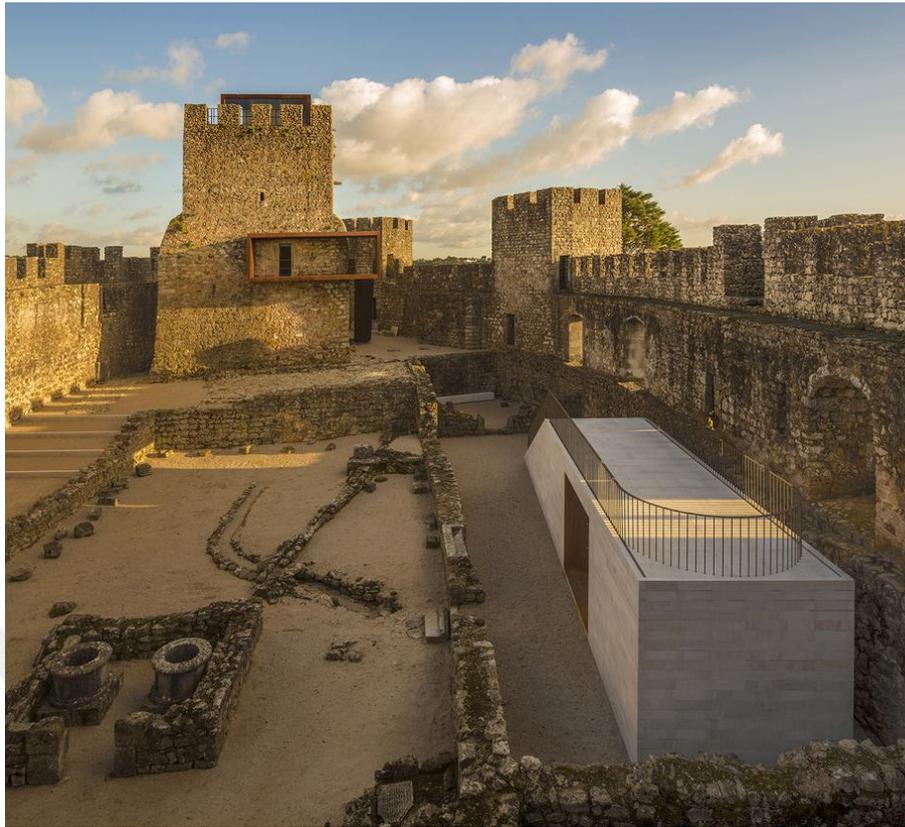
Figure 3.24. An interior angle showing the additions to the watchtower and wards. Retrieved from <https://www.archdaily.com/563933/pombal-castle-s-visitor-centre-comoco-arquitectos> in December, 2021

Architectural interventions to the castle included the design of a volume to be placed in the wards, a viewing balcony to be positioned on the watchtower, and steel stairs to access this balcony. The balcony intervention aims to carry the original function of the tower to the present day. The intervention of the steel stairs, which will provide access to the balcony (Figure 3.28), provides the accessibility of the tower directly to the storey, while indirectly contributing to the visit ability of the castle. Among the contemporary interventions that had to be designed in the castle, the most focused piece was the new volume, which would include the visitor center (Figure 3.24) (Figure 3.26). This volume offers three spaces: a reception for visitors, a multimedia room to view the virtual history of the castle, and a storage area (Figure 3.27). As the ward area of the fort was filled with many original buildings remains, a new volume to be placed on that spot meant an inevitable confrontation with the existing elements that defined that area. In any case, this was the impetus to develop the main idea of the project (Archdaily, 2019).

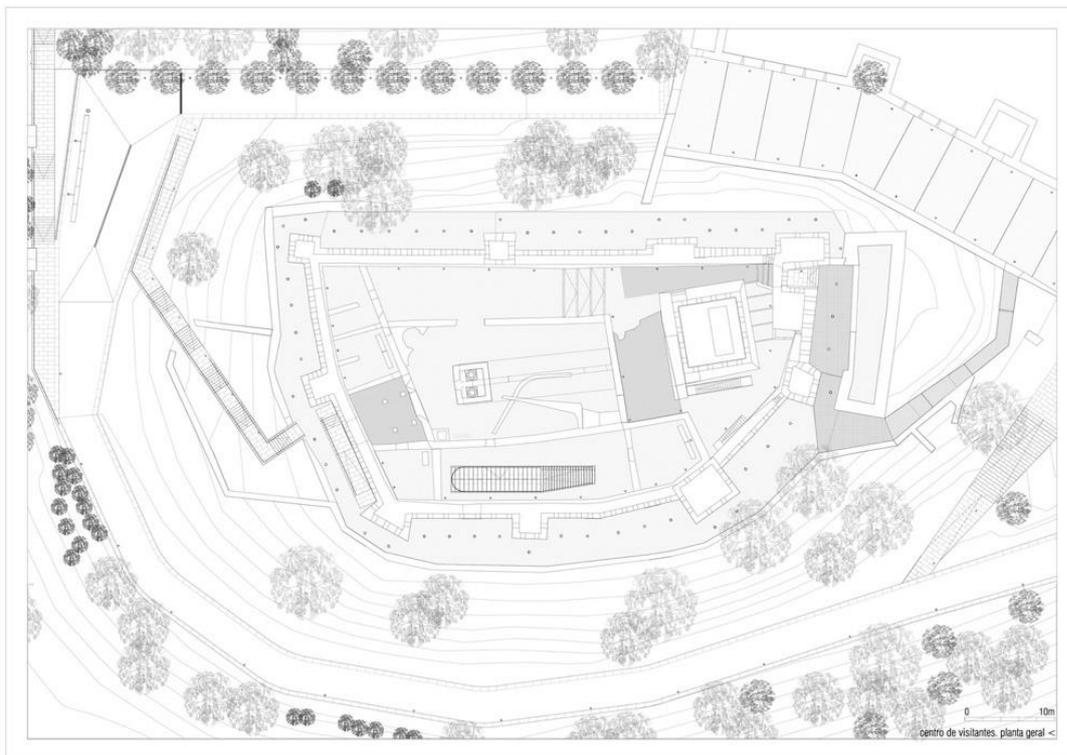
Figure 3.26. Technical drawing showing the current building's surroundings, ruins and contemporary additions. Retrieved from <https://www.archdaily.com/563933/pombal-castle-s-visitor-centre-comoco-arquitectos> in December, 2021

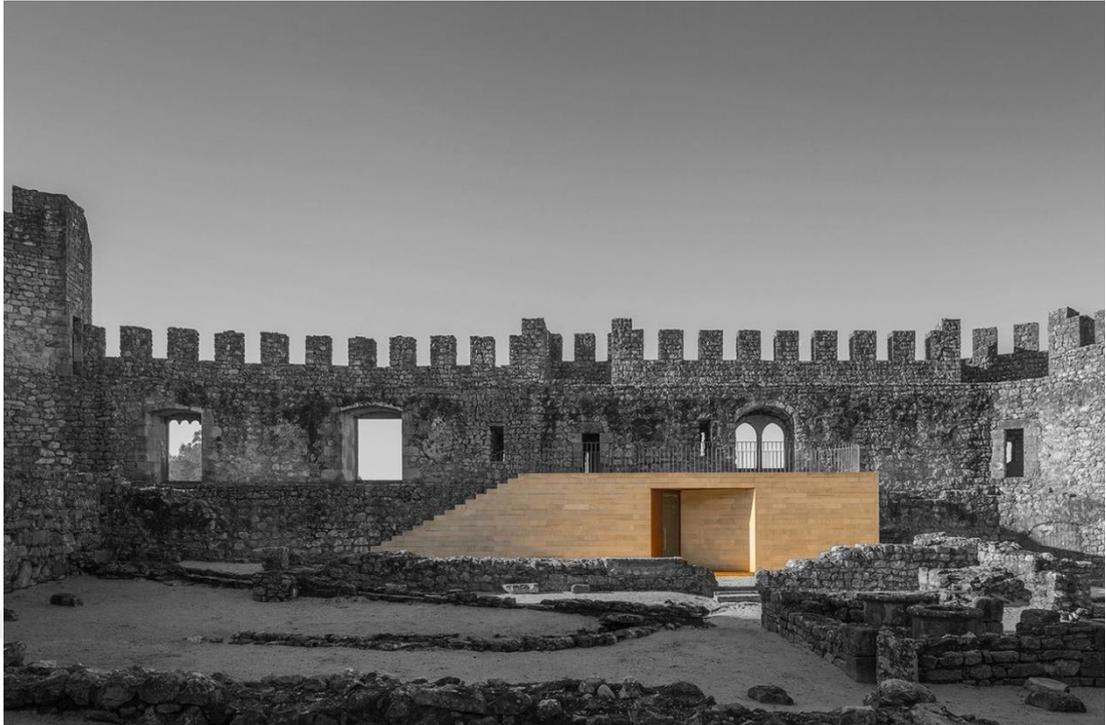
Figure 3.27. The new volume placed in the Wards section and its relationship with the ruins. Retrieved from <https://www.archdaily.com/563933/pombal-castle-s-visitor-centre-comoco-arquitectos> in December, 2021 and edited by the author.

The volume in the wards, which can be called the main intervention, was covered with a stone material that resembles the original material of the building in terms of texture and feel, considering its relationship with the existing remains. It does not settle at the original level where the existing ruins were located, but at the current level. Despite this, it is not in competition with the existing remains, but is seen as a volume that can be easily understood as a new intervention. While the workspace of the volume is used for the specified functions, it is possible to go above the volume with the staircase part integrated with the volume. On this level, there are basic railings designed from steel material. The balcony intervention, together with the steel staircase, can be called a parasitic intervention to the watchtower since it is positioned as attached to the exterior of the existing building. It represents a volume that has no equivalent in its original structure. Structurally, it does not give any reference to the original structure. However, in terms of function, it aims to present the observation / monitoring function of the watchtower of the building to the visitors who visit the castle today.

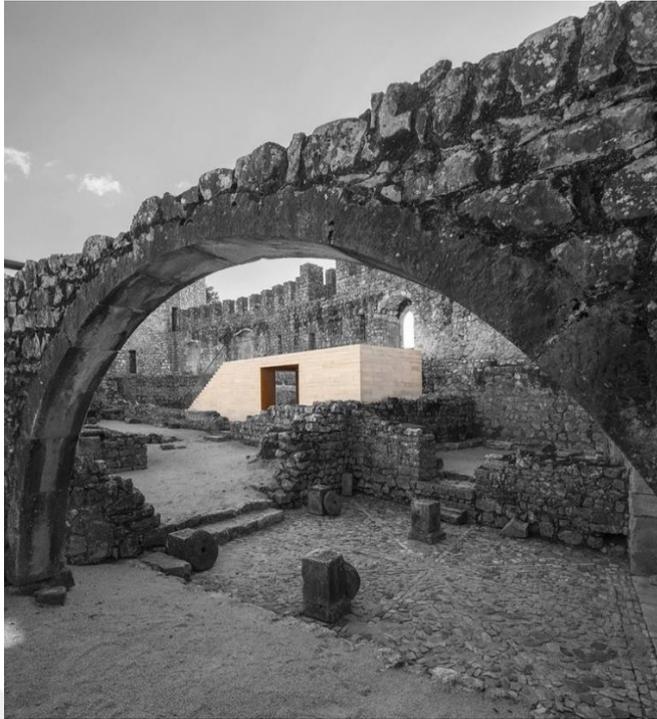
Figure 3.29. The new volume placed in the Wards section and its relationship with the ruins. Retrieved from <https://www.archdaily.com/563933/pombal-castle-s-visitor-centre-comoco-arquitectos> in December, 2021 and edited by the author.

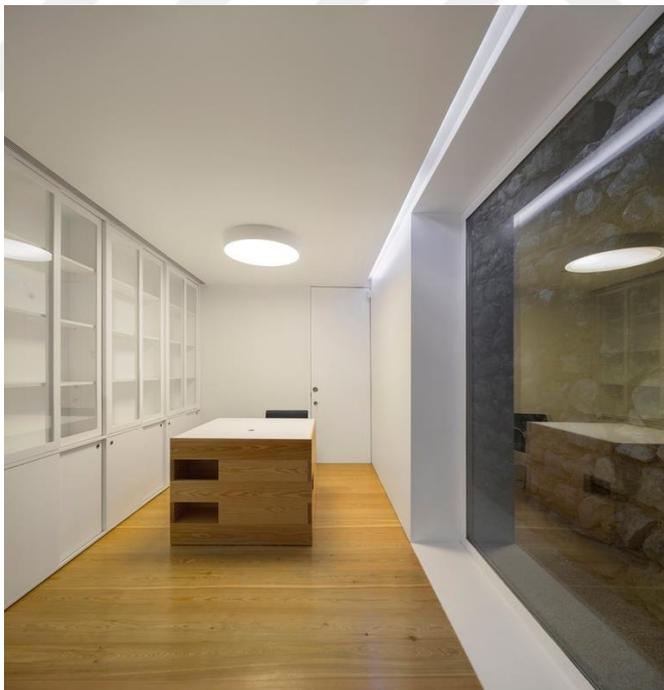
Figure 3.30. The interior of the new volume added to the Wards section. Retrieved from <https://www.archdaily.com/563933/pombal-castle-s-visitor-centre-comoco-arquitectos> in December, 2021

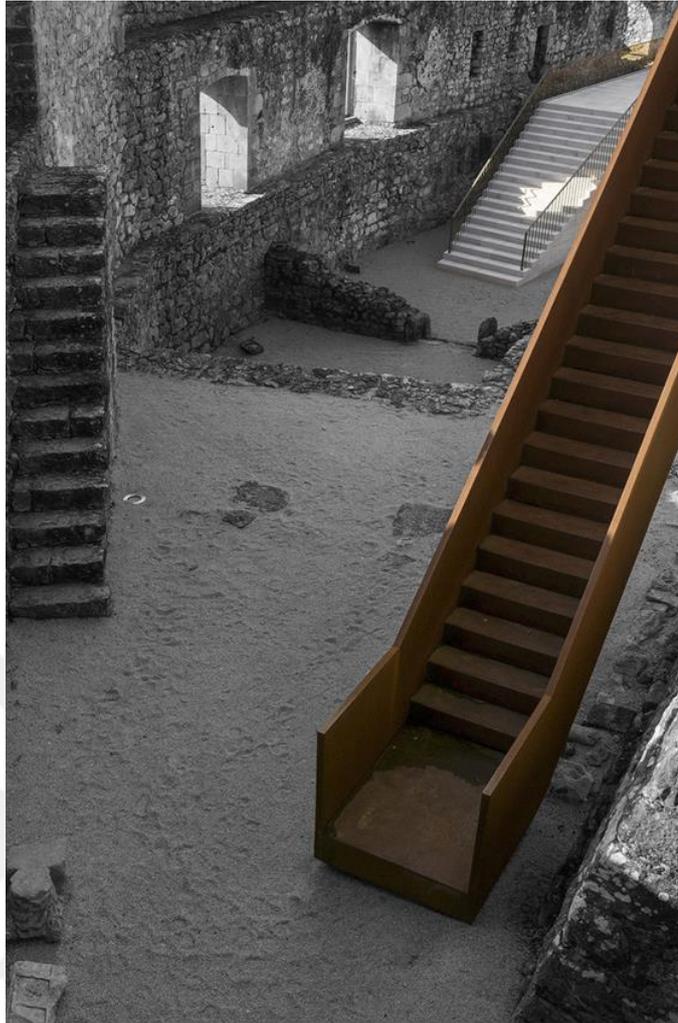
Figure 3.31. Contemporary staircase addition to the watchtower. Retrieved from <https://www.archdaily.com/563933/pombal-castle-s-visitor-centre-comoco-arquitectos> in December, 2021 and edited by the author.

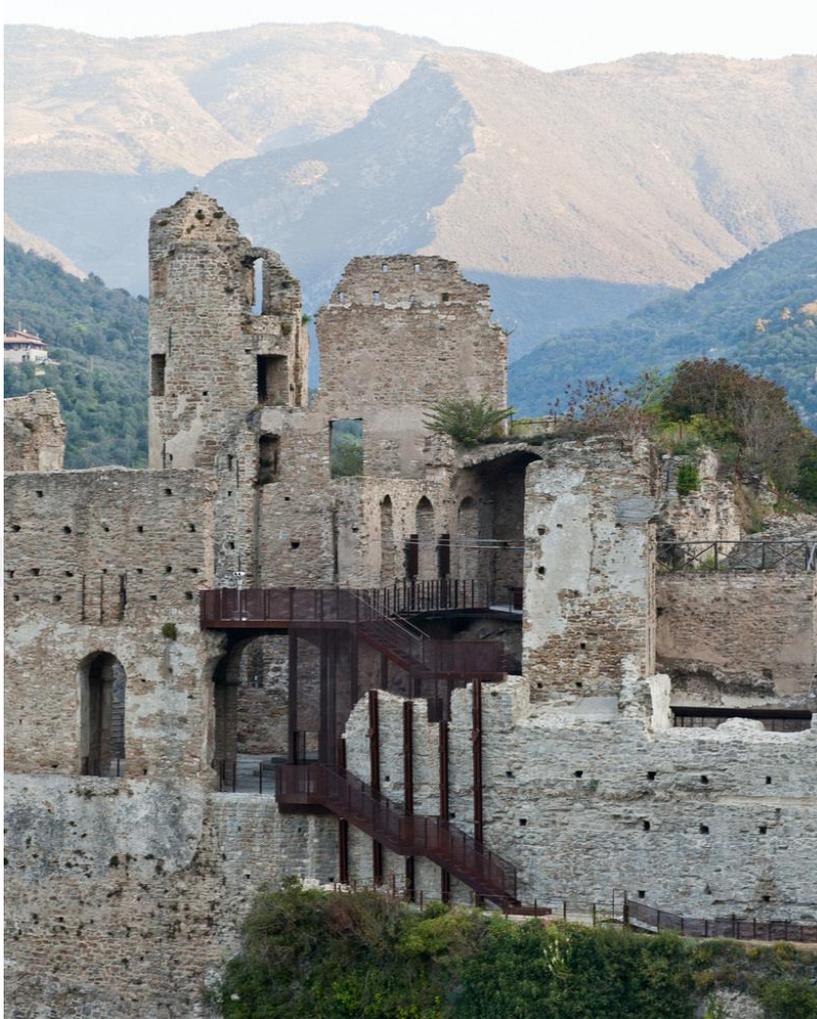
Figure 3.32. Contemporary staircase extension located in the place of the destroyed wall of the castle. Retrieved from <https://www.archdaily.com/934655/restoration-of-castello-dei-doria-a-dolceacqua-ld-plus-sr-architetti> in December, 2021

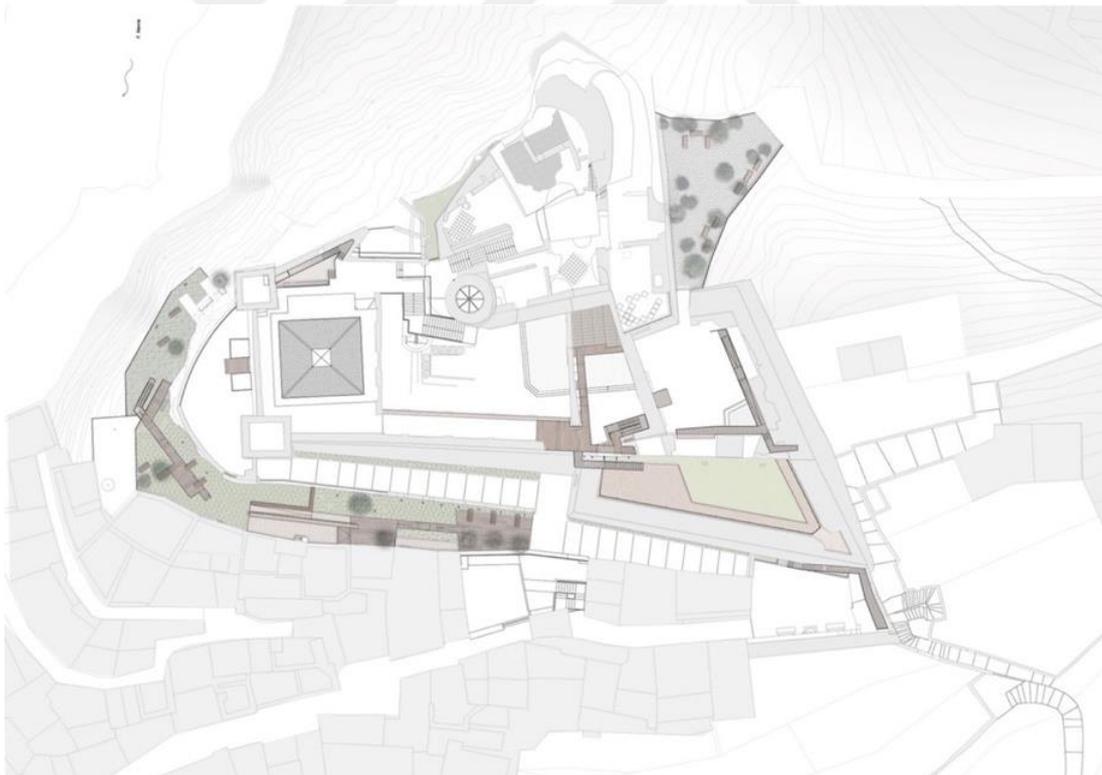
Figure 3.34. Technical drawing showing the current building's surroundings, ruins and contemporary additions. Retrieved from <https://www.archdaily.com/934655/restoration-of-castello-dei-doria-a-dolceacqua-ld-plus-sr-architetti> in December, 2021

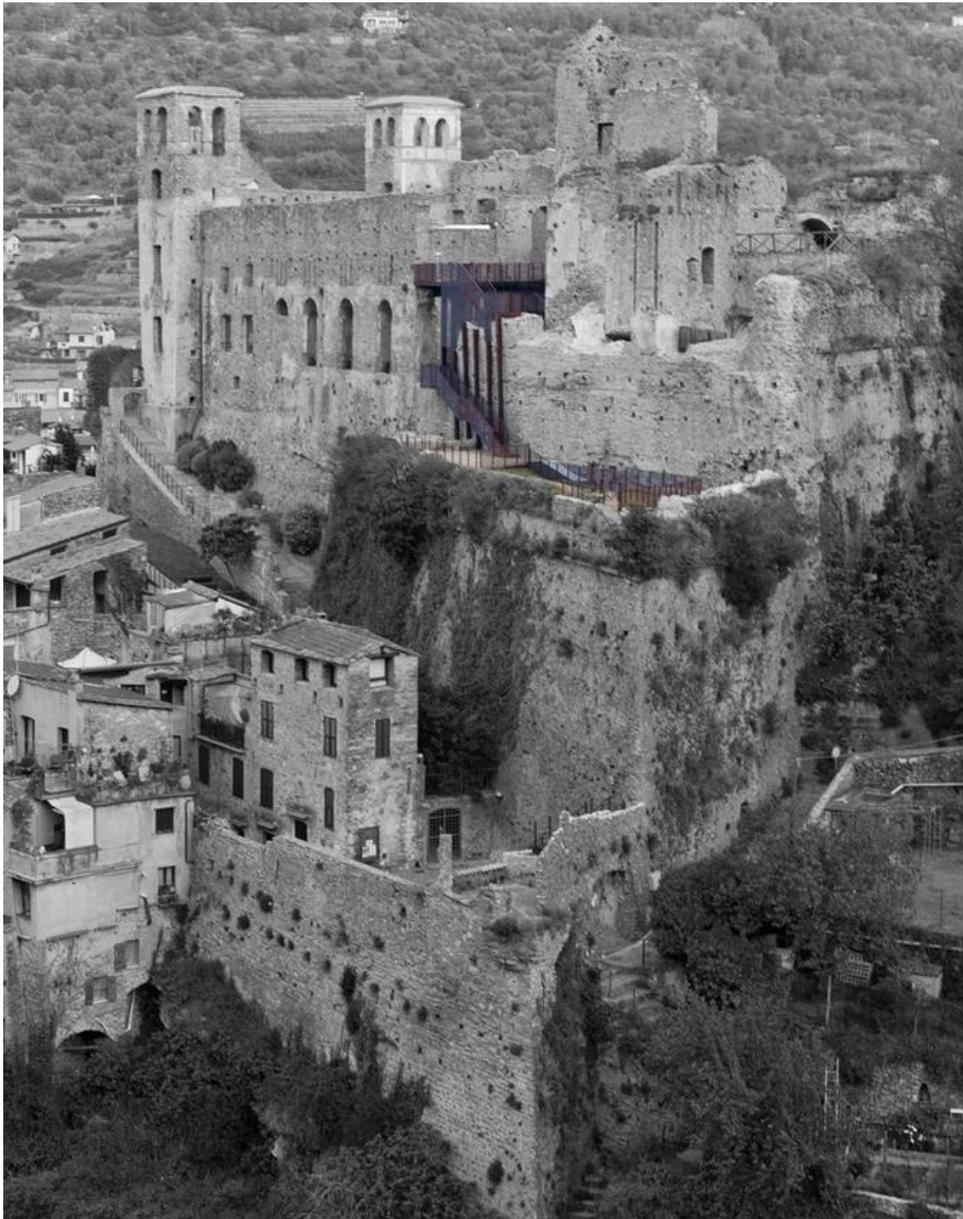
Figure 3.35. The relationship of the castle with the city and the role of the contemporary staircase extension in accessibility. Retrieved from <https://www.archdaily.com/934655/restoration-of-castello-dei-doria-a-dolceacqua-ld-plus-sr-architetti> in December, 2021 and edited by the author.

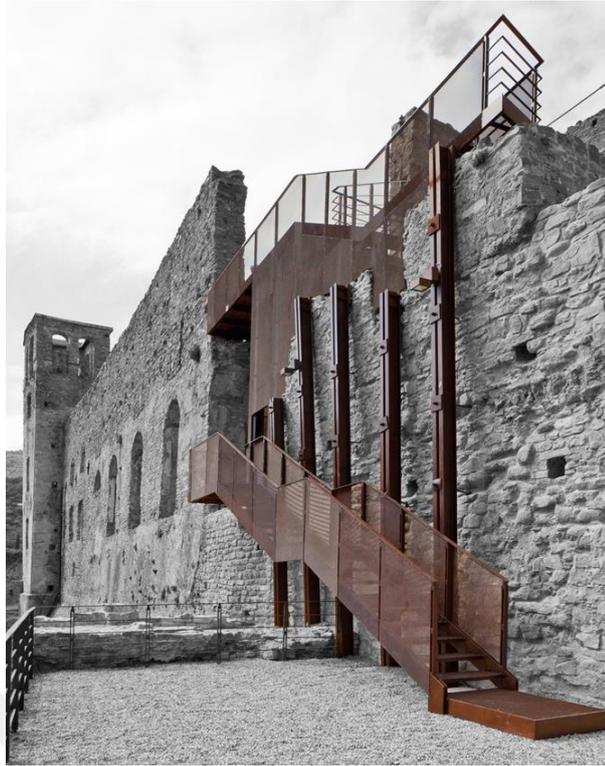
Figure 3.36. Metal staircase addition that allows circulation between the different levels of the castle. Retrieved from <https://www.archdaily.com/934655/restoration-of-castello-dei-doria-a-dolceacqua-ld-plus-sr-architetti> in December, 2021 and edited by the author.

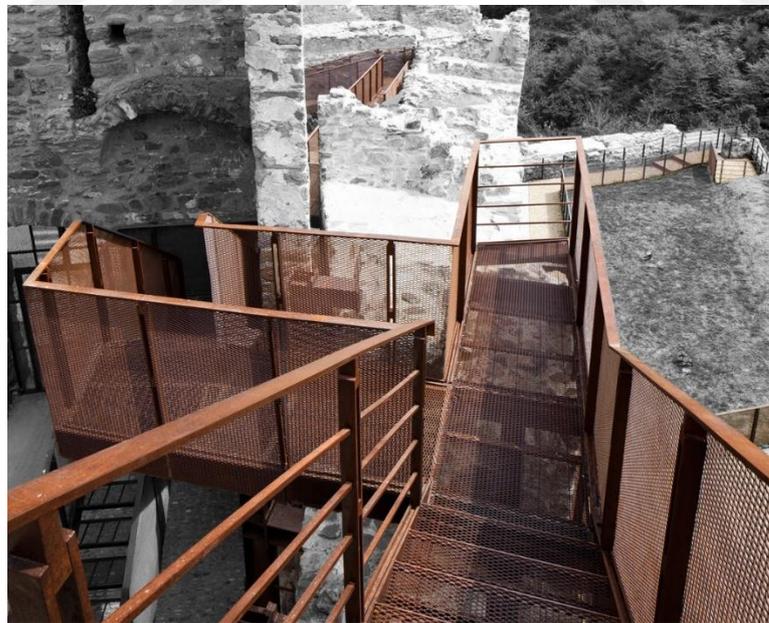
Figure 3.37. Metal details of the contemporary staircase addition. Retrieved from <https://www.archdaily.com/934655/restoration-of-castello-dei-doria-a-dolceacqua-ld-plus-sr-architetti> in December, 2021 and edited by the author.

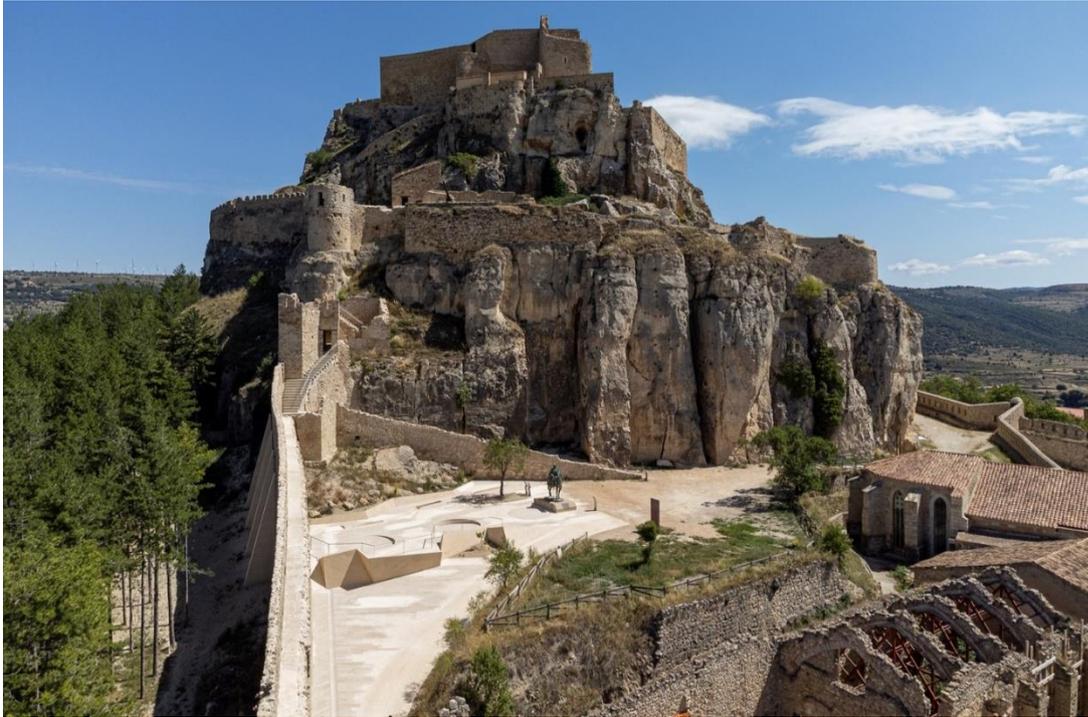
Figure 3.38. General view with contemporary concrete insert. Retrieved from <https://www.archdaily.com/967724/castle-of-morella-restoration-carquero-arquitectura> in December, 2021

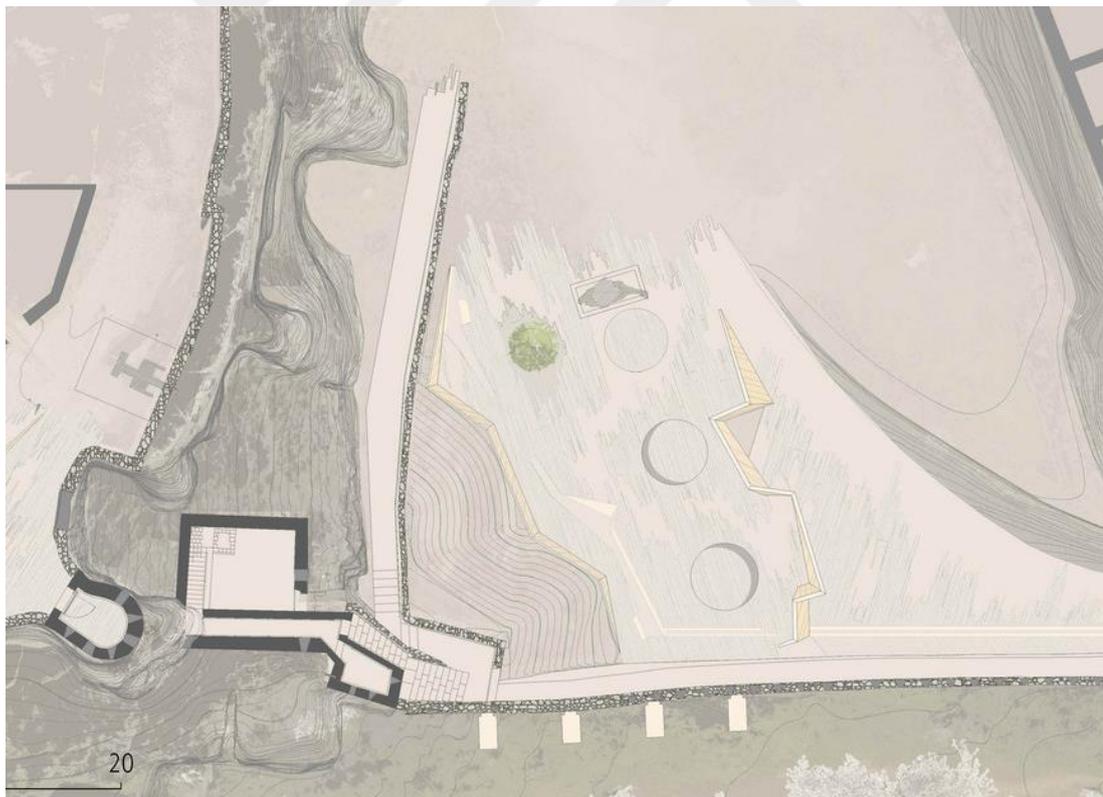
Figure 3.40. Technical drawing showing the current building's surroundings, ruins and contemporary additions. Retrieved from <https://www.archdaily.com/967724/castle-of-morella-restoration-carquero-arquitectura> in December, 2021 and edited by the author.

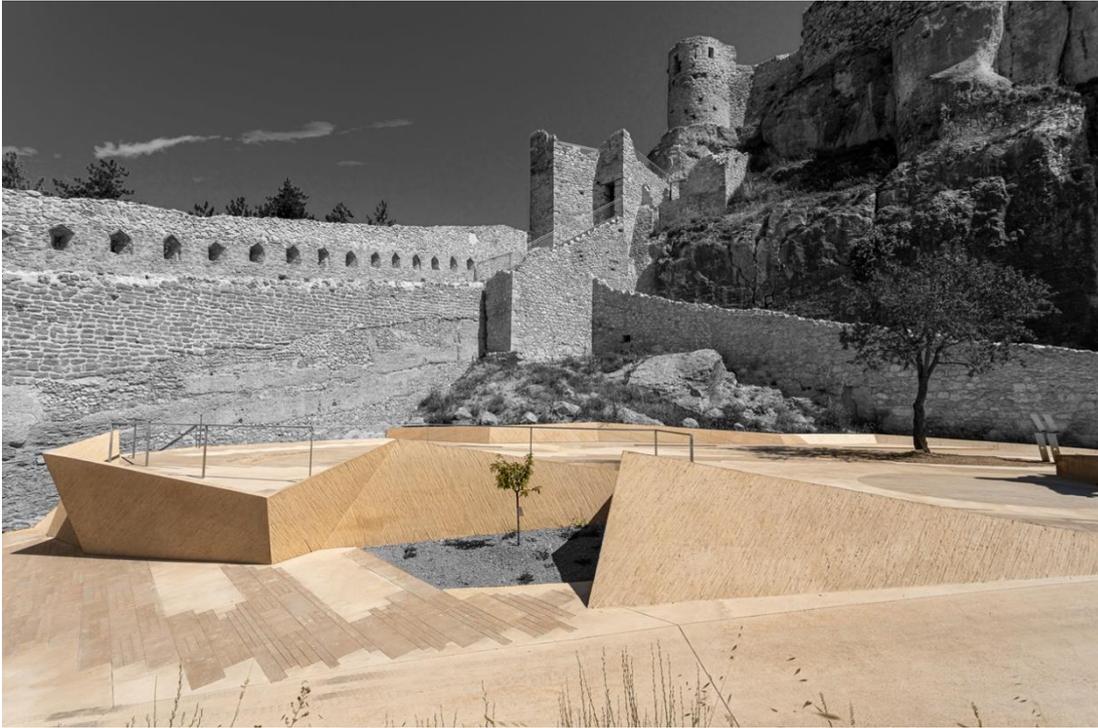
Figure 3.41. Seating units. Retrieved from <https://www.archdaily.com/967724/castle-of-morella-restoration-carquero-arquitectura> in December, 2021 and edited by the author.

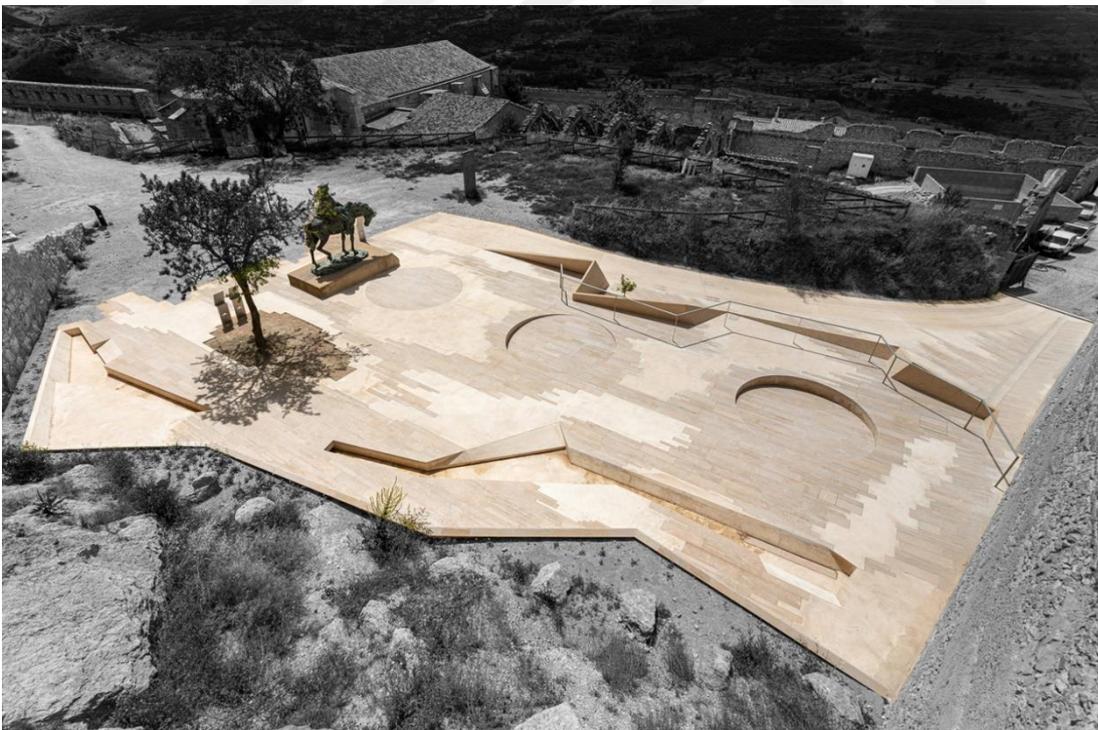
Figure 3.42. Contemporary concrete addition mass. Retrieved from <https://www.archdaily.com/967724/castle-of-morella-restoration-carquero-arquitectura> in December, 2021 and edited by the author.

For the necessary additional structural elements, tones and textures integrate with the rest of the existing remains and harmonious materials such as lime concrete, stainless steel and fiberglass are used. Likewise, stainless steel has been used for the necessary additional functional elements such as doors, observation points, and a surface that integrates with the rest of the intervention has been achieved.

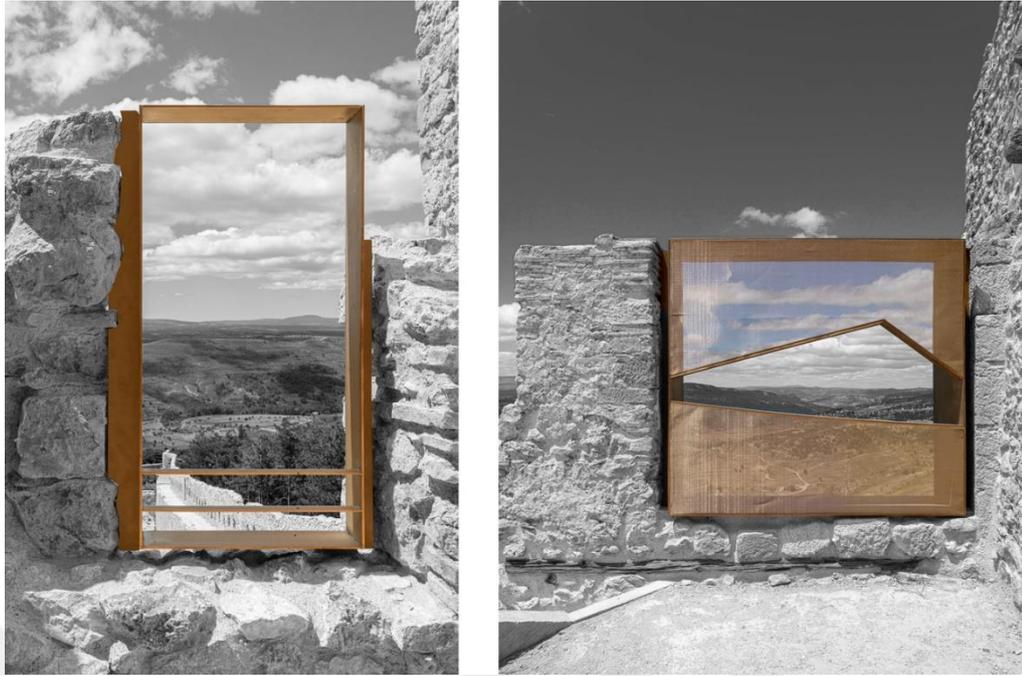
Figure 3.43. Contemporary frame inserts that define openings in the original structure. Retrieved from <https://www.archdaily.com/967724/castle-of-morella-restoration-carquero-arquitectura> in December, 2021 and edited by the author.

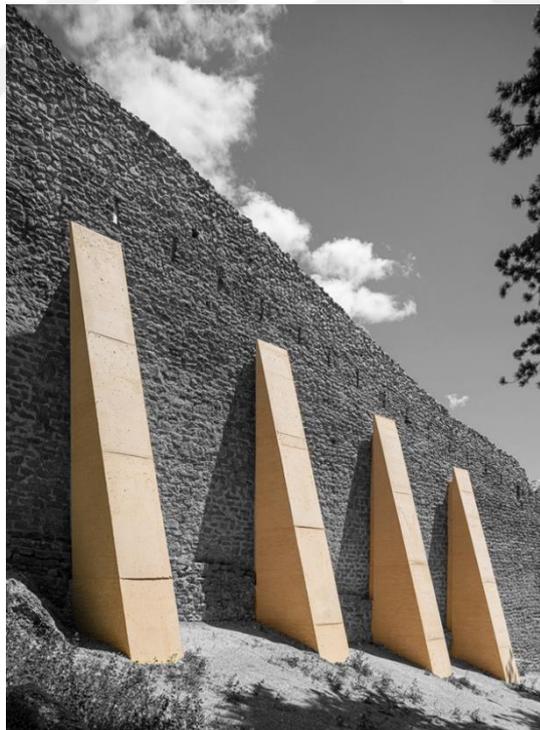
Figure 3.44. Four buttresses were placed on the outside of the walls. Retrieved from <https://www.archdaily.com/967724/castle-of-morella-restoration-carquero-arquitectura> in December, 2021 and edited by the author.

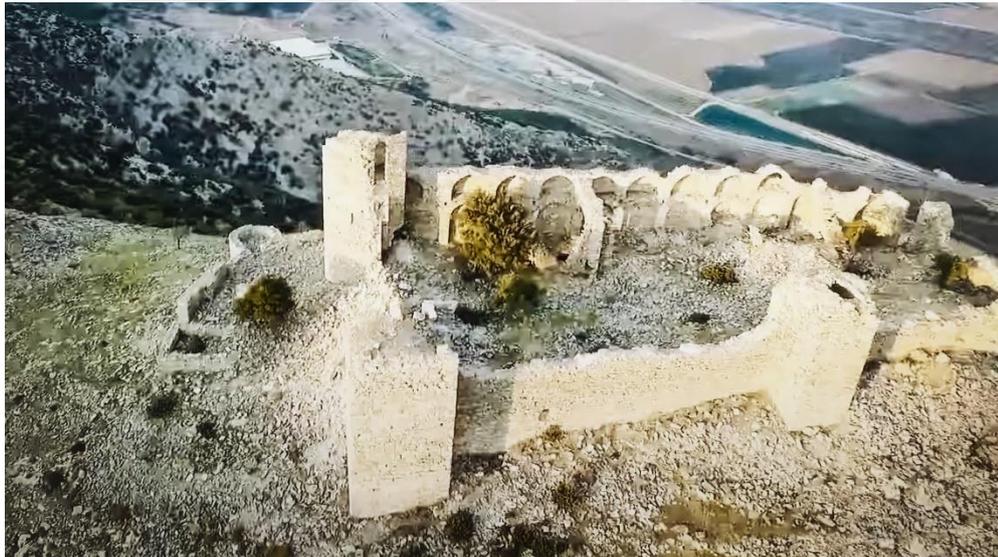
Figure 4.2. The current ruined state of the goat castle. (West-East Direction).

construction method indicates that it was built between the 12th and 13th centuries (Figure 4.2). It is estimated that it was built in the 12th century by the Komnenos and reinforced and renewed in the 13th century by the Laskaris. The castle consists of an irregular rectangular citadel and an outer castle that frames the citadel from the west and north. Since the south and east sides of the hill are steep cliffs, there is no external wall structure in these directions. The entrance to the castle is on the west side of the outer wall. The inner castle was built on a rectangular ground plan in 4 directions. The entrance of the castle was opened by a door in the western and northern directions, but the wall on the western facade completely collapsed in 2005 as a result of a series of earthquakes (Figure 4.3) (Tok, 2016).

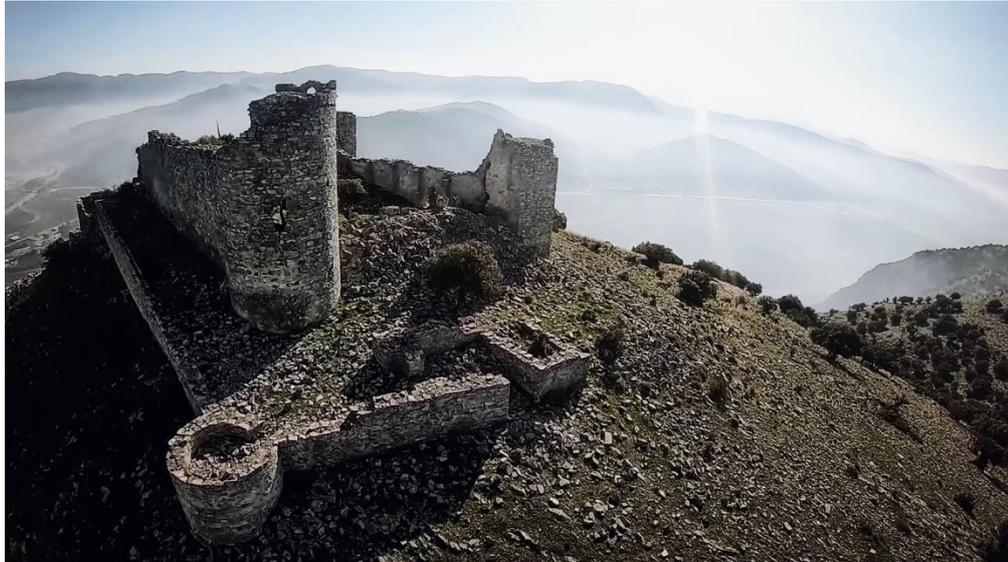
Figure 4.3. The outer fortress wall and the recently demolished inner fortress west side wall. Retrieved from https://www.youtube.com/watch?v=LjVmvPEExtY&ab_channel=D%C4%B0N%C3%87ERSERTKAYA in December, 2021 and edited by the author.

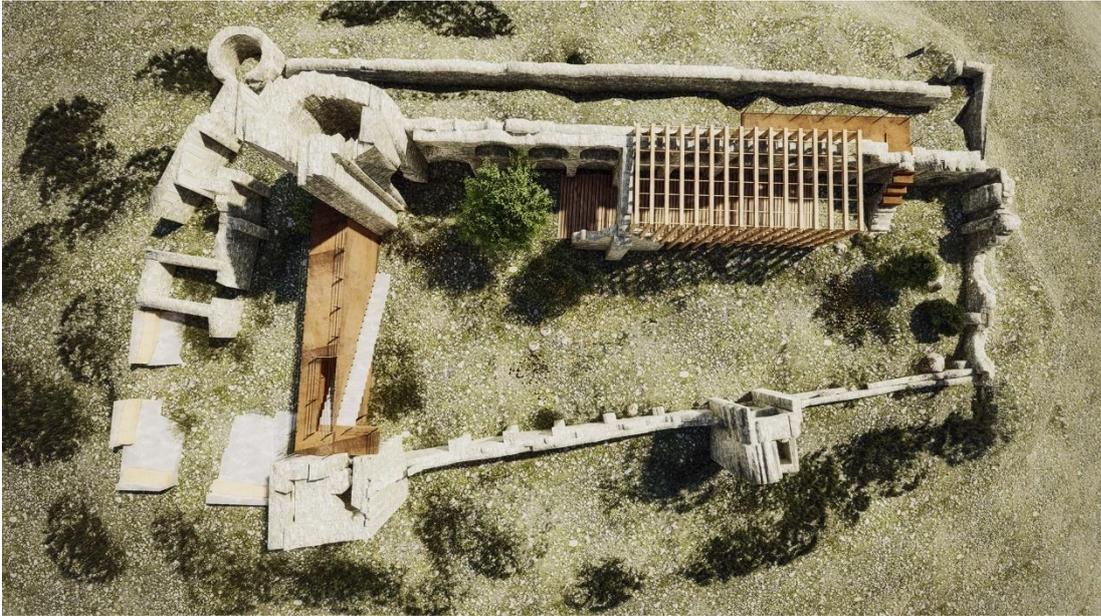
Figure 4.6. Top view of proposed adaptive reuse interventions to existing structure.

Based on the traces of the outer castle walls, which were completely destroyed on the western facade of the castle, seating units with similar characteristics in shape and volume were placed on the original walls. Since the castle structure itself and the interior of the castle are for visiting and observation functions, the outer castle area was considered more suitable to fulfill functions such as resting and waiting. The sloping and polygonal shape of the concrete mass that defines the seating area represents the demolition of the outer castle wall and its blending with the topography, but at the same time shows its existence today. Considering that the entrance to the castle was from the same facade of the original structure and that this is the first facade encountered when reaching the castle, this area defines a welcoming space. (Figure 4.6)

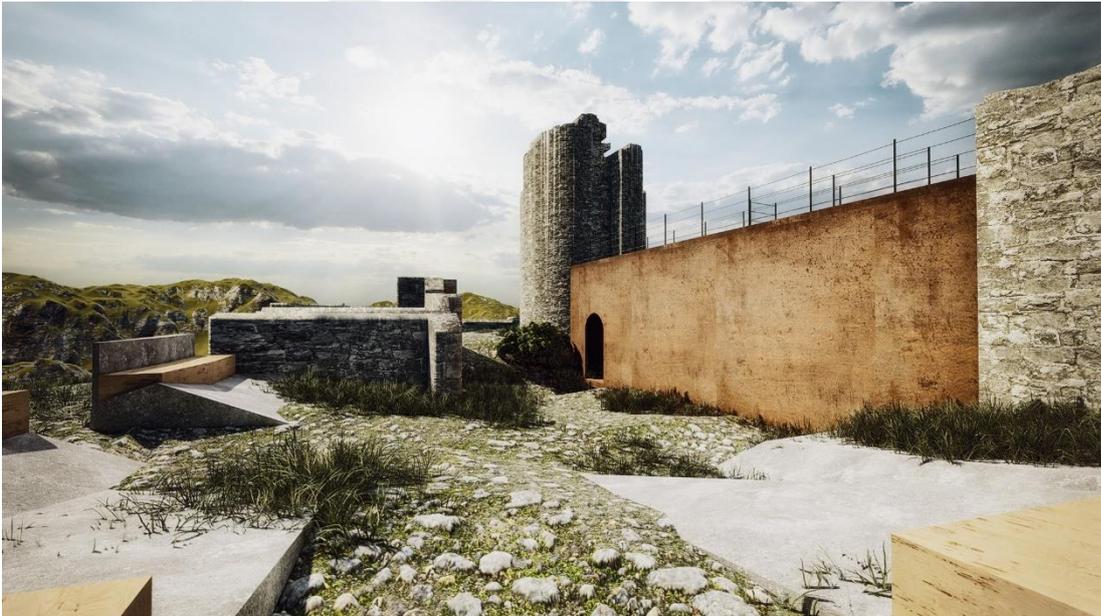
Figure 4.7. Concrete resting area at the western end of the outer castle, seating units and a steel box extension built to replace the demolished west wall of the inner castle.

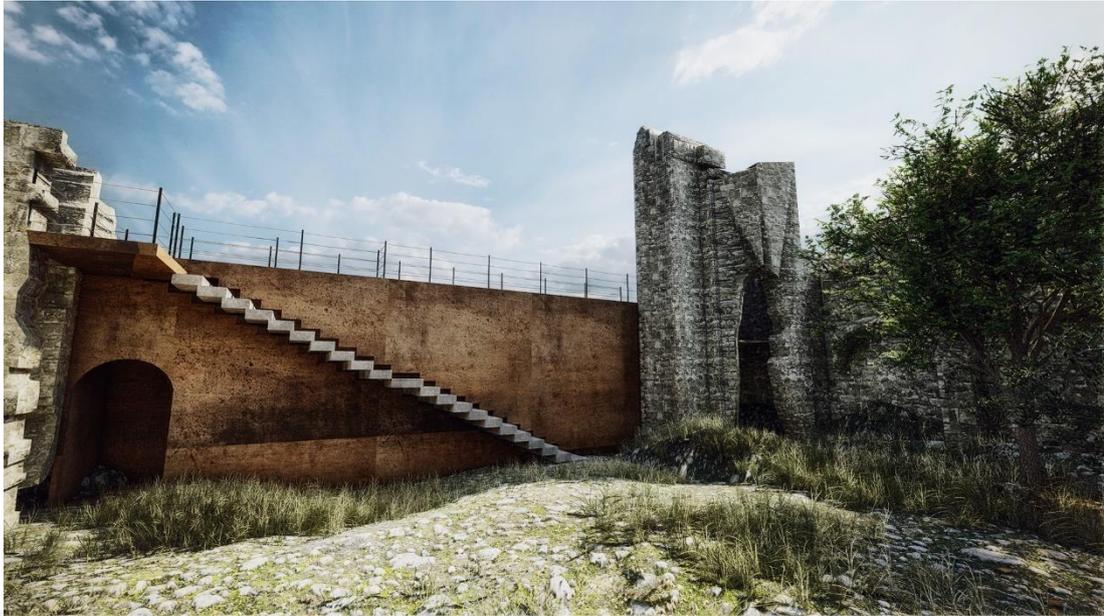
Figure 4.8. The view of the steel box extension and the concrete staircase from inside the castle interior.

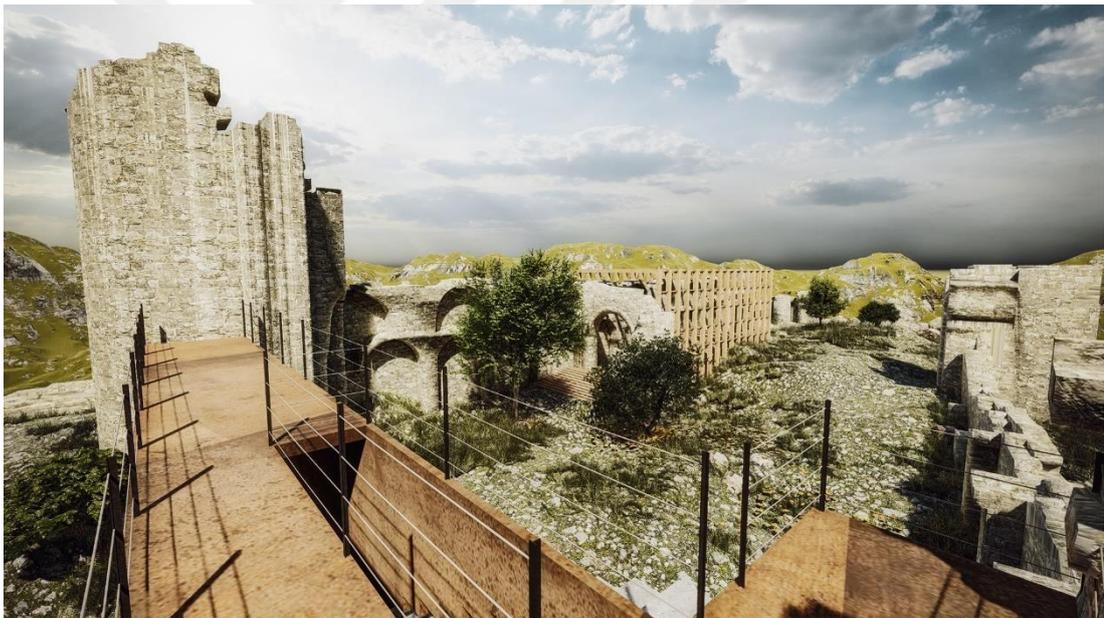
Figure 4.9. Interior view of the castle over the steel box addition.

When the interior defined by the castle is reached, almost no remains can be found, except for the remains of an arch from the part where the soldiers' wards were located that also stated in the restitution project. This interior space, known as the ward, is defined by the wooden flooring covering the area where the place is located and a permeable wooden top cover that can be called a pergola. This wooden structure, which touches the northern interior of the castle, appears from the outside as a mass that indicates that there is an interior space there, while at the same time forming a corridor through which visitors can circulate. (Figure 4.9) (Figure 4.10) (Figure 4.11)

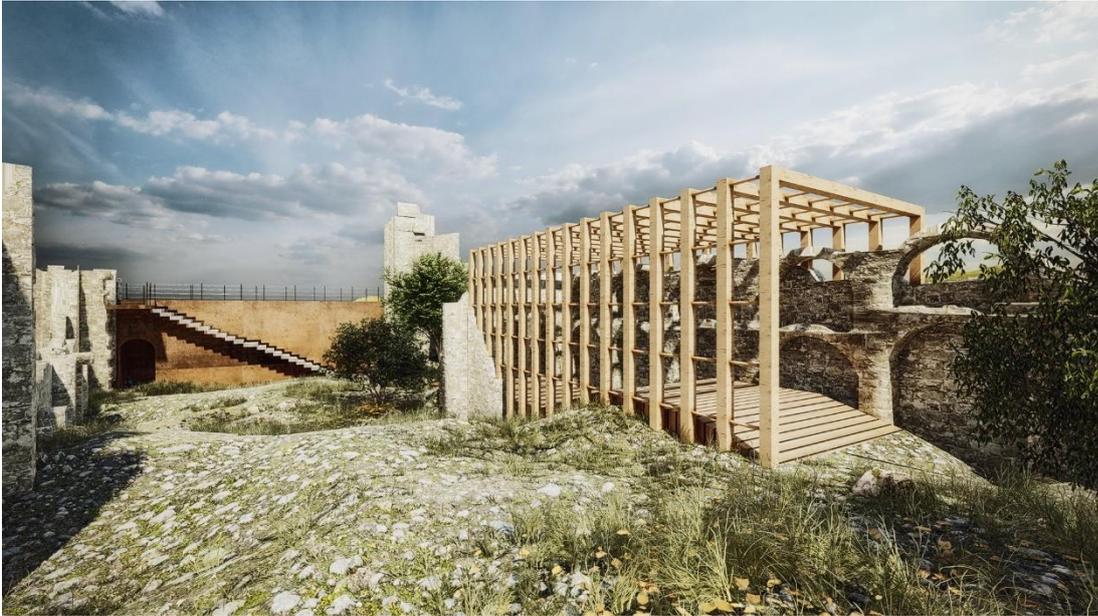
Figure 4.10. Addition of pergola and wooden flooring defining the ward area and steel box addition at the back.

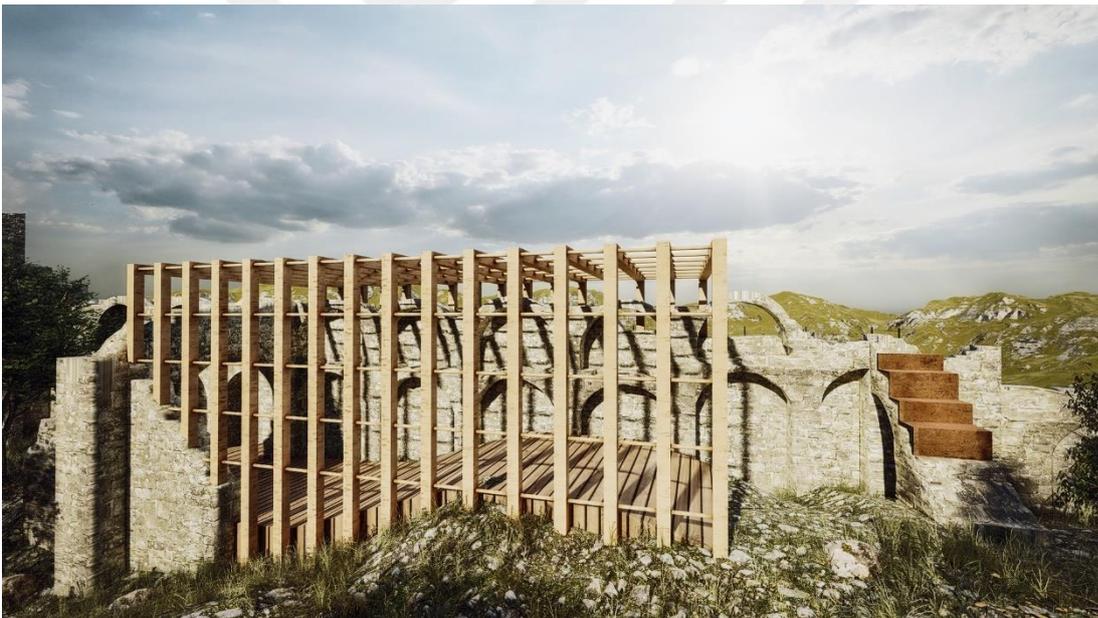
Figure 4.11. The ward part and the remnant of the existing staircase.

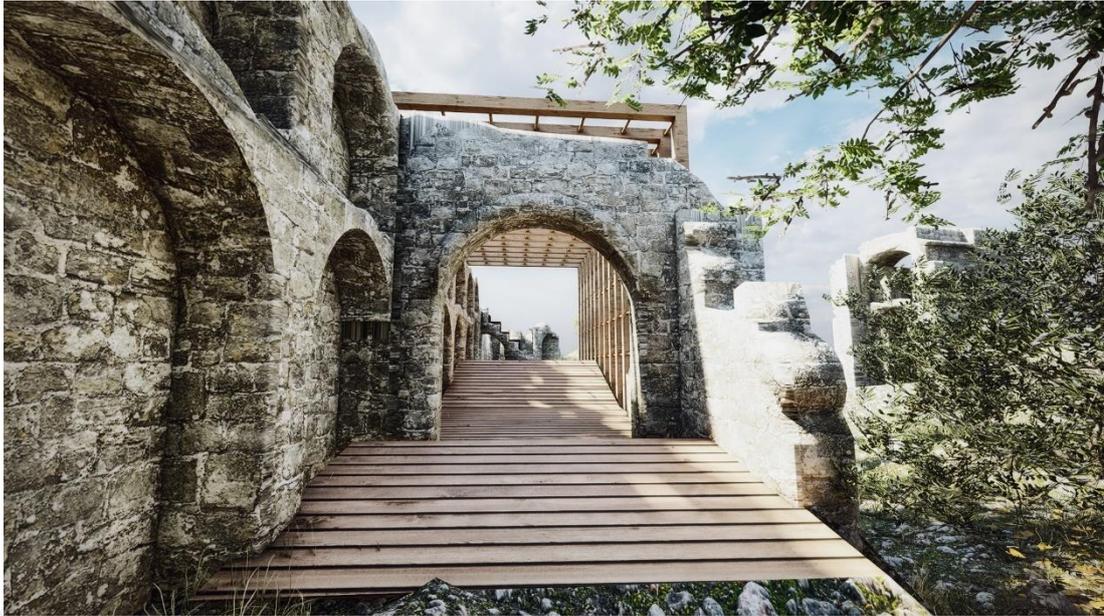
Figure 4.12. Addition of pergola and wooden flooring defining the ward area from another perspective.

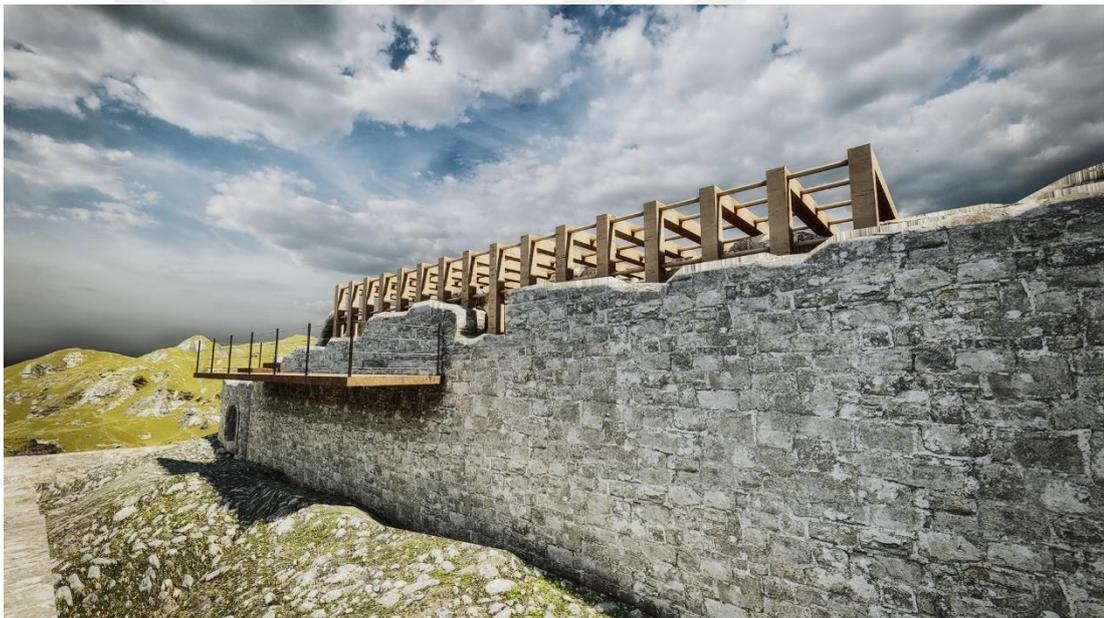
Figure 4.13. The steel balcony extension on the north wall of the inner castle and the pergola legs placed on the wall.

The steel staircase attachments climbing up the north wall and the steel balcony extension hanging on the same wall were built with steel material for protection and durability. There is a light railing system on the steel balcony extension, as in the steel box extension.
