MASTER THESIS

**FACADISM AS AN INTERVENTION STRATEGY
FOR ADAPTIVE REUSE OF HISTORIC BUILDINGS**

ASLI TATLIBAŞ

MSC. IN INTERIOR ARCHITECTURE

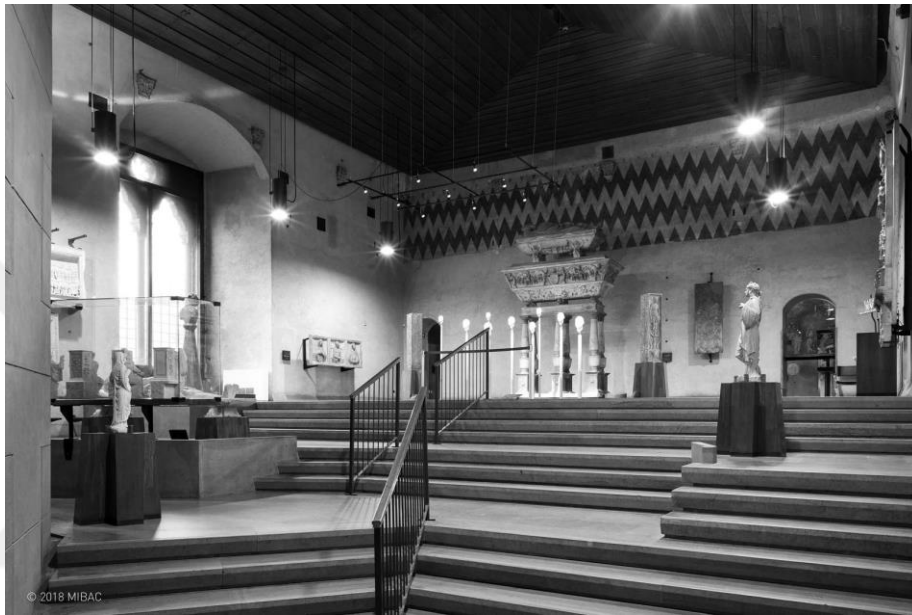
Figure 2.1. Sala degli Scarlioni, Castello Sforzesco Retrieved from:

BBPR and Carlo Scarpa introduced a contrasting relationship of old and new in their groundbreaking designs. In 1956, BBPR, which was constituted by four recognized Italian architects of that time, transformed the Sforzesco Castle into a museum (Figure 2.1.). The new design involved compatible but nonimitative elements like display panels and lighting fixtures, and the project reflected a juxtaposition of the new and old designs. (Bollack, 2013, p. 14).

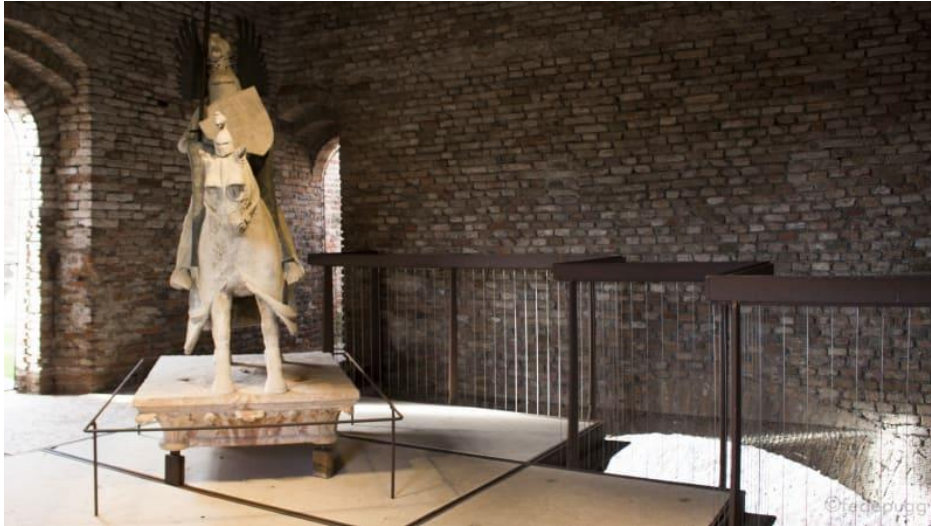
Figure 2.2. Castellvecchio Museum Retrieved from:

In Castelvechio Museum (1959-1973), Carlo Scarpa combined contemporary elements with the old fabric (Figure 2.2.). The medieval castle was converted into a museum through a creative design process where its identity, function, and physical qualities were altered.

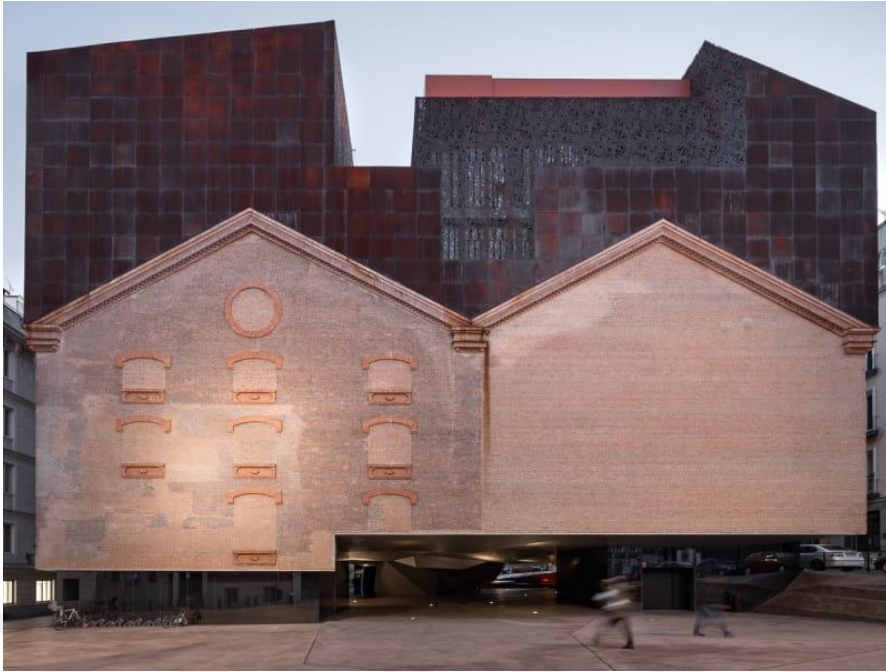
Figure 2.3. Caixaforum Retrieved from:

An old power station was transformed into a cultural center by Herzog & de Meuron in 2008. In this project, the base of the original building was separated from the rest of the structure to be removed later on. Removing the base created a communal area for the public and the visitors while providing shade and some level of coverage (Figure 2.3.). This tactic was also aimed at defining the main entrance of the cultural center without using much space from the narrow streets. The only preserved aspect of the historic fabric is the outer brick walls at the final stage (Herzog & de Meuron, 2008).

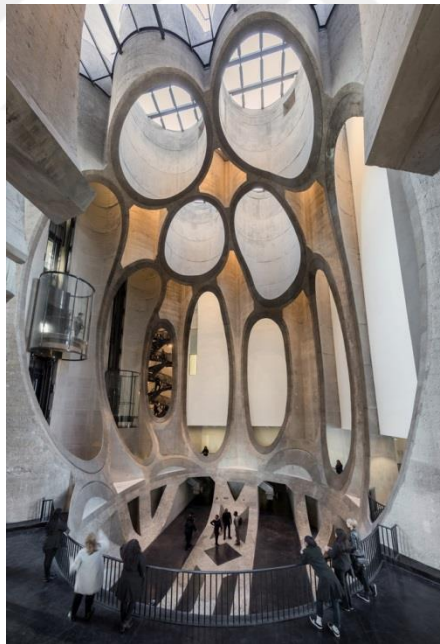
Figure 2.5. Interior of Zeitz Mocaa Retrieved from:

In 2017 Heatherwick Studio transformed an old grain silo complex into a contemporary art museum. The industrial building was abandoned in 1990, and after it was left empty for more than 20 years, it was re-functioned to be included in contemporary life. In order to add an atrium to the center of the existing fabric, the cylindrical form of the silos was partially carved, and this area was re-functioned as the museum area (Figure 2.5.). This way, the visitors are allowed to see the structural details of the original texture and its relationship with the new design. The inspiration behind the carved shape was the form of grain.

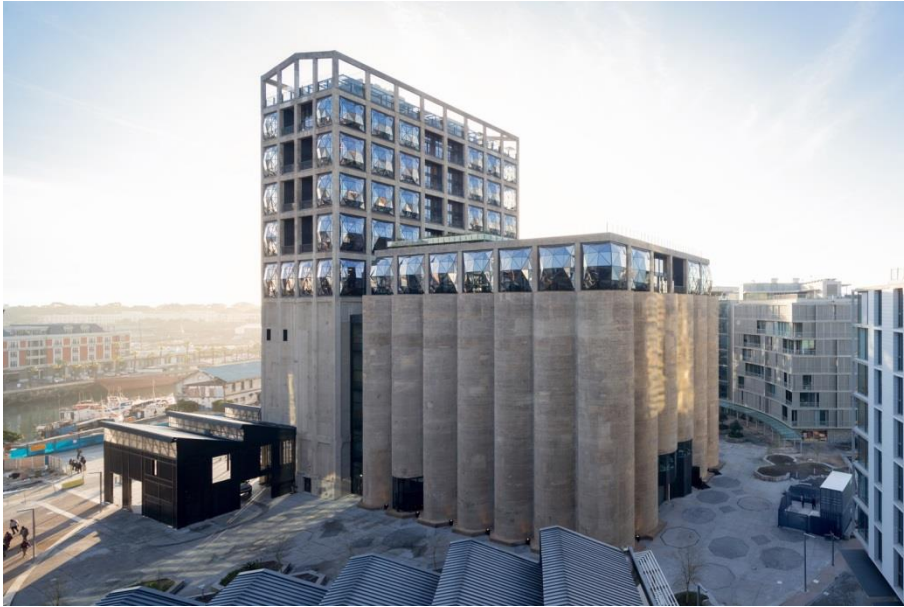
Figure 2.6. Zeitz MocoA Retrieved from: <https://www.archdaily.com/879763/zeitz-museum-of-contemporary-art-africa-heatherwick-studio/59bc1871b22e38139f000155-zeitz-museum-of-contemporary-art-africa-heatherwick-studio-photo>

Some of the outer walls of the building were transformed into three-dimensional windows to allow the maximum level of daylight inside (Heatherwick Studio, 2017) (Figure 2.6.).

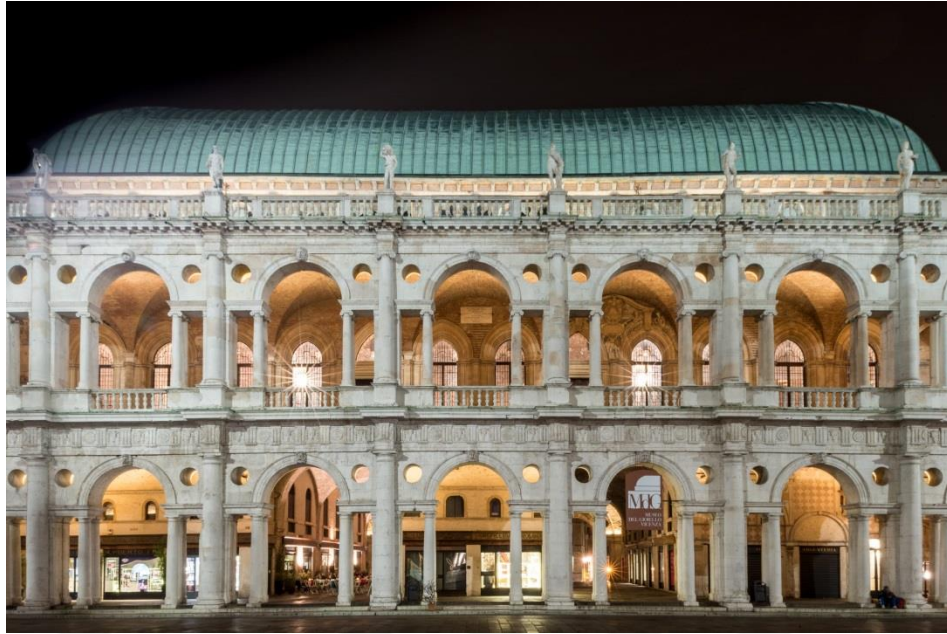
Figure 3.2. Basilica Palladiana by Andrea Palladio Retrieved from:
<https://divisare.com/projects/378798-andrea-palladio-mario-ferrara-basilica-palladiana#lg=1&slide=2>

In Palladio's intervention to the Gothic structure of Palazzo della Ragione, the addition of a new outer shell in the new Renaissance can be seen. This addition creates a portico where a new circulation route is defined between the building's exterior and interior, which eventually generates a unique connection. Even though the new facade embodies the building, the initial gothic front of the structure is kept intact.

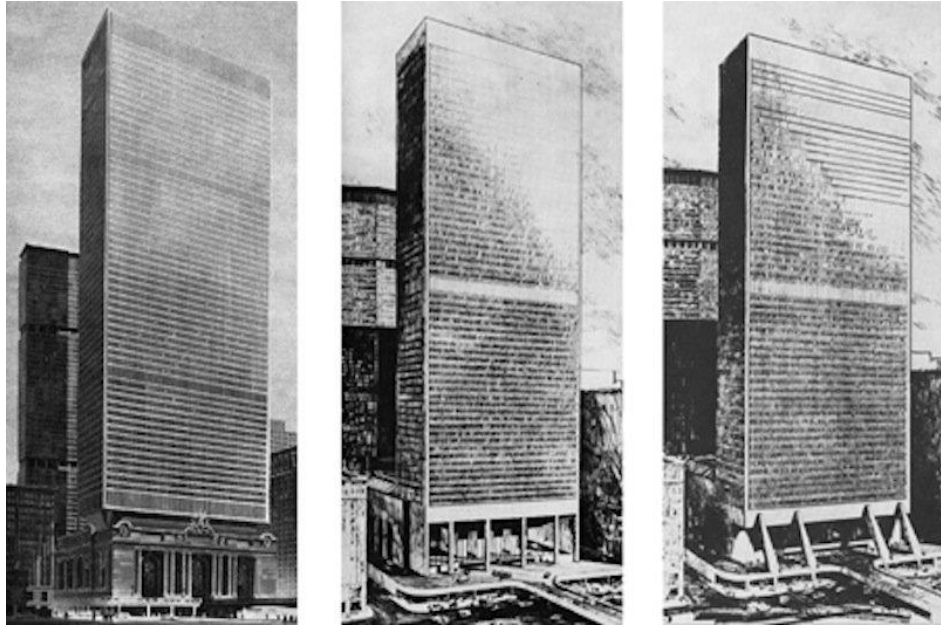
Figure 3.4. Marcel Breuer's proposals to add a tower atop Grand Central Retrieved from: <https://www.6sqft.com/how-preservationists-and-jackie-o-got-the-supreme-court-to-save-grand-central-terminal-in-1978/>

The proposal consisted of a tower on top of the existing structure by demolishing a portion from the internal part (Figure 3.4.). The main goal was to provide more office areas for the people who worked in the station. The 55-story tower project received much backlash from the public and conservationists.

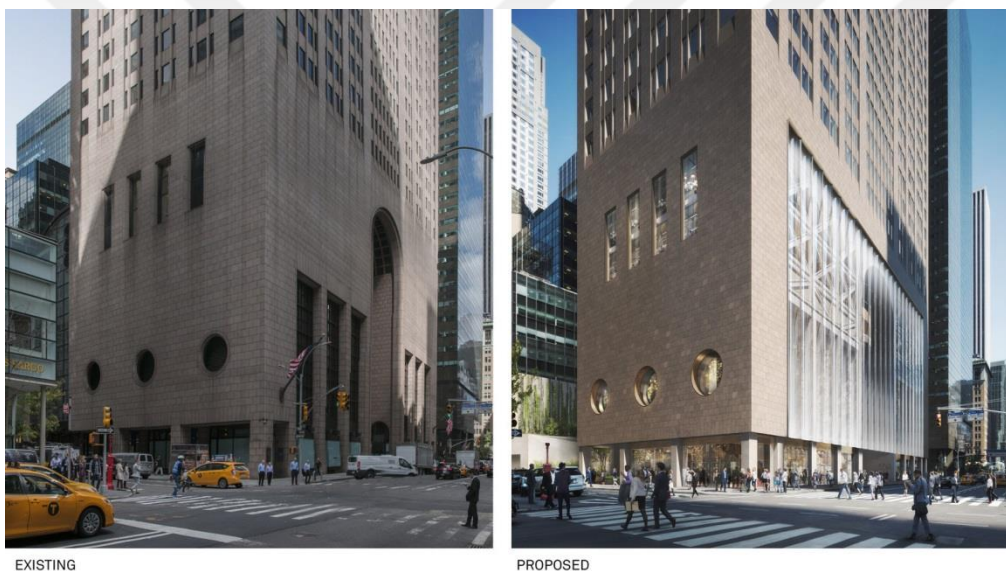
Figure 3.6. Comparison between the existing scheme and proposed renovations

A similar situation took place in a relatively recent year. The very famous AT&T Headquarters designed by Philip Johnson was subjected to a renovation proposal. According to the proposed project, the existing stone facade of the building at the street level was to be replaced with a transparent material. The massive arched entry on the front facade would be removed to recreate a hazy appearance (Figure 3.6). Since the plan was announced, critics and the general public have had conflicting views. Major organizations such as DOCOMOMO and change.org launched campaigns to protest the proposal. By considering the reactions and emphasizing the importance of the skyscraper as a postmodernist building, New York Landmarks Preservation Commission refused the proposal and designated the structure as a historic landmark to ensure its preservation.

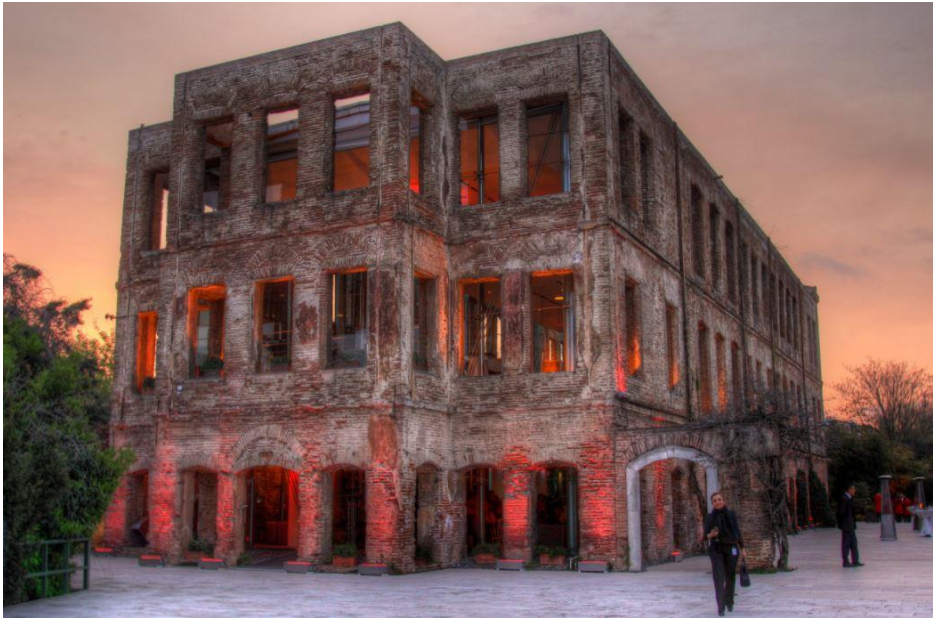
Figure 3.8. Esma Sultan Mansion, 2001 Retrieved from: <https://www.gadarchitecture.com/uploads/projects/100041/gad-architecture-gad-mimarlik-2546454c6541fa06efd262bcc388474f0d67ea97.jpg>

matches the mansion's original volumetry. Although the facade does not reflect the interior of the building, it benefits from its functionality. In this case, the internal parts were not demolished deliberately during the redevelopment process; however, this project reflects the facadism approach's characteristics.

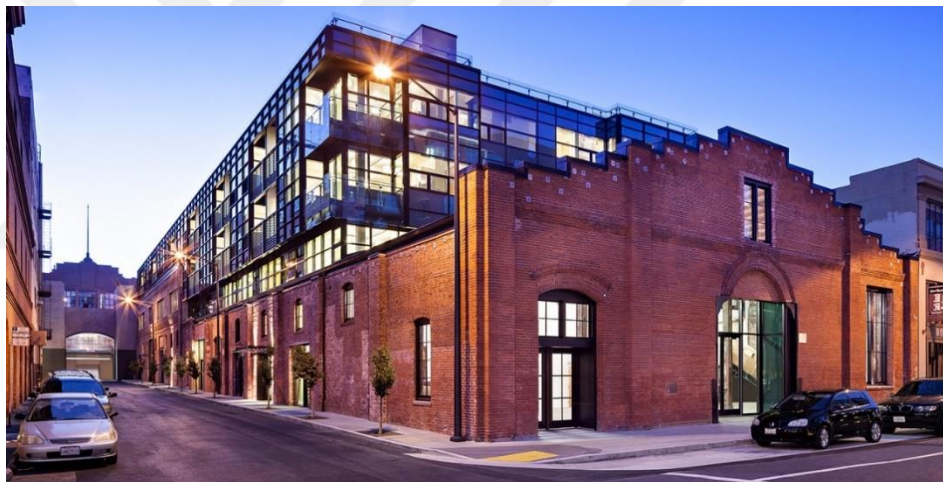
Figure 3.9. 178 Townsend Retrieved from:
<https://interfaceengineering.com/work/178-townsend>

In 2012, Ian Birchall + Associates redeveloped a historic building designed as a light company building (Figure 3.9.). After the renovation project, the building became a residential building offering luxury apartments. Exterior masonry walls were the only remaining parts of the original structure. The architects proposed an addition to fit inside the boundaries of the facade and exceed the original volumetry of the historic host building. Entirely made of aluminum and glass, the new visually light design aimed to contrast with the historical texture.

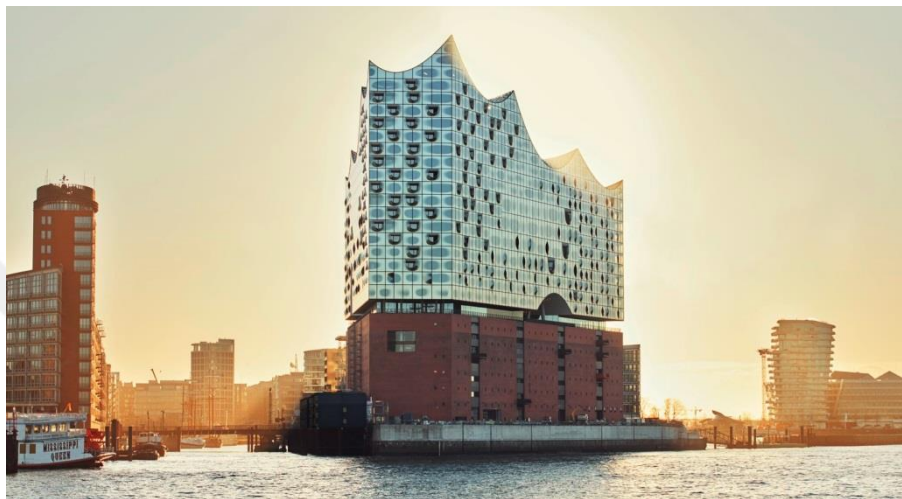
Figure 3.10. Elbphilharmonie Retrieved from:

As a contemporary example, Herzog & de Meuron re-functioned a building on the Hamburg harbor in 2016 (Figure 3.10.). Named the Kaispeicher A, it was initially designed and used as a warehouse for cocoa beans. This structure features a performance theater, a hotel, and luxury apartments and is designed to be

multipurpose. The new building rises above the brick block of the older building as its extrusion. The new addition is identical to the ground plan of the Kaispeicher; however, at the top, it takes a different tack from the basic shape of the structure below. Most of the new functional areas take place in the contemporary addition. The historical host building is mainly used for service areas such as technical rooms and a car park. Although the historic fabric is preserved to some extent, the remarkable facade of the new structure comes dominant over the warehouse.

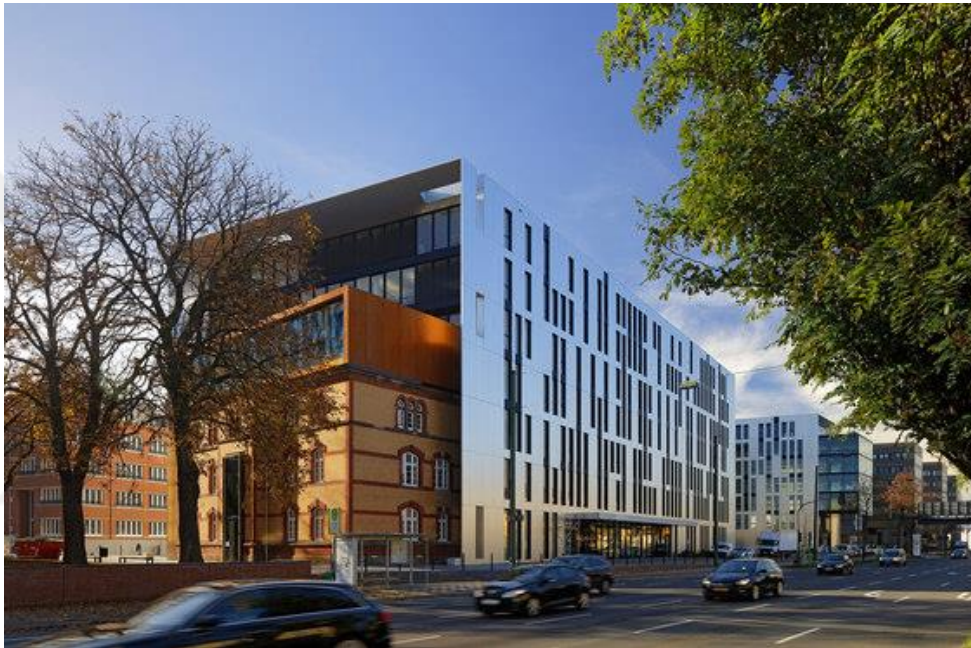
Figure 3.12. Clara & Robert Retrieved from:

SOP Architekten gave new life to the Wilhelmine barracks with a renovation project in 2015 (Figure 3.12.). Initially built in 1890, the historical structure is currently one of the biggest existing military complexes in the Rhineland. The architects proposed a volumetric expansion from the boundaries of the historic host building while preserving the original facade. In the new design, monolithic corten steel is used to create the new shell, covering a significant portion of the yellow brick facade. In order to gain more space for the proposed function, the office complex, the contemporary addition exceeds the volumetric balance of the barracks by two stories.

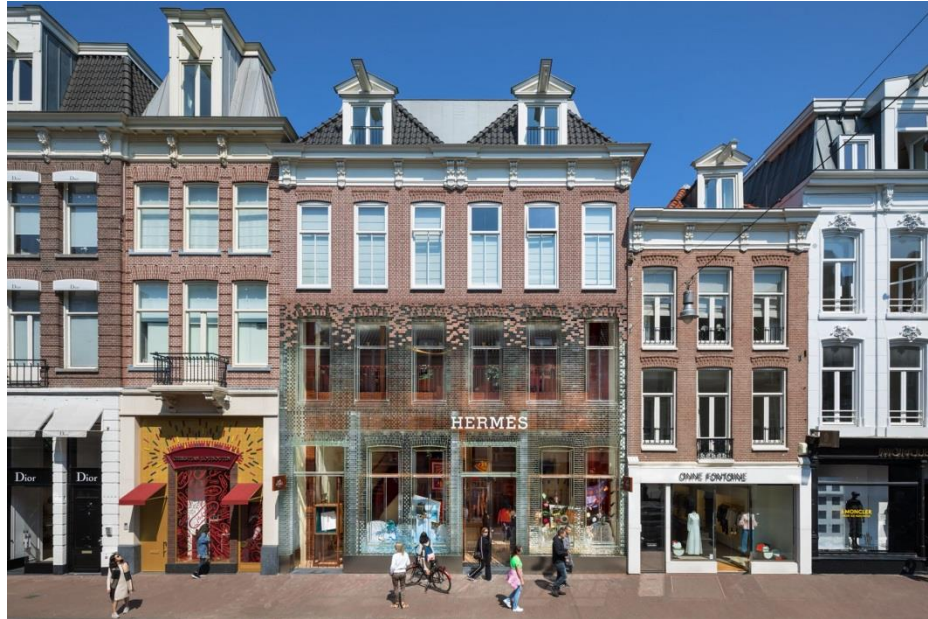
Figure 3.14. Crystal House Retrieved from:

One of the contemporary examples of this method is located in Amsterdam. The architecture firm MVRDV re-functioned a traditional townhouse for a retail company. The initial design idea consists of integrating contemporary techniques and materials while respecting the local character and also responding to the needs of the newly proposed function. For this reason, instead of the original terracotta bricks, the front facade of the townhouse is made of glass bricks. The new design entirely mimics the original facade, including the detailing of window frames. The glass bricks start from the ground level and slowly dissolve into the original material on the first-floor level. Finalized in 2016, the Crystal House provides the structure with a window surface that serves as a display (Figure 3.14.). MVRDV has taken a very innovative approach to re-functioning in a practical way. As a result, their intervention to the structure respects the historical appearance, which stands out among other structures.

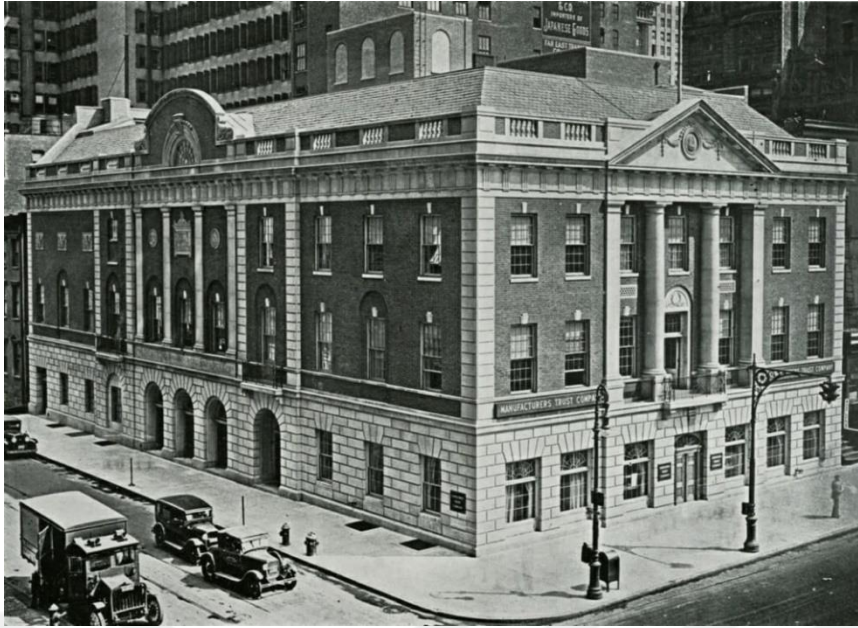
Figure 4.4. Tammany Hall Circa 1930s Retrieved from:
<https://bkskarch.com/work/tammany-hall/>

The site for the Tammany Hall from Union Square was purchased in 1927 by the Tammany organization. Architects Thompson, Holmes & Converse, and Charles B. Meyers for the project were chosen. The building's facade was completed a year later, and the interior components were finished in the months that followed. The final structure consisted of three and a half stories (LPC, 2013) (Figure 4.4.).

Limestone is used on the exterior until the upper level of the first story, and the rest of the facade is made from oversized red bricks. Tammany organization stated that the composition of the main facade was inspired by the Federal Hall, where President George Washington swore his inauguration oath. The Doric columns and the frieze, the portico, and the high basement level are perceived from Union Square. Both visual facades of the building carry firm details of Neo-Georgian Style such as the arched windows openings with stone keystones, principle windows that are enframed by fake arches, wrought balconies, the brickwork in the Flemish pattern (Figure 4.5).

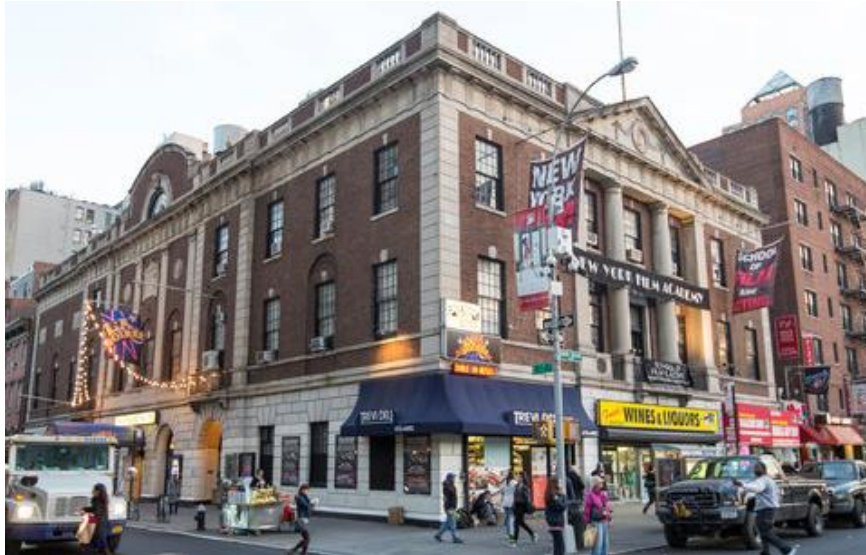
Figure 4.7. Tammany Hall in 2013 Retrieved from:

Even though the facade of the building was designed to be balanced and symmetrical in Georgian style, the structure's interior has a rather complex plan layout (Figure 4.7.).

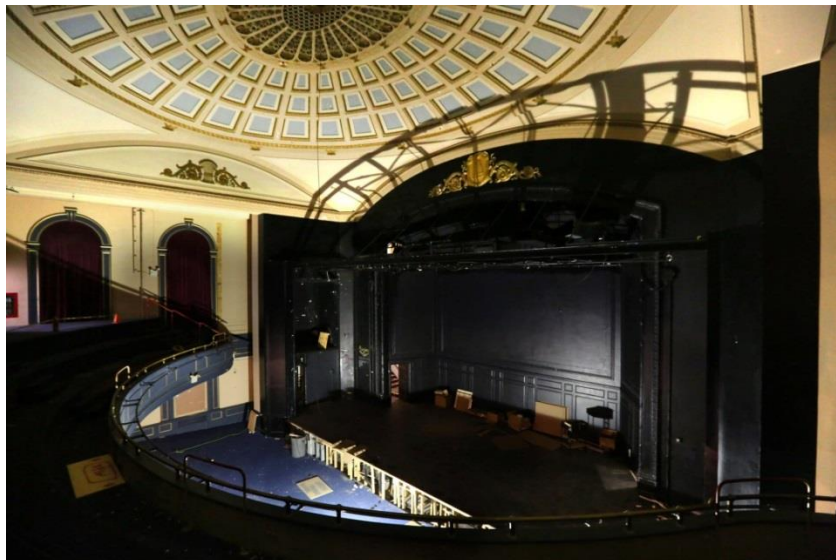
Figure 4.8. Auditorium Retrieved from:

The internal part of the building incorporates a large auditorium. The most striking aspect of the auditorium is the coffered dome ceiling, which has been used for more than one purpose over the years and wanted to be protected even during the last intervention period (Figure 4.8.). At this point, it was stated that the physical stability of the auditorium was not sufficient, and the plaster on the wall started to fall off (Cotter, 2016).

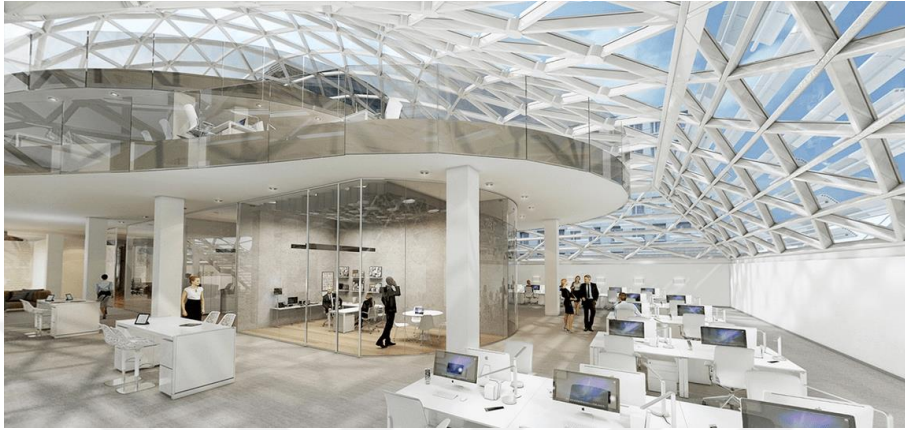
Figure 4.10. Interior of the New Glass Dome Retrieved from:

A new interior was constructed for the existing facades, and in addition to this, three more stories were included in the roof structure. The new roof was shaped in the form of a turtle shell made out of glass which was inspired by the background of the populist social club, the initial owners of the building (BKSK Architects, 2020) (Figure 4.10.) (Figure 4.11.).

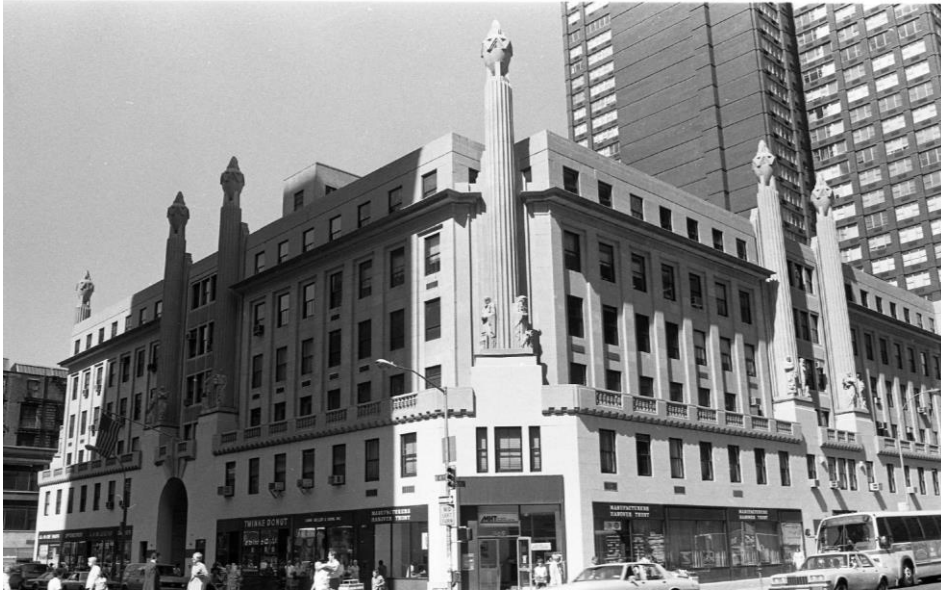
Figure 4.16. International Magazine Building in 1988 Retrieved from: NYC Landmarks Preservation Commission Archive

Although the International Magazine Building looks like a rectangular building from the outside, the plan layout is horseshoe-shaped. Accompanied by a central courtyard hidden from the outside world, the remarkable limestone facade makes it hard to walk by without noticing (Figure 4.16. and Figure 4.17.).

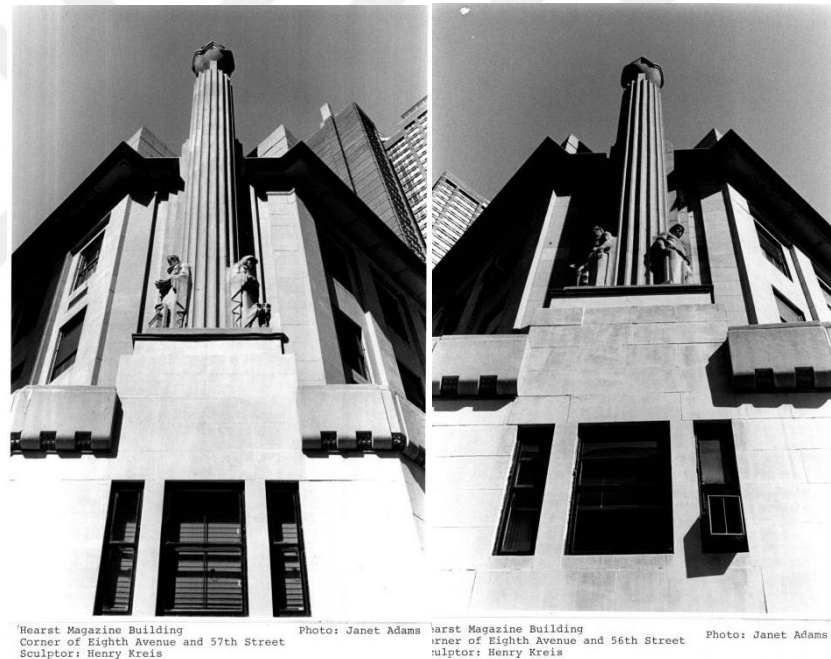
Figure 4.18. International Magazine Building Corner Details Retrieved from: NYC Landmarks Preservation Commission Archive

this arch. The fluted columns are placed on the right and the left side of this arch-shaped entrance. Stepped and angled setbacks are used to connect these columns to the main structure. The sculptural figures representing "Comedy and Tragedy" and "Music and Art" are installed on the junction point of these columns with the third story. The garish columns are topped with horizontal zigzag bands and urns above the sixth story (LPC, 1988b) (Figure 4.18).

A balcony separates the ground floor with modern shopfronts/display windows and the second story with steel sashes from the upper floors. The setback of the building starts from the third floor and, the following two levels rise above this setback. On the chamfered corners of the building, the sculptures "Sport and Industry" and "Printing and the Sciences" are installed. These corners on the ground floor mark entrances of shops and, the scales of the windows on the second floor are varied.

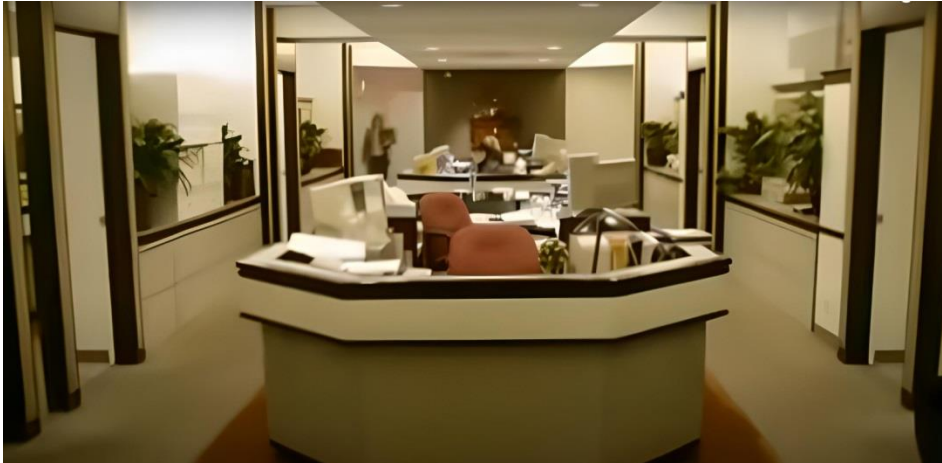
Figure 4.19. International Magazine Building Interior Retrieved from:
<https://www.thirteen.org/programs/treasures-of-new-york/>

Internal parts of the historic host reflect the facade's prevailing style, art deco. The geometric-shaped details of the interior can be seen in the wall covering materials to the furniture used in the spaces (Figure 4.19.).

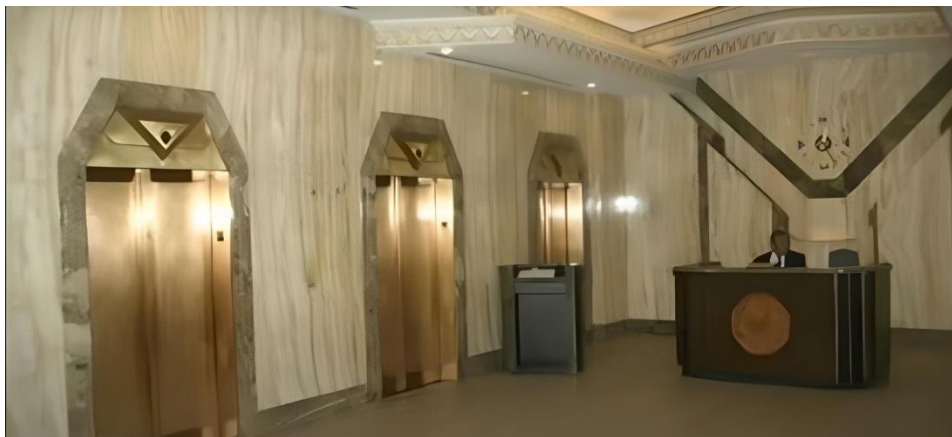
Figure 4.20. International Magazine Building Interior Retrieved from:
<https://www.thirteen.org/programs/treasures-of-new-york/>

Natural tones are commonly used in workplaces that draw attention due to their low ceilings. The interior, which is free of ornaments and exaggerations and has basic and sharp lines, is reminiscent of the design style of the 1920s (Figure 4.20.).

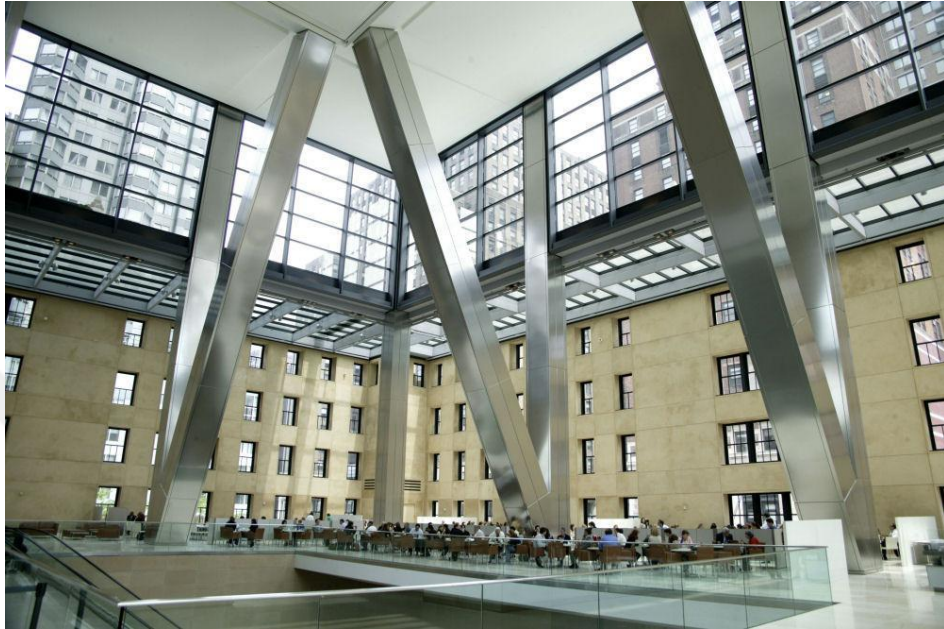
Figure 4.23. Hearst Tower Lobby Retrieved from:

Foster + Partners (2006), indicated that the new lobby on the third level was inspired by the existing raised interior courtyard of the historic fabric located on the same floor. The design team aimed to define the interior of the remaining facade as a grand piazza. To utilize the outer walls as this piazza's facades, they were furred out with limestone-colored stucco (Figure 4.23).

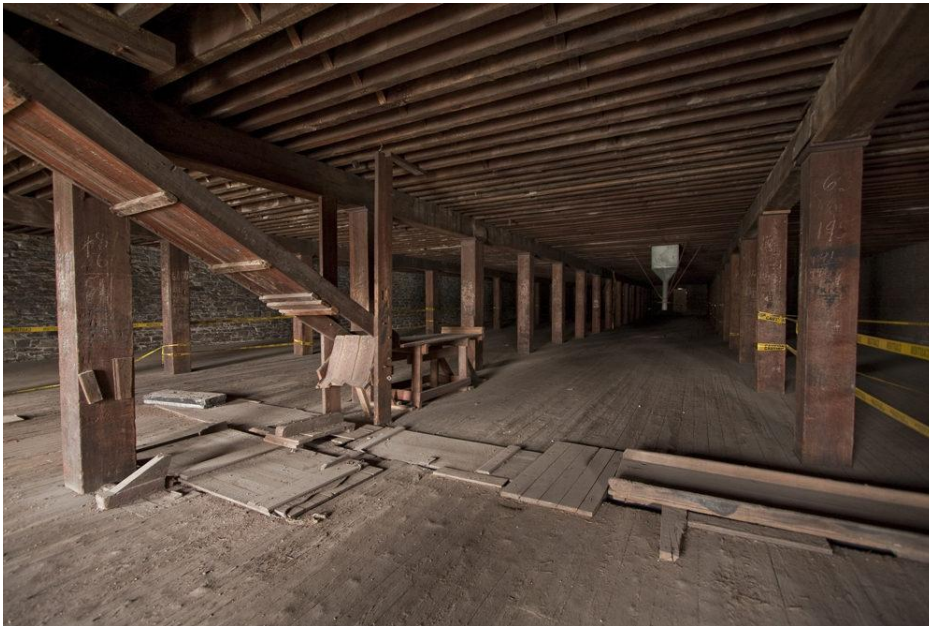
Figure 4.31. Empire Stores before the beginning of the construction in 2014
Retrieved from: <http://dumbonyc.com/blog/2016/01/24/empire-stores-dumbo-brooklyn-shopping-center/>

Although the Empire Stores look like one building, the actual structure consists of seven warehouses completed in two separate stages. All seven warehouses are built in dark red brick and heavy frame timber construction. (Figure 4.31. and Figure 4.32.).

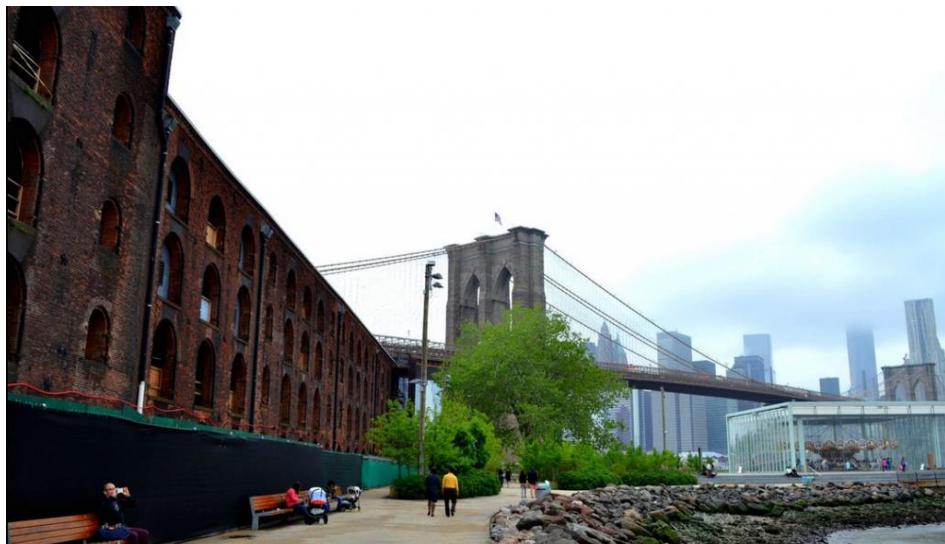
Figure 4.33. Waterfront Side of Empire Stores in 2014 During Construction

The iconic facade shows the effects of the weather and physical conditions on the red bricks for almost 150 years (Figure 4.33.). On top of that, traces of some street art made with spray paints can be seen in the photos. Frankly, Empire Stores reflects its magnificent existence on its exterior walls.

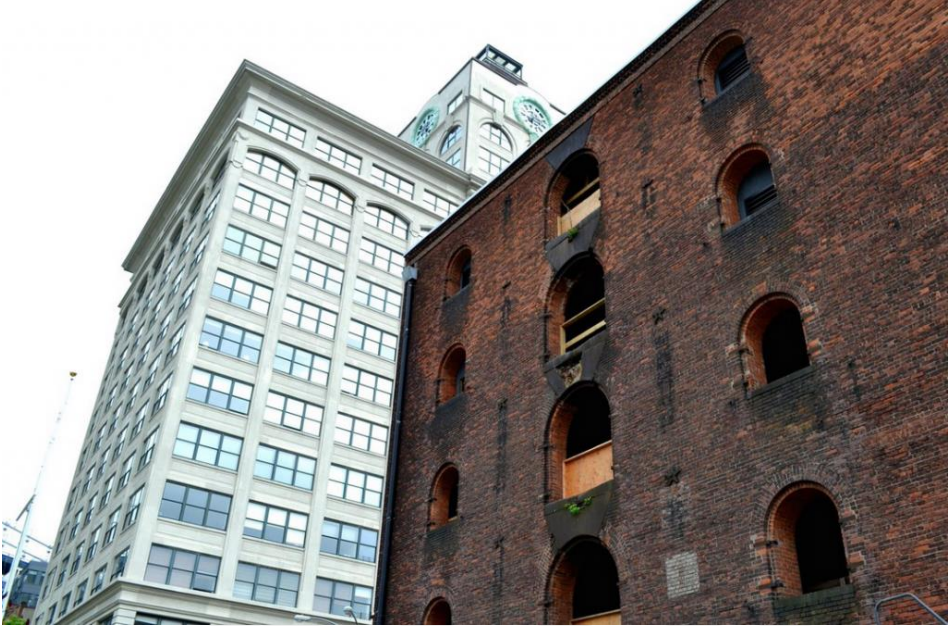
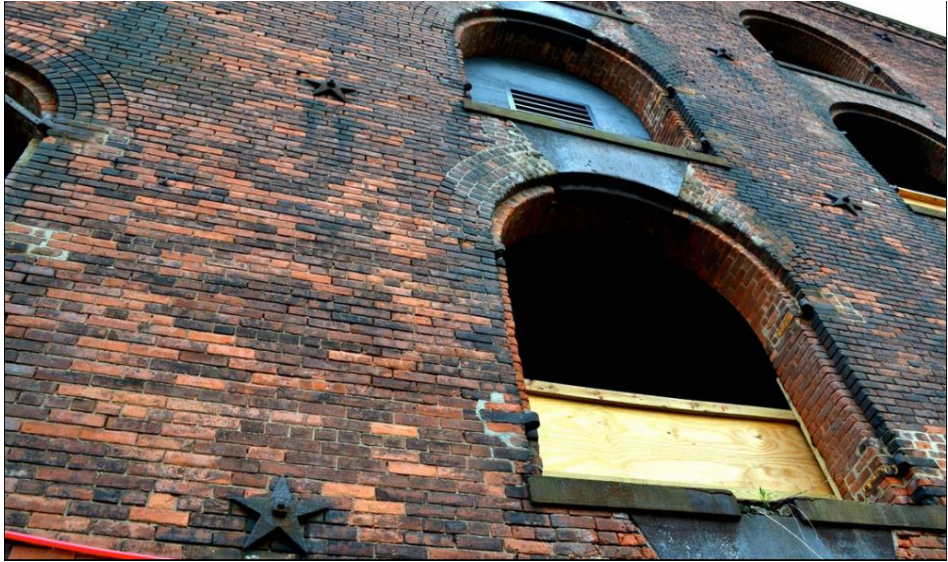
As the developer, Jack Cayre of Midtown Equities states, rusty parts of the building are the ones that make it authentic and attractive (Cayre, 2014) (Figure 4.34. and Figure 4.35.).

Figure 4.34. Facade of Empire Stores Retrieved from:
<https://brooklyneagle.com/articles/2014/05/21/industrial-eye-candy-dumbos-empire-stores/>

Figure 4.35. Facade Detail Retrieved from:
<https://brooklyneagle.com/articles/2014/05/21/empire-state-of-mind-inside-the-iconic-empire-stores-warehouses/>

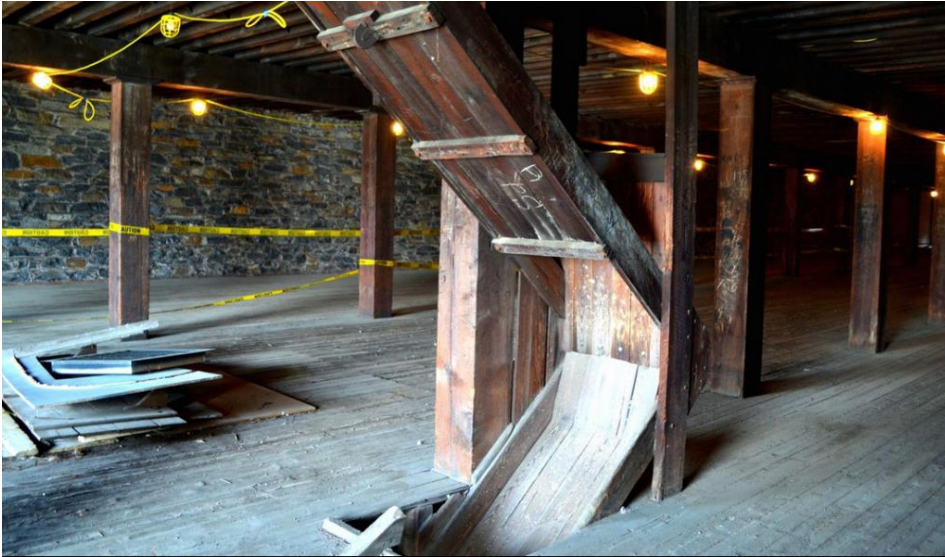
Figure 4.37. Wooden Chute for Sliding Coffee bean Bags Retrieved from:
<https://brooklyneagle.com/articles/2014/05/21/empire-state-of-mind-inside-the-iconic-empire-stores-warehouses/>

Some original mechanisms that were used when the buildings served as a warehouse were preserved inside the building for many years. Wooden chutes, metal funnels, and some carvings on them are still visible today. (Figure 4.37 and Figure 4.38)

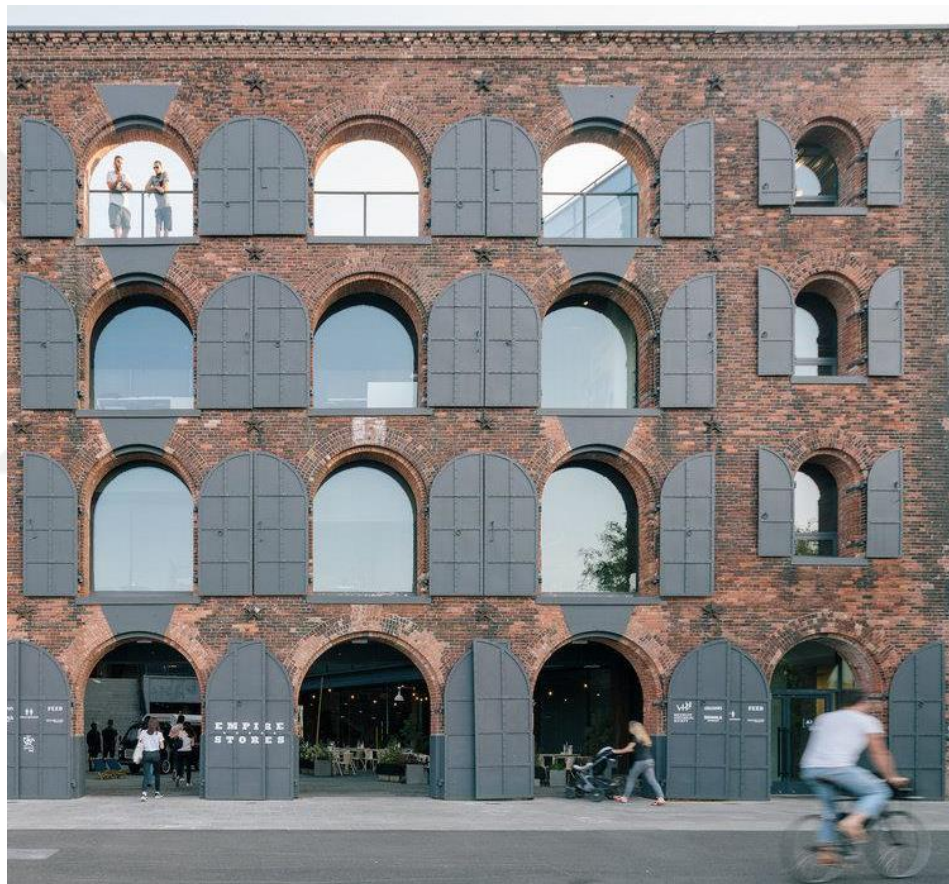
Figure 4.39. Facade of the Empire Stores after Renovation Retrieved from:
<http://s9architecture.com/empire-stores>

program, the building is planned to serve as a creative workplace and community hub (S9 Architecture, 2020). The newly created space consists of retail and dining areas, public spaces, and exhibition galleries. The first step in the construction phase was structural strengthening to ensure the safeguard of the building physically. Jay Valgora (2020), the head architect of Studio V Architecture, stated that the iron shutters used on the windows provided the building with movement and made the architecture of the building non-static. The iron shutters are preserved as essential facade elements and, the windows are covered with glass panels to keep stuff out (Figure 4.39. and Figure 4.40).

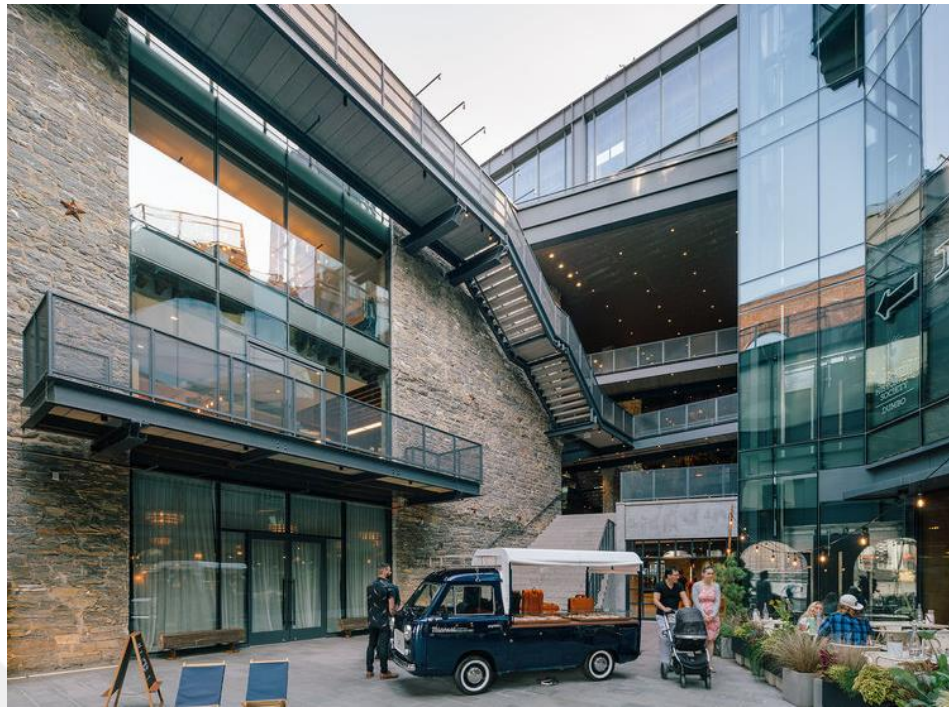
Figure 4.41. The Interior Courtyard of Empire Stores Retrieved from:
<https://s9architecture.com/work/#/empire-stores/>

Perhaps the boldest intervention made was carving out the separator schist walls in the center of the building to create a public courtyard (Figure 4. 41.).

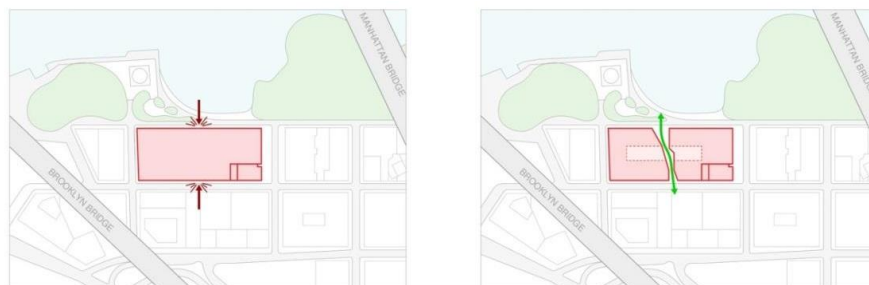
Figure 4.42. Courtyard Diagram Retrieved from:
<https://www.archdaily.com/895040/empire-stores-s9-architecture/5b05f3b0f197cc14a200052b-empire-stores-s9-architecture-diagram>

This courtyard cuts through the building like a passageway and connects two entrances of the building (Figure 4.42).

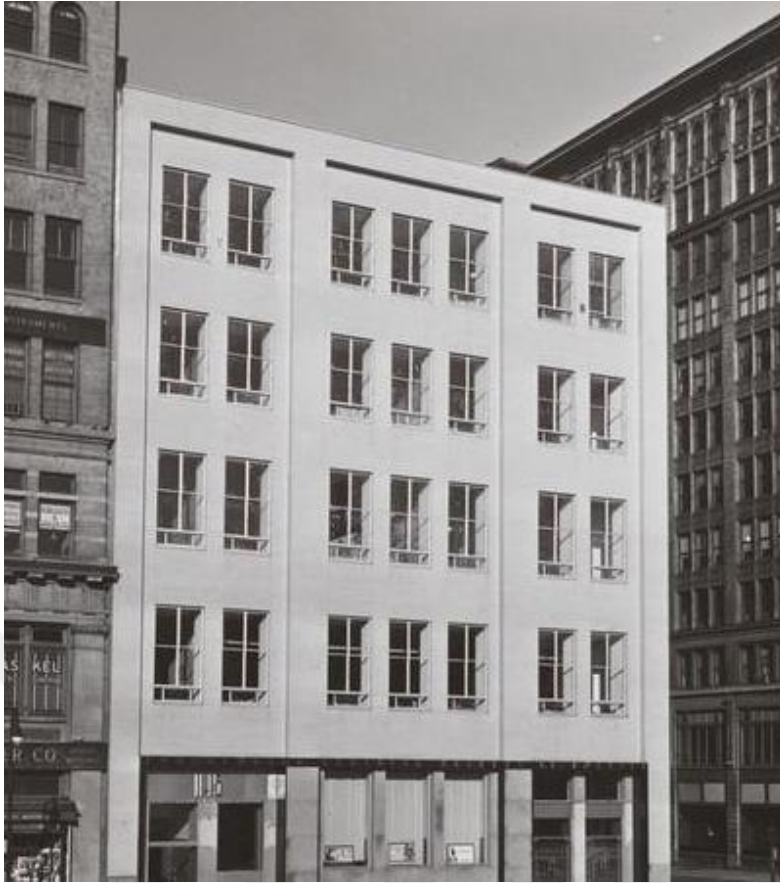
Figure 4.46. Tiffany Building in 1950s Retrieved From:
<https://ephemeralnewyork.wordpress.com/tag/tiffanys-union-square/>

Tiffany Company stayed in this location until 1905 when the jewels' elite audience moved toward Uptown. Until it started to be used in 1925 by Amalgamated Bank, the building was used as a warehouse. As the cast-iron facade began to deteriorate in the following years, a tragic accident took place. A piece from the facade fell off the building and killed a person on the street. The cast iron was stripped off, and the structure was covered with a white brick box (Figure 4.46.) The building was rumored to be demolished after it was sold in 2006, but instead of demolishing the structure, architects decided to renovate the structure securely (Walks of New York, 2011).

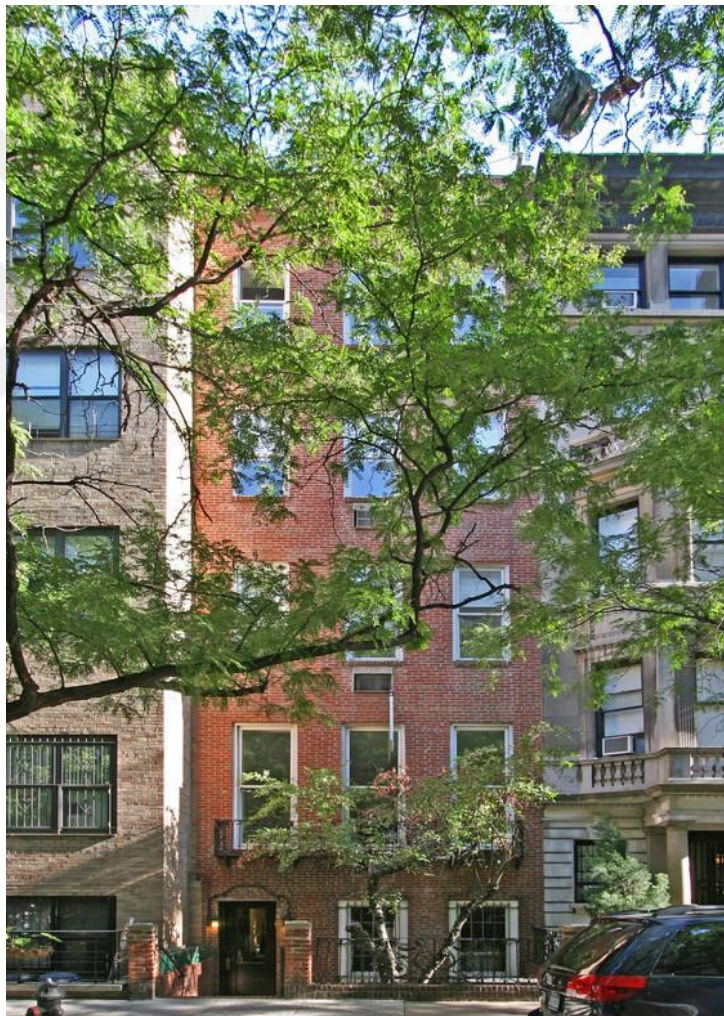
Figure 4.51. 45 East 74th Street before Renovation Retrieved from:
<https://observer.com/2013/06/blinded-by-the-white-after-10-m-renovation-newly-limestoned-45-east-74th-asks-30-m/>

The structure was initially built-in 1879. As one of a row of six, the building has four stories and a basement like the neighboring structures (Figure 4.51.). Differentiating from the Italianate-style buildings on the south side of the street, these speculative row houses reflected Queen Anne's style.
