MASTER THESIS

**FACADISM AS AN INTERVENTION STRATEGY
FOR ADAPTIVE REUSE OF HISTORIC BUILDINGS**

ASLI TATLIBAŞ

MSC. IN INTERIOR ARCHITECTURE

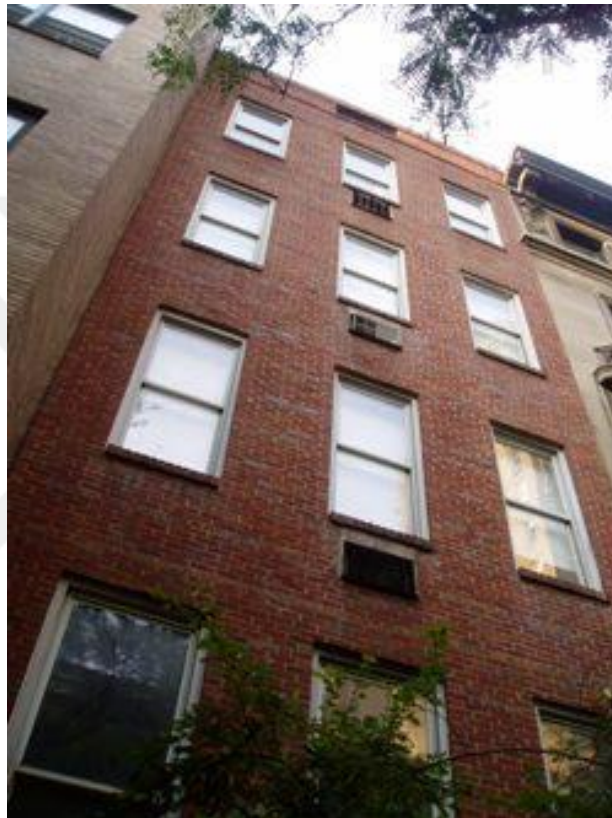
Figure 4.52. 45 East 74th Street before Renovation Close Up Retrieved from: <https://observer.com/2013/06/blinded-by-the-white-after-10-m-renovation-newly-limestoned-45-east-74th-asks-30-m/>

As the development and evolution began in the district, the building's facade was deformed by a renovation in the 1950s. This renovation caused the building to lose its characteristic elements, such as its stoop and roof cornice. The facade was clad in dull red brick, and it was damaged in order to have holes for air conditioning systems (Figure 4.52.).

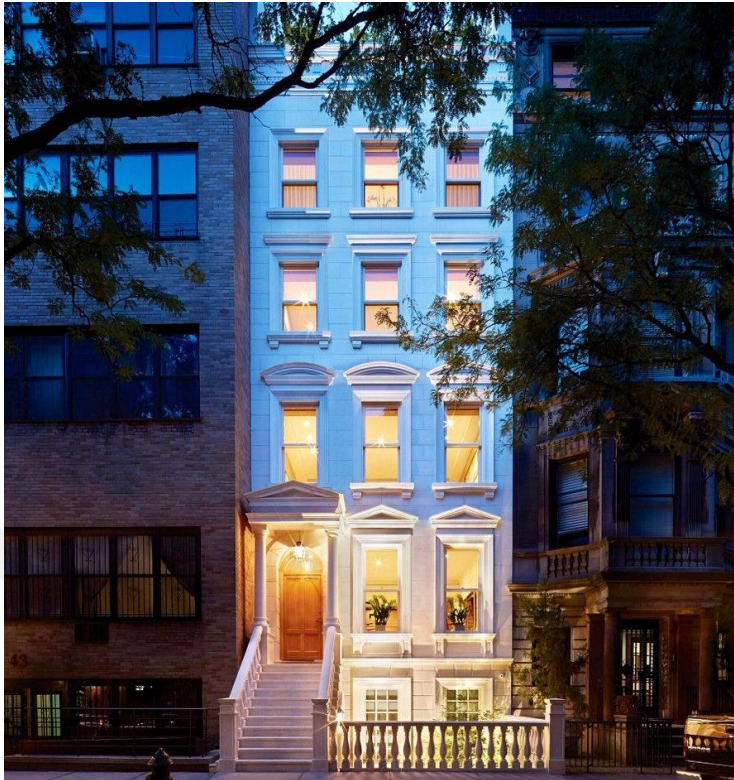
Figure 4.55. 45 East 74th Street at Night Retrieved from:
<https://tr.pinterest.com/pin/855683997923662565/>

The exterior of the structure was altered majorly as well. Ornamental doric columns were used for the balustrades for front yard fencing. The pediments of the windows

and the stoop were reinstated from limestone coherently with the initial design. The demolished roof cornice was also brought back as the new design (Figure 4.55.).

The aim for the exterior of the building was to bring back some of its original features by imitating them with new material; however, for the internal part of the building, all of its characteristic features were lost for contemporary living spaces. The facade of the building blends with its surrounding neighborhood in means of style and material. Additionally, the contemporary intervention to the building allows it to be an active component in the daily life of the people as it is utilizable and can provide the needs of a current living style (Table 4.7.).

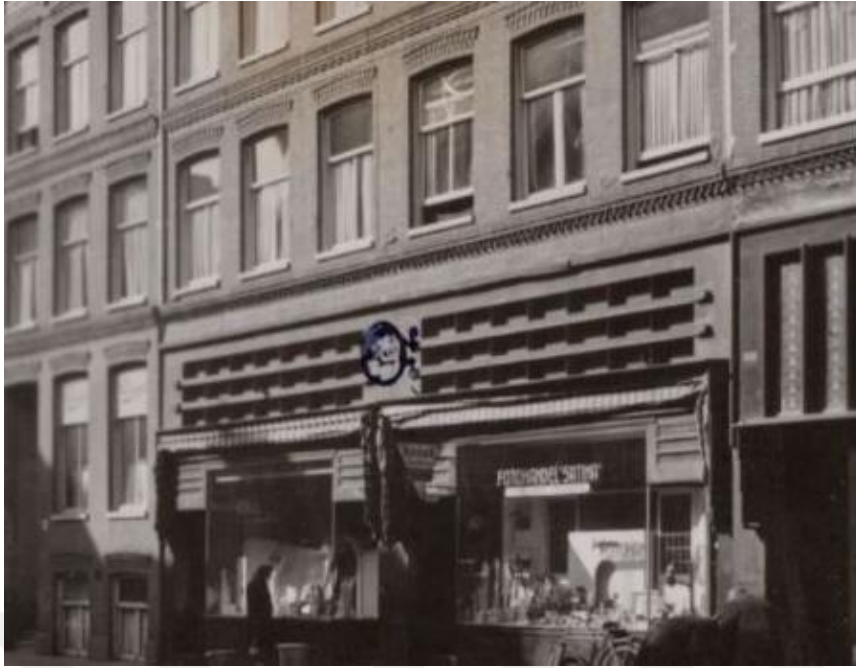
Figure 4.58. P.C. Hooftstraat 140-142 n.d. Retrieved from:
<https://archieff.amsterdam/beeldbank/?mode=gallery&view>

The building carries the characteristics of a traditional Amsterdam house. The structure is mainly made out of red brick, and it reflects the importance and how common brick usage is in Dutch architecture. By consisting of three stories, the structure blends in with the surrounding buildings, which are also three or four stories high. The ground floor of the typical Amsterdam townhouse is reserved for retail use, and the upper two floors are used for residential purposes. In this structure, it is observed that the facade is divided horizontally in line with the floor heights, and each window is crowned with arch-shaped frame details (Figure 4.58.).

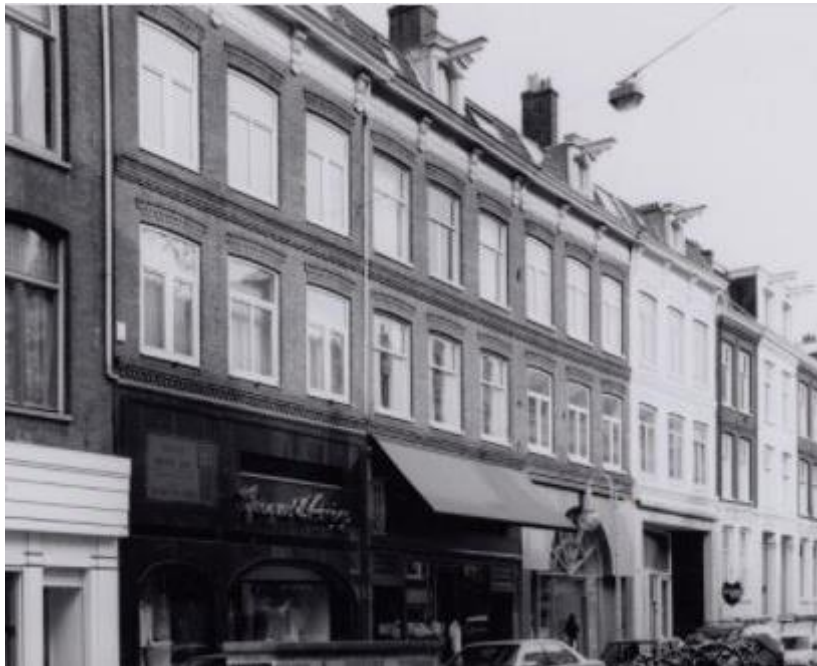
Figure 4.59. PC Hooftstraat 142 Retrieved from:
<https://archieff.amsterdam/beeldbank/detail/>

The apartment's entry door is positioned on the left side of the building to avoid dividing the front facade, which is an essential aspect of a classic Amsterdam home. Over the years, the structure went through some alterations, including the changes on the ground level (Figure 4.59.).

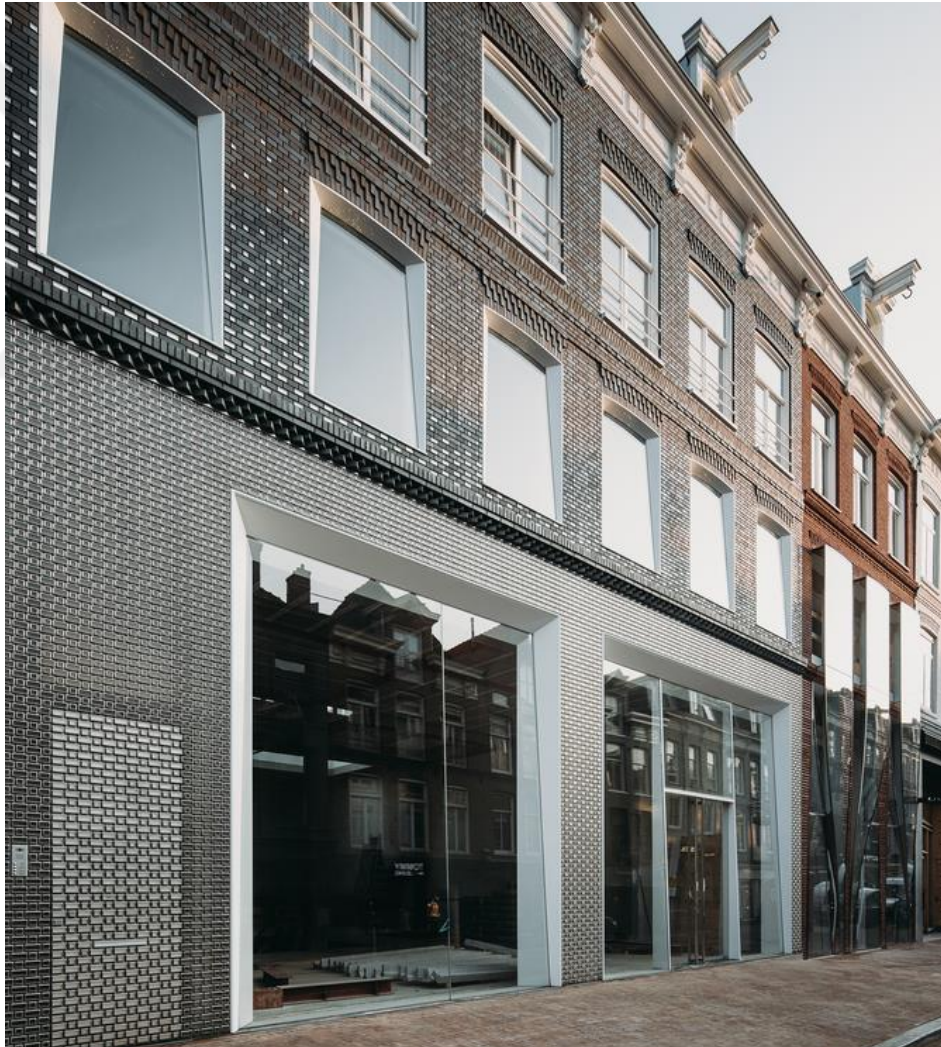
Figure 4.60. Brick Pixelation by UN Studio Retrieved from:

The design group intended an eye-catching design that would adapt to the present street condition. As one of the most famous shopping streets in Amsterdam, high-end brands compete with each other not only by their products but also by the design of their store. On the ground floor level of the historic building where the store section will be located, the facade material was altered to create the illusion of a pixelated image (Figure 4.60.).

Instead of working with traditional bricks, stainless steel bricks with inlays made out of glass were used to create the facade of the store level. The traditional brickwork of a Dutch townhouse in anthracite color was used on the second-floor level (Figure 4.61.). The trick material allows the front to be experienced differently from different angles and keeps a respectful stance to the area's architectural heritage.

All bricks are manufactured in different sizes to create a similar pattern to the brick facades of the upper levels. In order to create privacy in the entrance area of the apartment, the inlays of the stainless steel bricks of the entrance door were made out of opaque glass (Figure 4.62.). Every single detail on the facade was custom-made to create a harmonious unity.

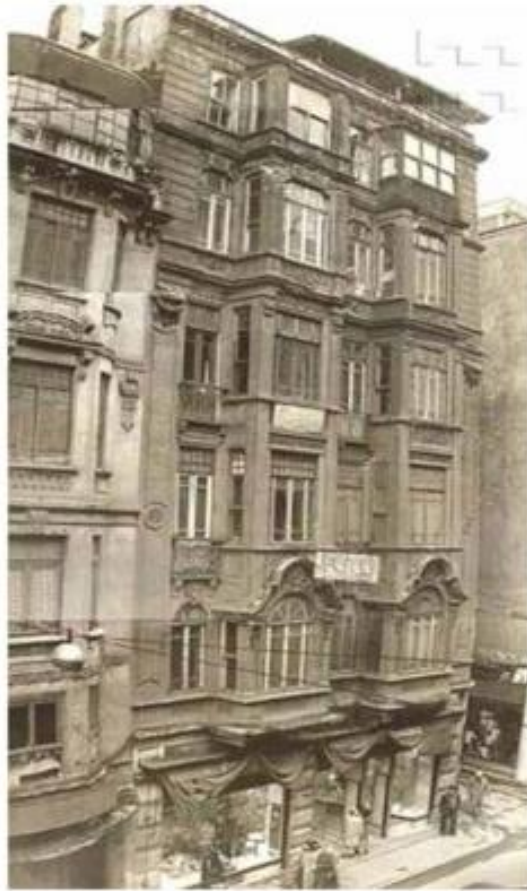
Figure 4.66. The historic structure, 1920s Retrieved from:

The whole structure is made out of a masonry brick system. It is observed that the frontal facade of the building is more detailed than the rest. Rectangular blocks frame the store level, and the first-floor windows have window buttresses supporting them. The front of the first three floors is decorated with ornaments, whereas the rest of the floors have simpler facade designs (Figure 4.66.).

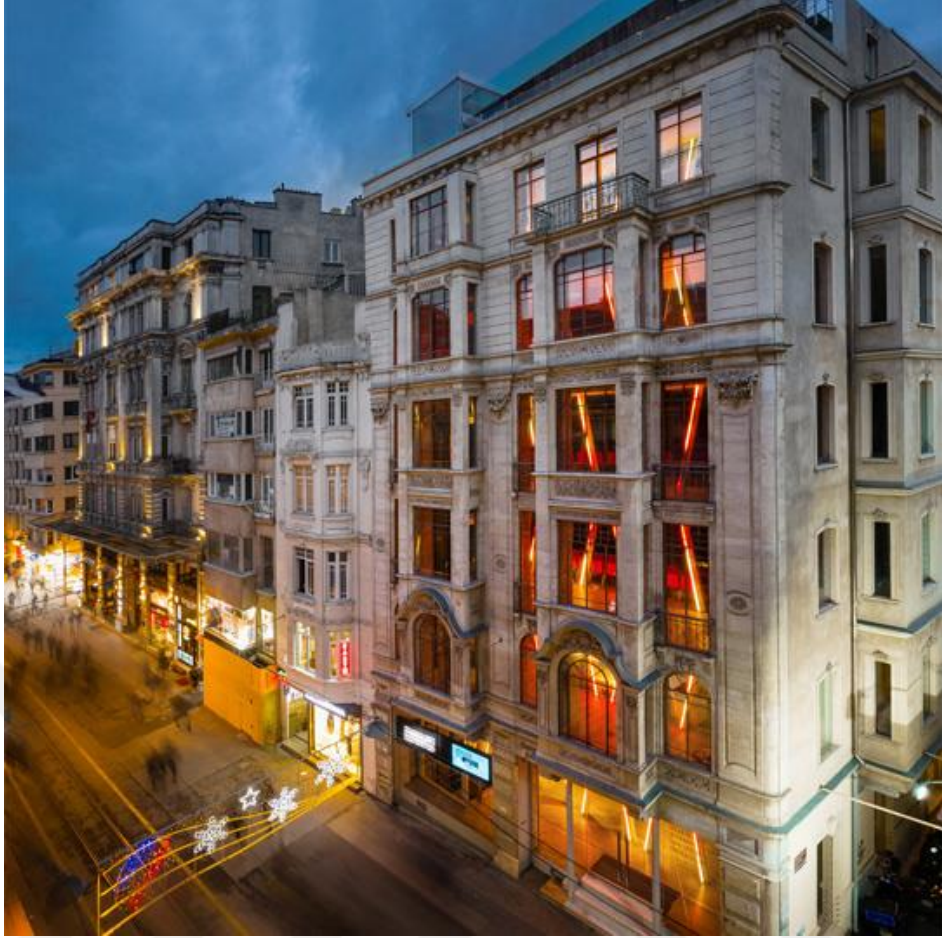
The new design aims to preserve the structure's outer shell, whereas the interior is wholly demolished. The new contemporary interior system is carried by light diagrid columns, contrasting with the historic façade (Figure 4.67.). The tension between the old and the new creates an ideal space for art where multiple types can be presented.

Figure 4.67. Borusan Cultural Center at night Retrieved from:

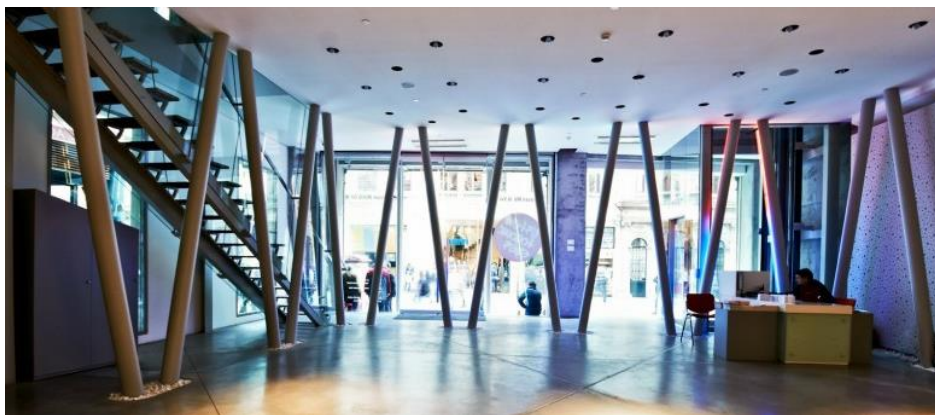
The facade of the ground floor has a monolithic glass that allows the activities inside to be visible to the people passing by on the İstiklal Street. This facade is also the entrance of the center (Figure 4.68.).

Figure 4.68. Borusan Cultural Center ground floor Retrieved from:

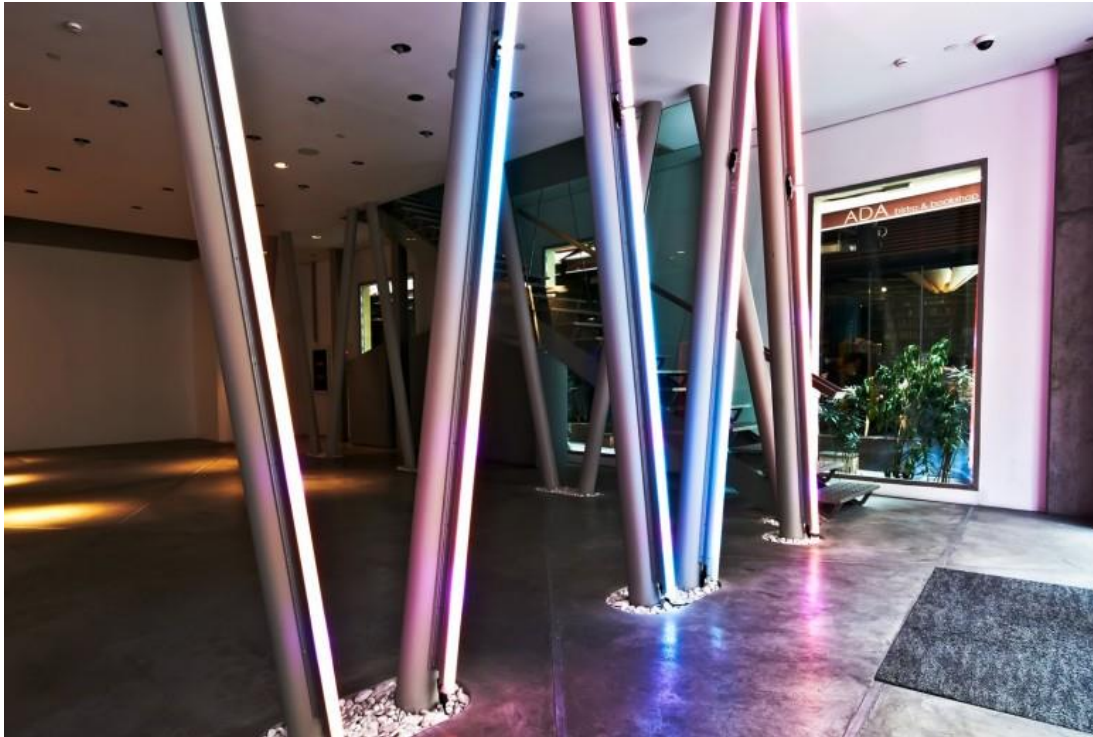
The new columns of the contemporary structure are placed remotely from the historic facade creating a buffer zone in the transition from old to new. These V-shaped columns are illuminated with colorful LED lights, which give it a unique appearance from the outside as well as inside (Figure 4.69.). The new building consists of 2 major concert halls, six rehearsal rooms, and a multipurpose area used for various activities.

Figure 4.69. Colored V-shaped columns Retrieved from:

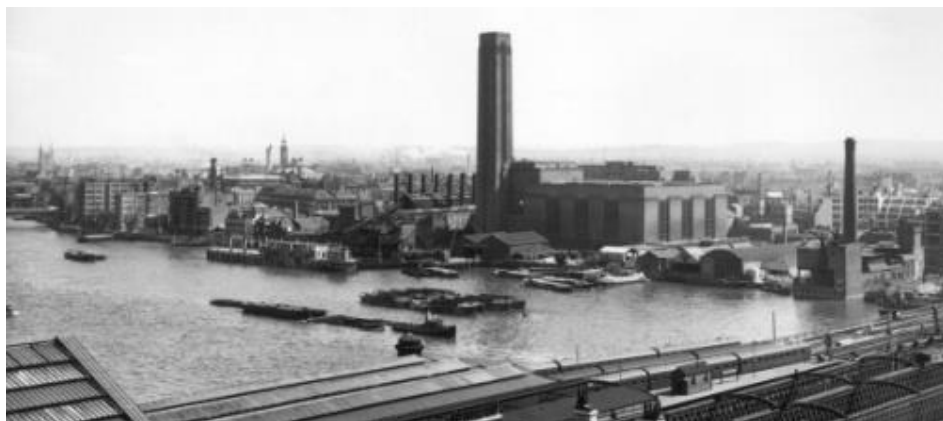
After the initial power station in the area went through a crisis of causing extensive air pollution and inefficiency. The station was intended to be renewed earlier, but WWII prevented it. Sir Giles Gilbert Scott made the new design. The structure was steel framed and clad with brick. The central chimney that dominates the Bankside area's skyline was intentionally made shorter than the St. Paul's Cathedral, which is located on the other side of the river (Figure 4.72.).

Figure 4.72. Bankside Power Station Retrieved from: <https://greatwen.com/2016/06/15/tate-modern-a-tale-of-two-power-stations/>

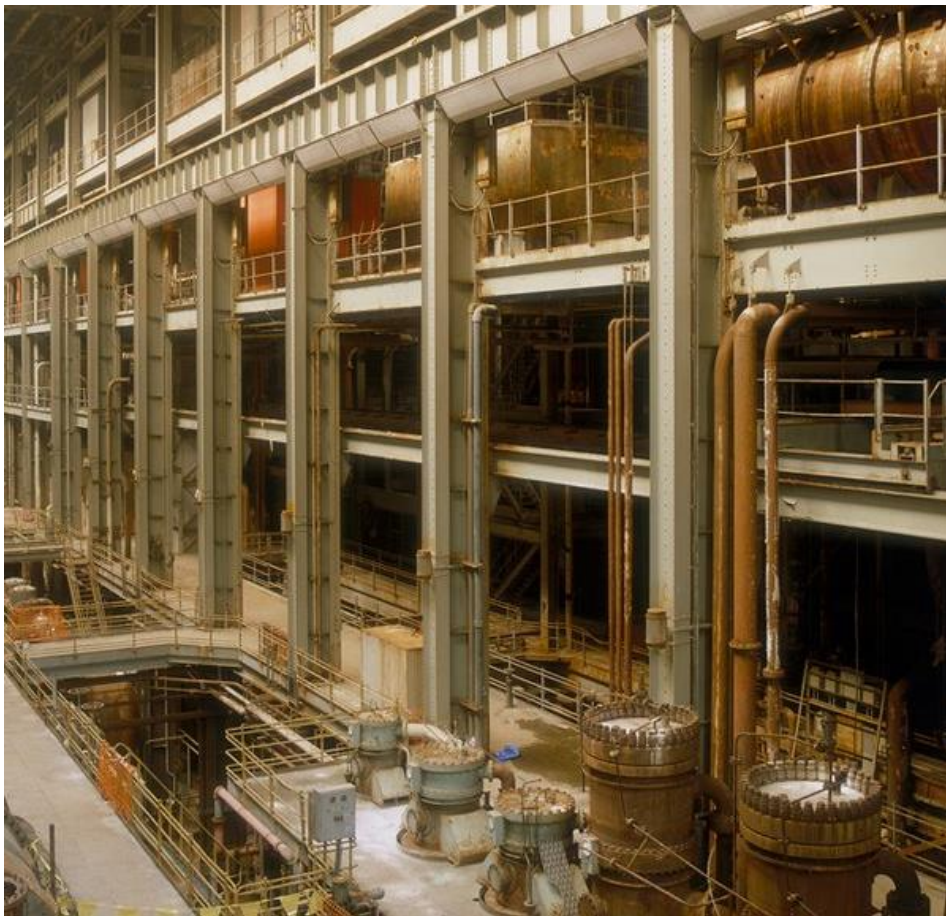
The initial plans of the structure consisted of three sections; the turbine hall, the boiler house, and electricity transformers and switch house. The turbine hall was a significant area with a considerable ceiling height. Some of the brick walls of the hall were left unfinished, and the steel construction beams were visible, which is common in most industrial structures (Figure 4.73.). The narrow vertical windows stretch up through the facades on each end of the hall (Figure 4.74.). The construction work was carried out in two stages, and the building was completed in 1963. The complex was abandoned for years before a revitalizing project was prepared.

Figure 4.73. The turbine hall prior to remodeling Retrieved from:
<https://www.tate.org.uk/visit/tate-modern/look-behind-art-tate-modern>

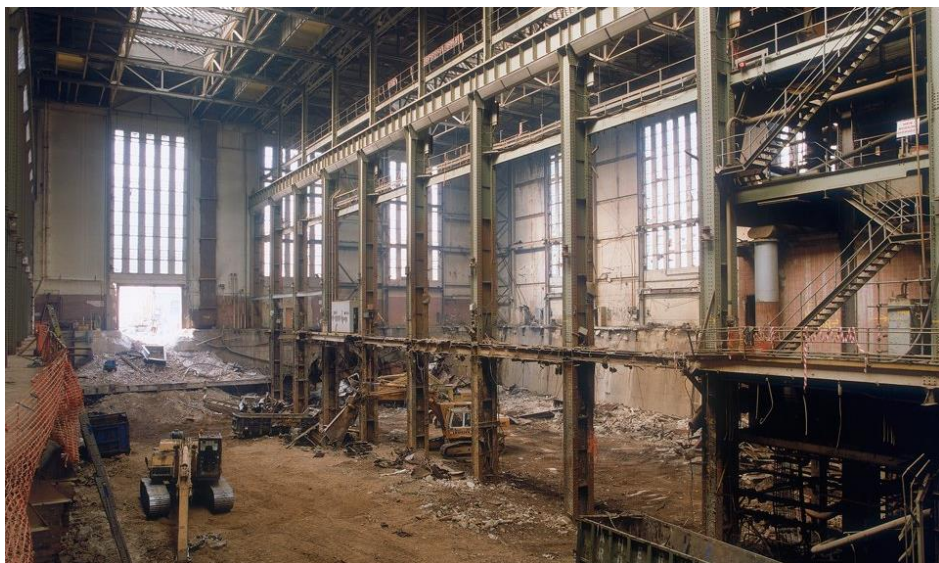
For the remodeling of the building, an architectural design competition was organized in 1995. The minimal exterior alterations proposed by Herzog& de Meuron played a significant role in their win. As small as the exterior intervention, the structure's interior was almost completely demolished (Figure 4.75.)

Figure 4.75. Demolition of the interior of the turbine hall Retrieved from:
<https://www.tate.org.uk/visit/tate-modern/look-behind-art-tate-modern>

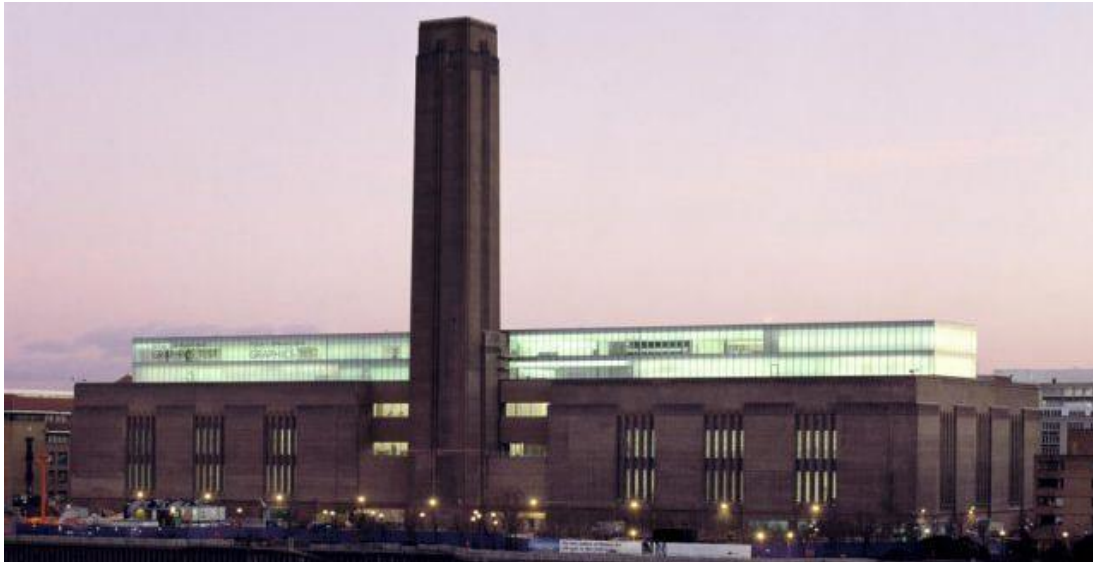
The most noticeable exterior change is the light beam added on top of the structure. This horizontal mass was aimed to contrast with the vertical chimney of the historic structure. The industrial character of the building sought to be preserved and carried on with the new additions. (Figure 4.76.).

Figure 4.76. Light beam illuminated Retrieved from:
<https://www.arkitektuel.com/tate-modern/>

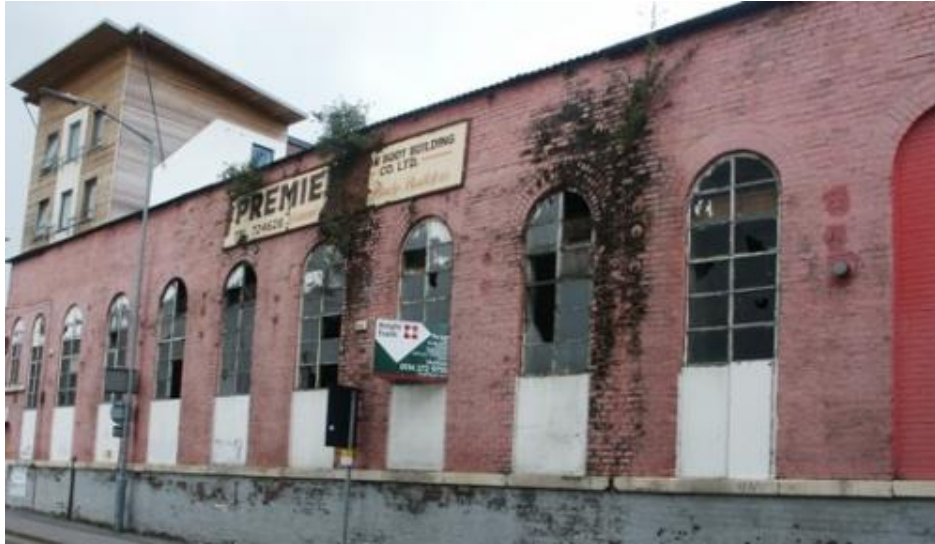
The historic industrial building is made with the Victorian style, the plain and red brick dominating the used materials in the structure. Although there are no interior photos from the initial state of the facility, it is known that the interior was not divided into spaces; it was used as a single space. The facade of the structure, which blends well with the surrounding red brick facades, is slightly fragmented by the tall windows and their grid iron frames (Figure 4.80.). Occupying the corner of a plot, the structure dominates the junction of streets (Figure 4.81.).

Figure 4.80. 192 Shoreham Street before remodeling Retrieved from: <http://arttuu.blogspot.com/2012/03/192-shoreham-street-sheffield.html>

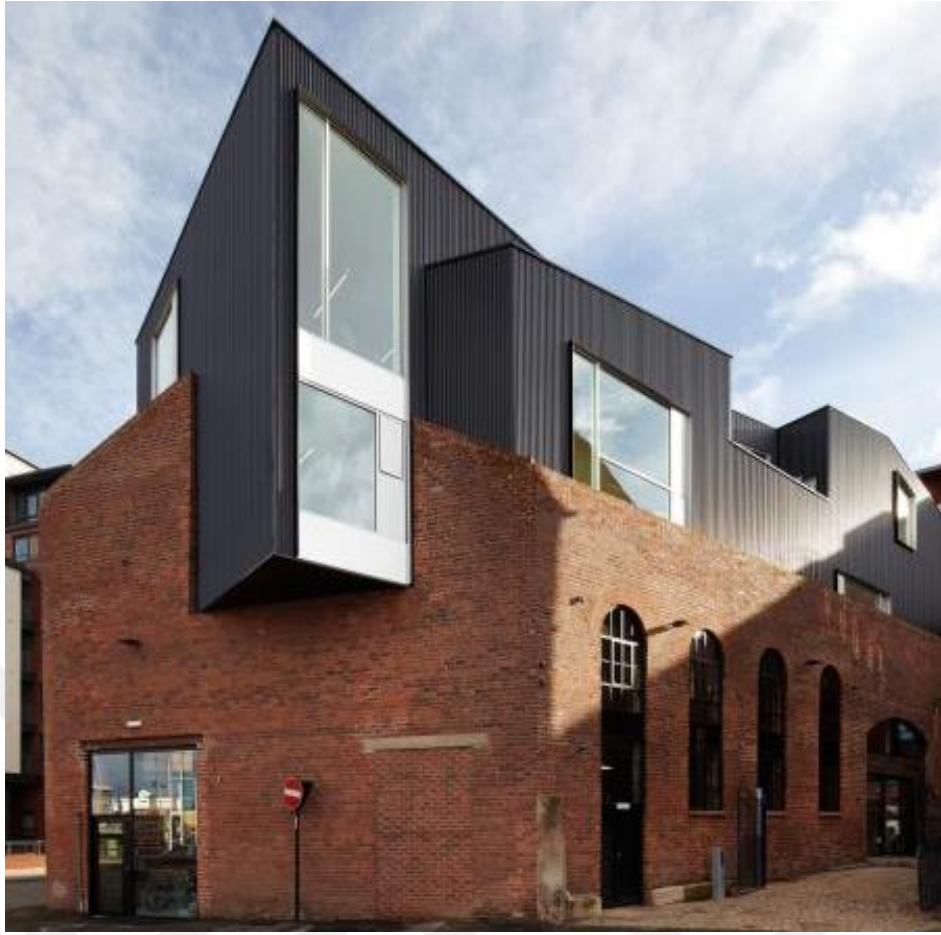
The design proposal made by Project Orange aimed to create a landmark that would draw attention from the public. The once redundant building was given a new function that would revive the area. The internal part of the structure was completely removed, leaving only the outer shell intact. The remaining parts of the historic building were used as a base, and the volumetry of the building was vertically extended (Figure 4.82.).

Figure 4.82. New Addition Retrieved from:

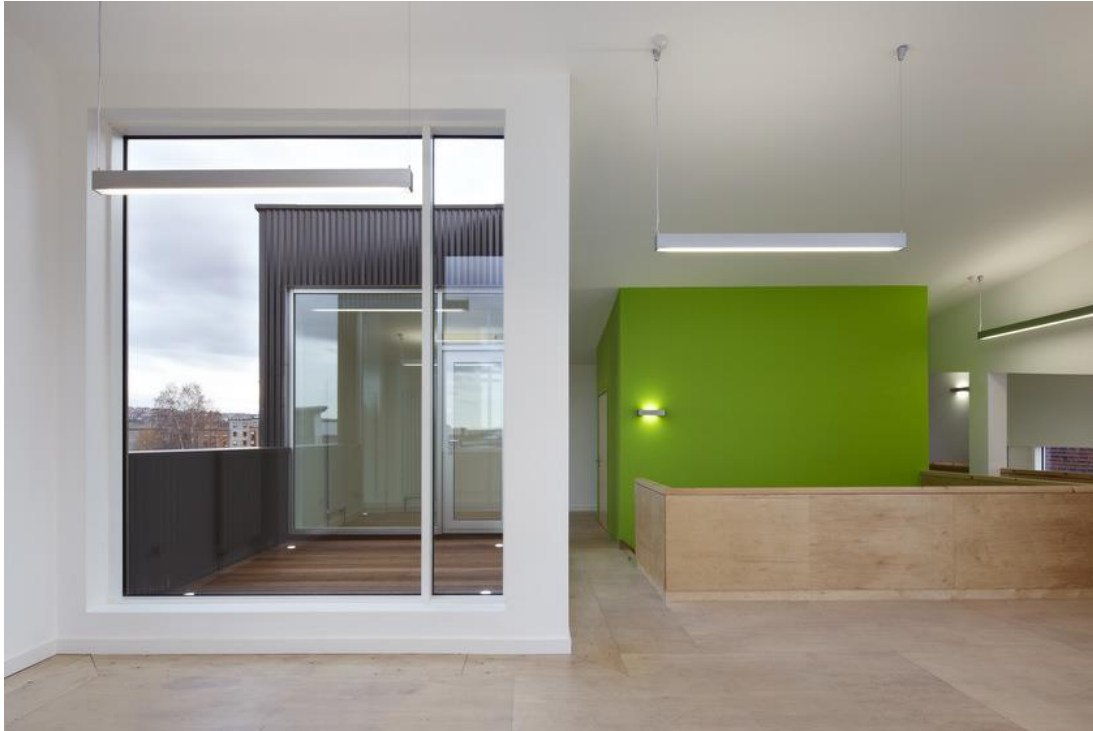
The new addition references the former industrial roofs that dominated the area. The contemporary materiality of the new structure creates a contrast with the historical texture of the base. Internal parts of the new building are dominantly made out of natural wood and plasterboard walls, creating a calm but contemporary atmosphere (Figure 4.83.). The internal height is doubled compared to the previous measurements, increasing the spacious feeling of the interior.

Figure 4.83. Interior of the new structure Retrieved from:

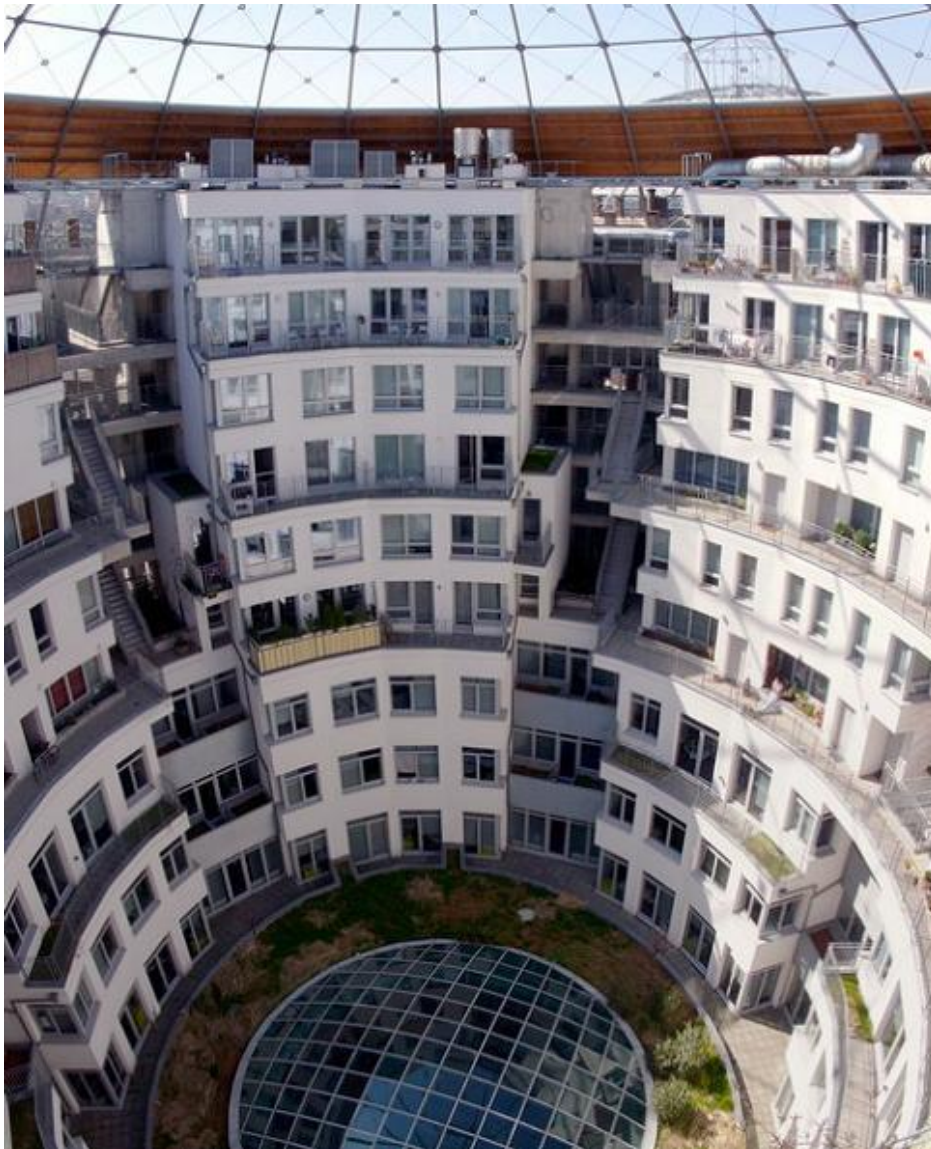
For the remodeling project of these structures, a design competition was held, and consequentially, four renowned architects were chosen to intervene with the gasometers. Jean Nouvel, Coop Himmelblau, Manfred Wehdorn and Wilhelm Holzbauer were all assigned with one of the gasometers' interior design. The metallic roofs and brick facades were the only parts preserved from the initial constructions. The final state of the complex consists of apartments, offices, shopping halls, and

concert areas. The contrast between the interior and exterior of these structure can be observed clearly by the form and the materiality of the new additions (Figure 4.87.).

Figure 4.87. Interior of the Gasometers Retrieved from:
<https://twistedstifer.com/2009/10/gasometers-of-vienna/>
